EITRM116871: D2.3 Geoscientific evaluation of pilots

KAVA Reference (Number, Acronym, Full Title): 19160, UNEXUP, UNEXMIN Upscaling

Name of the author/Responsible partner: Hilco van Moerkerk, Zorana Milosevic, Steve Henley (RCI), Richard Papp (UGR), John Barnatt (Ecton Mine Educational Trust), Richard Shaw (Ecton Mine Educational Trust)

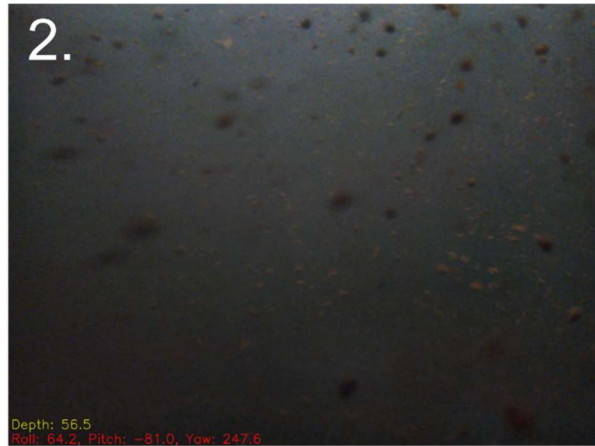
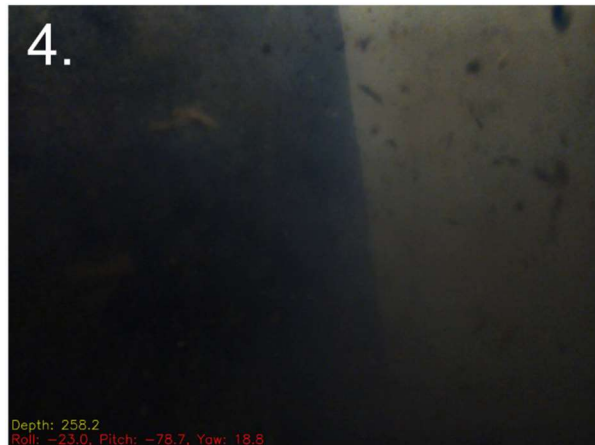
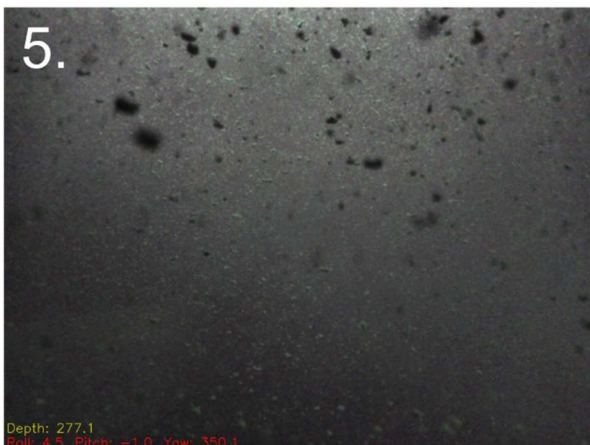
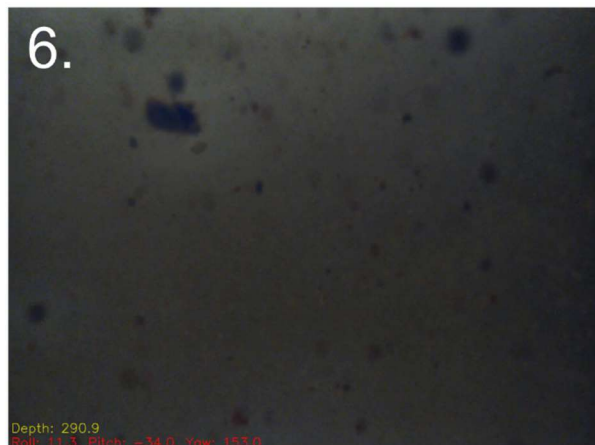
The opacity did not disappear in the deeper layers either (**Figure 2**), the sediment from the side wall of the shaft, corroded metal pieces, dust and other floating particles did not allow the visual survey of the parts of the shaft farther from the robot.

3. Figure - The opacity of the water.

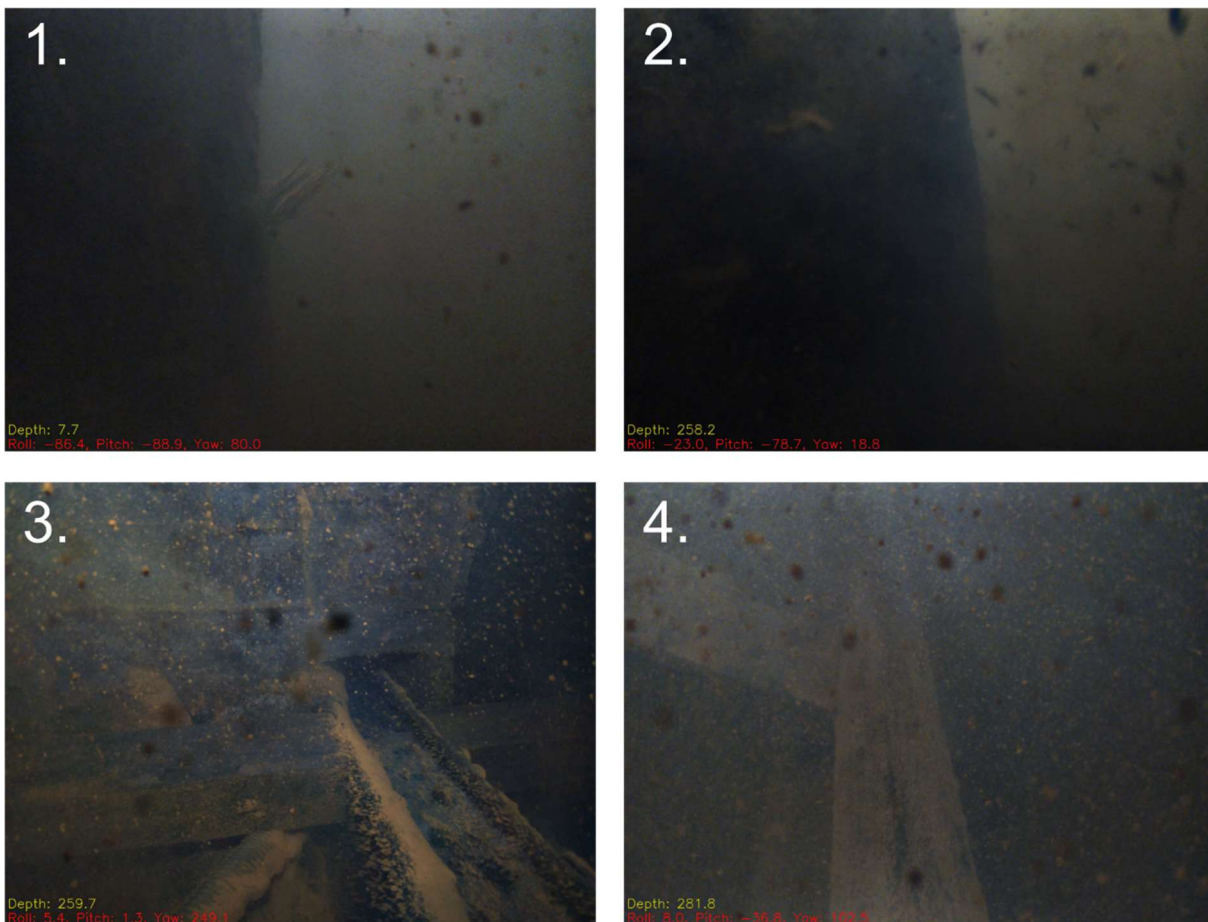
The wooden bar, placed in the middle of the shaft is visible in most cases up to the level of the “195 m pumping station” (**Figure 3**). With the help of other information collected during the dive, it can be stated that the wooden beam can be found up to the examined depth, it is not broken and has no missing parts.

4. Figure - The view of the wooden bar in different depths.

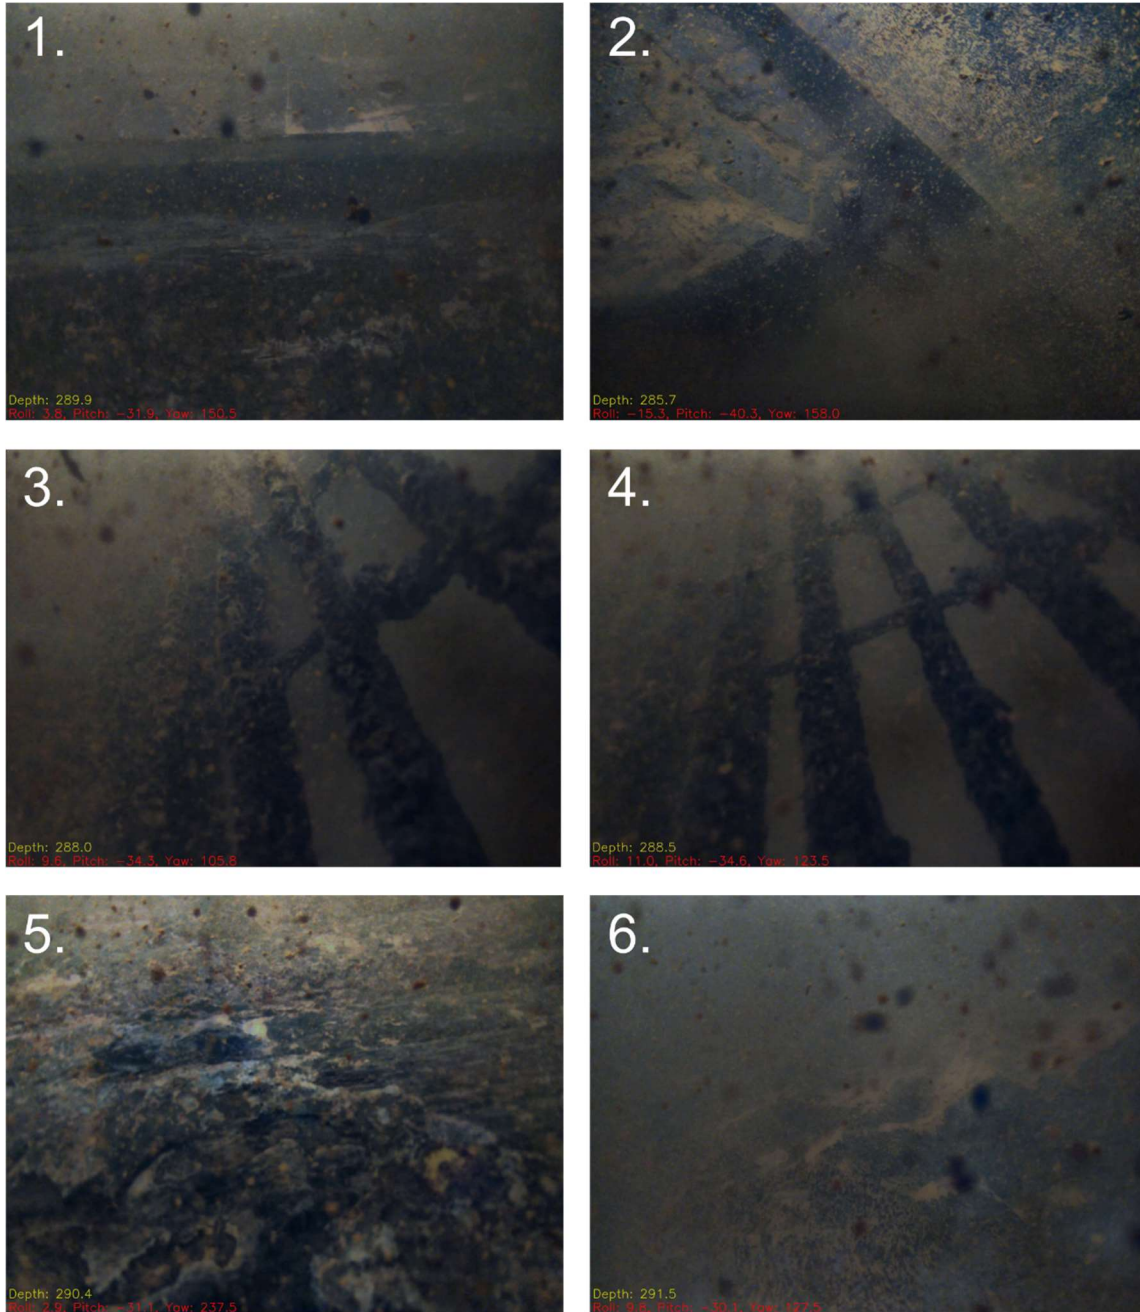
Access to the level to be tested was not possible, so visual observation of the pump station could not be performed. The entrance to the level of the pump station was examined by the robot for more than 30 minutes at the request of the mine, so that the most accurate point cloud possible under the given conditions was collected (see **Chapter 5.2**).

During the time spent near the entrance, the transparency of the water improved somewhat, but was never greater than 30 cm. The cameras were used to identify the concrete, metal and other elements

5. Figure - The view of the entrance of the "195 fm pumping station"
1-2. Concrete, metal and rock material around the entrance; 3-4. The closed metal gate; 5-6. The granite of the shaft.

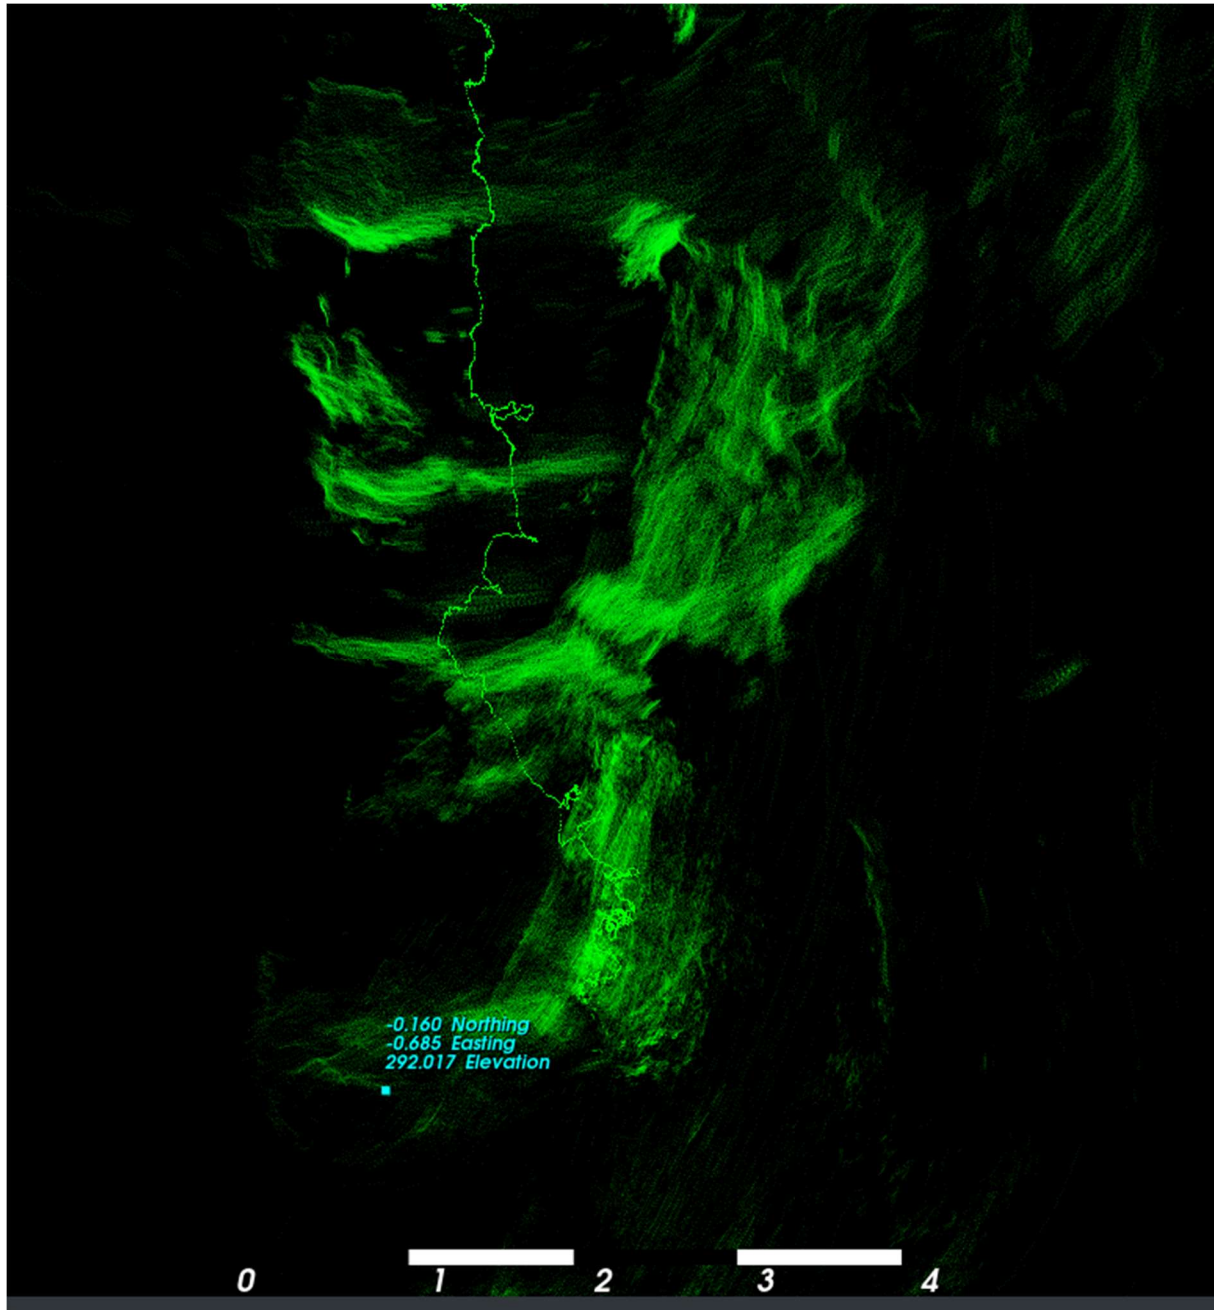
7. Figure - The point cloud of the entrance of the „195 fm pumping station” in between 288–292 m. The green curvy line represents the rout of the robot.

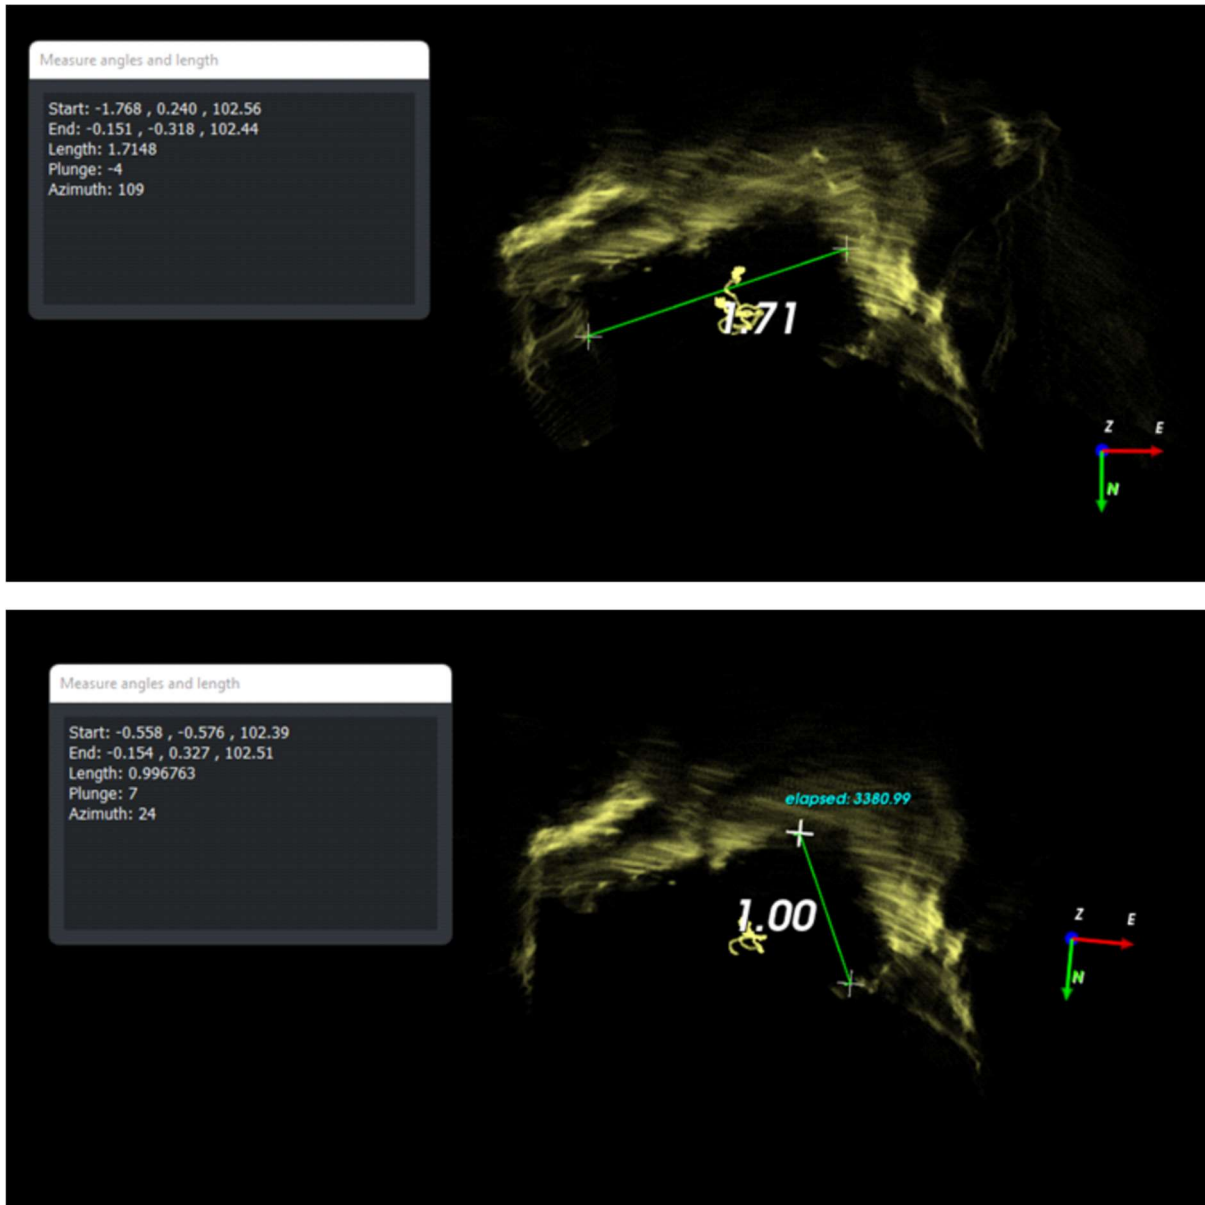
The **Figures 7–9** show that the dimensions of the shaft did not change during the dive. This also confirmed that the shaft structure was not damaged up to a water depth of 292 m.

8. Figure - The dimensions of the shaft (in metre) at ~100 m water depth

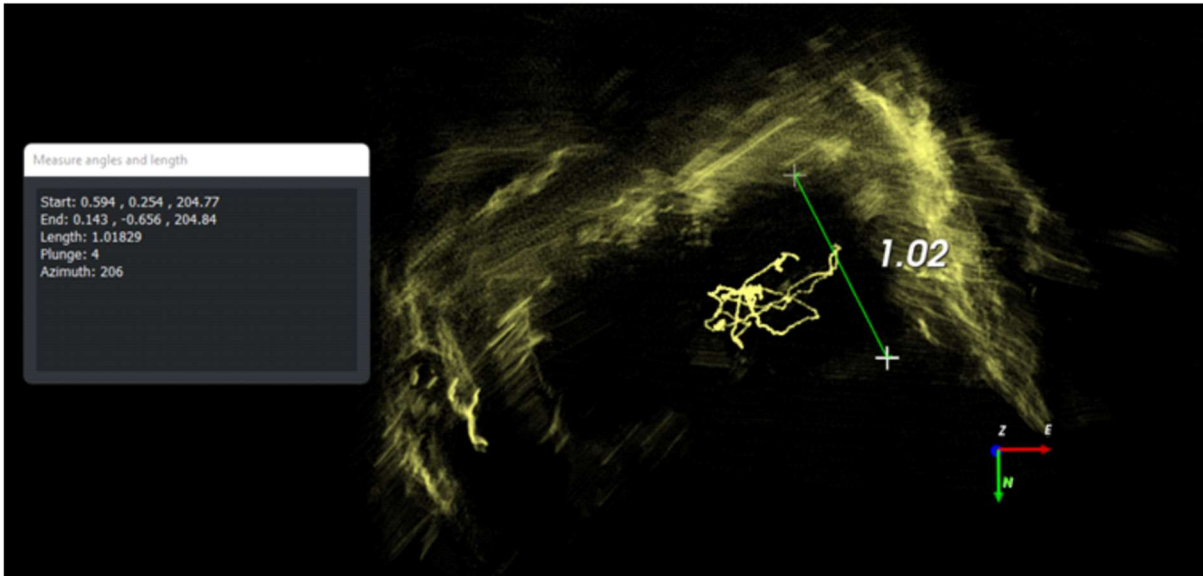
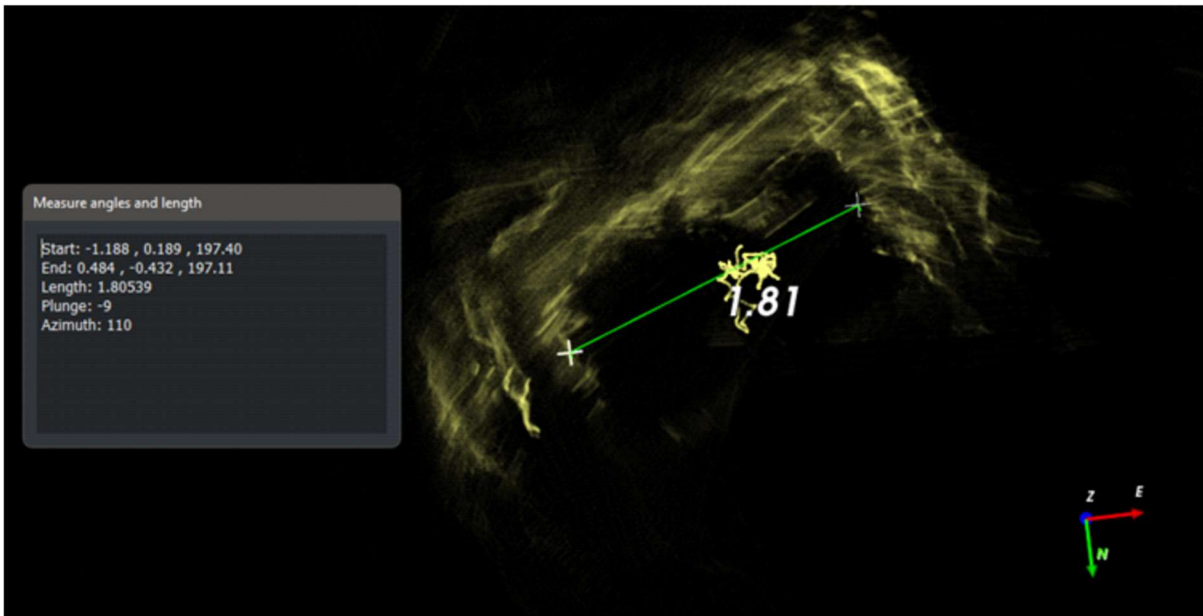
9. Figure - The dimensions of the shaft (in metre) at ~200 m water depth

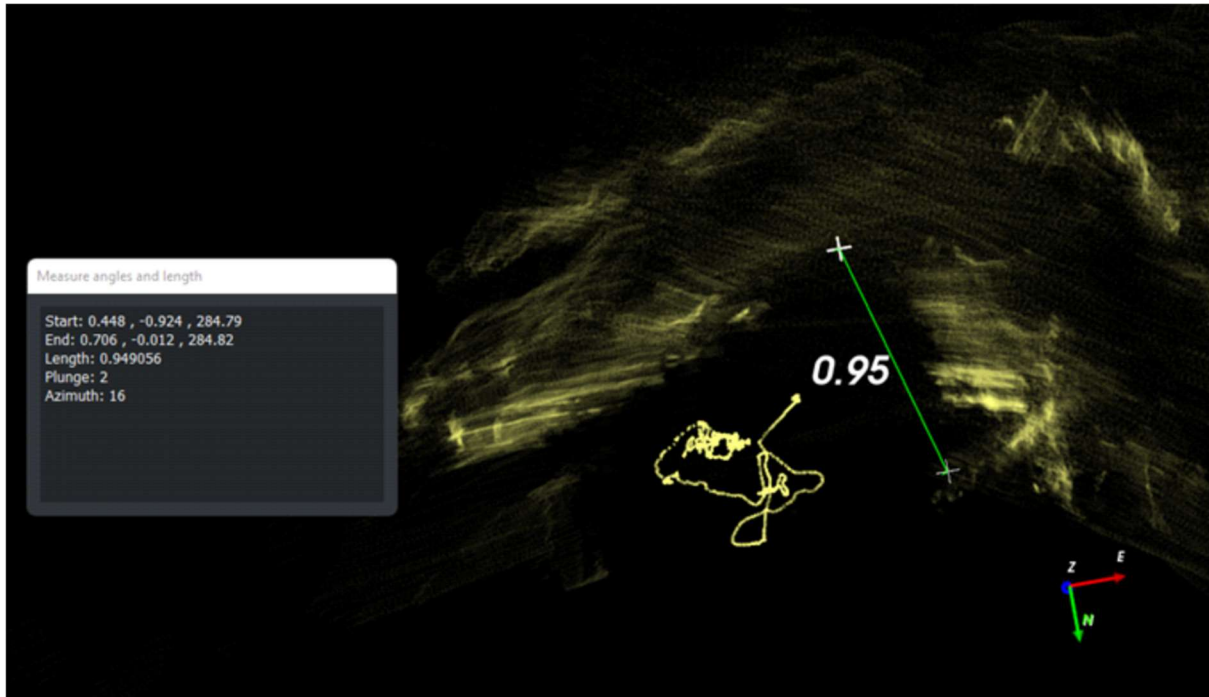
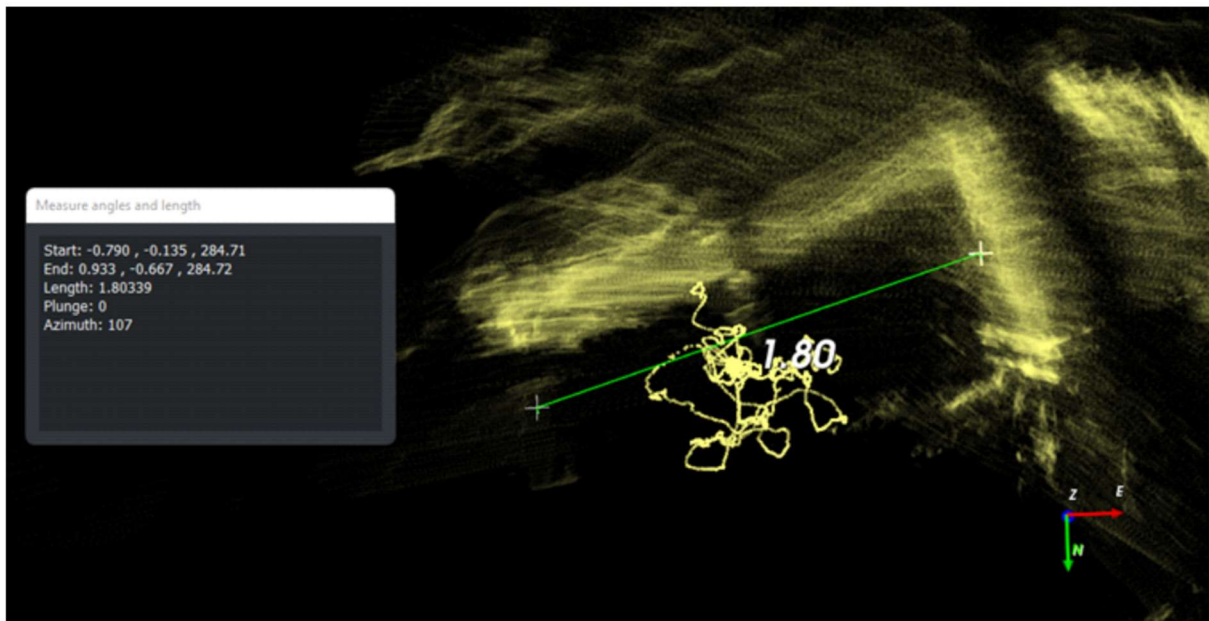
10. Figure - The dimensions of the shaft (in metre) at ~285 m water depth

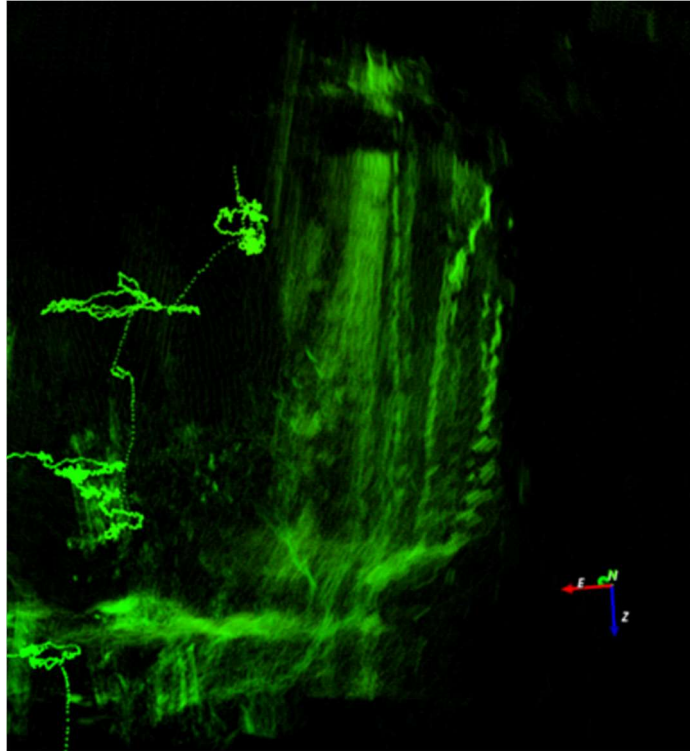
The closed gate and the dimension of it also can be seen on the sonar images (Figures 10–13).

11. Figure - The view of the gate at an angle

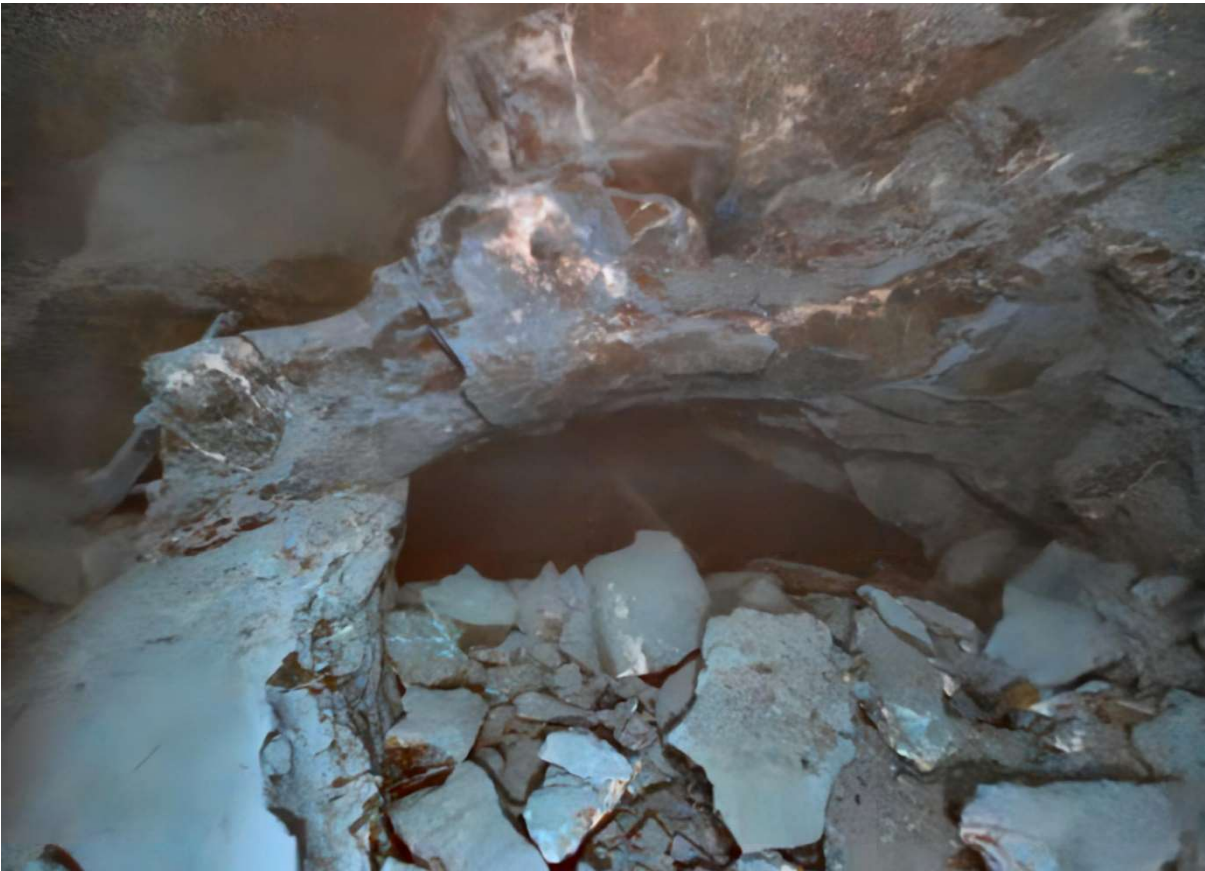
Plate 12: The open part of the PS9 'level' or 'side pipe working' at the south-east end of the pumping shaft. Much of the passage is filled with rubble and, out of shot, there is a complex arrangement of in-situ timbers supporting this backfill at the shaft wall; in total the passage was originally 2.5m high, with a roof at -58m and floor at -61.5m down the shaft. The passage has an unknown destination, but this is possibly the 'main pipe working' or it was a 'cross cut' to the documented 'Deep Level' at -62m. To the left is the large PS8 'side pipe working' lying at the north-east side of the shaft.

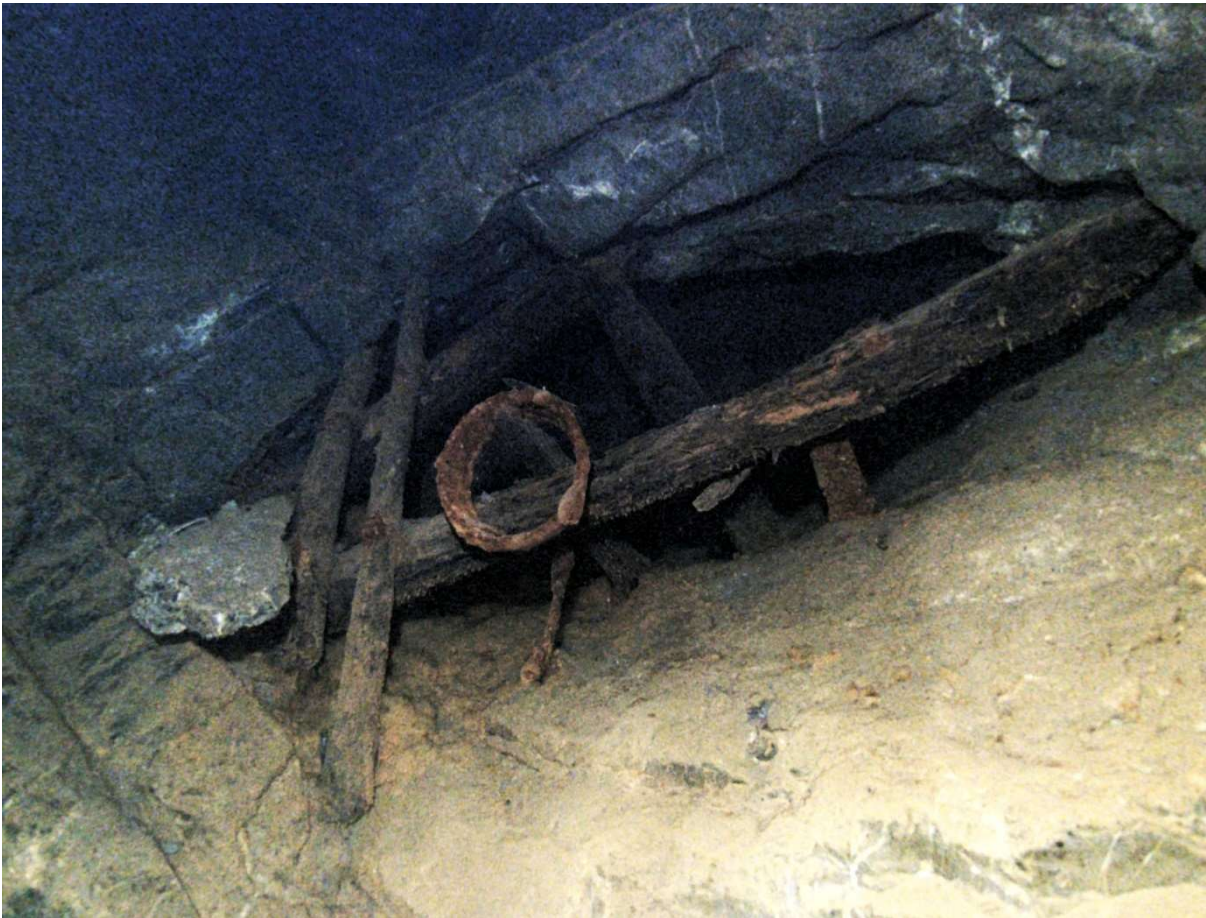
Plate 13: Looking diagonally upwards into the entrance of the 'side pipe working' at WS6 in the winding shaft, with a collection of timbers, some at least of which have collapsed downwards from within the working. The metal ring was placed here after the collapse

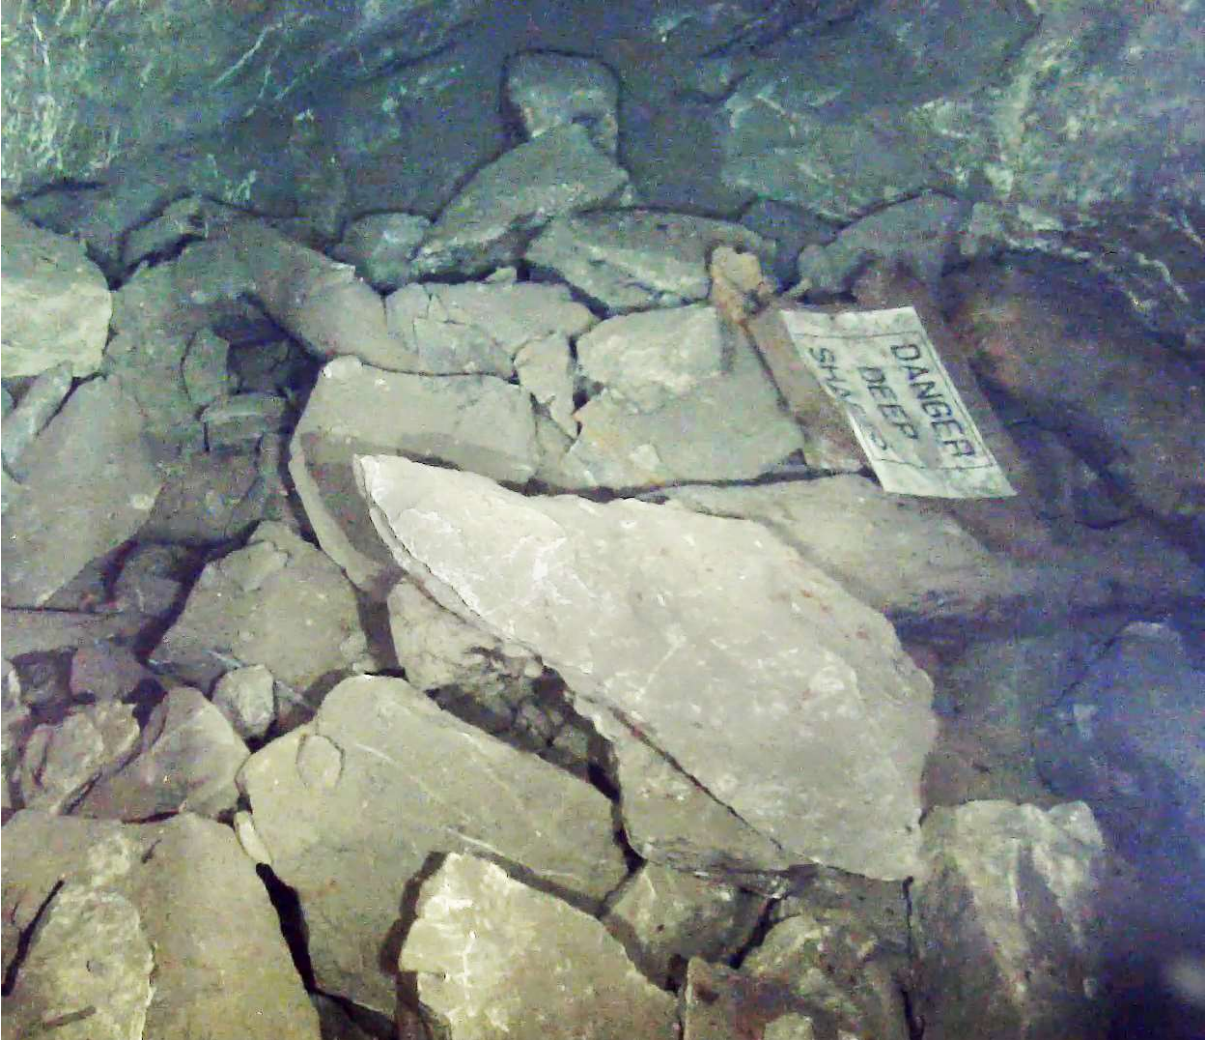
Plate 23: The rubble at the present NW6 base of the North Winze, presumed to have been thrown down in the 1790s after the trial using the shaft was abandoned. The danger sign only came down the shaft recently after it became detached from the modern safety chain at the shaft top

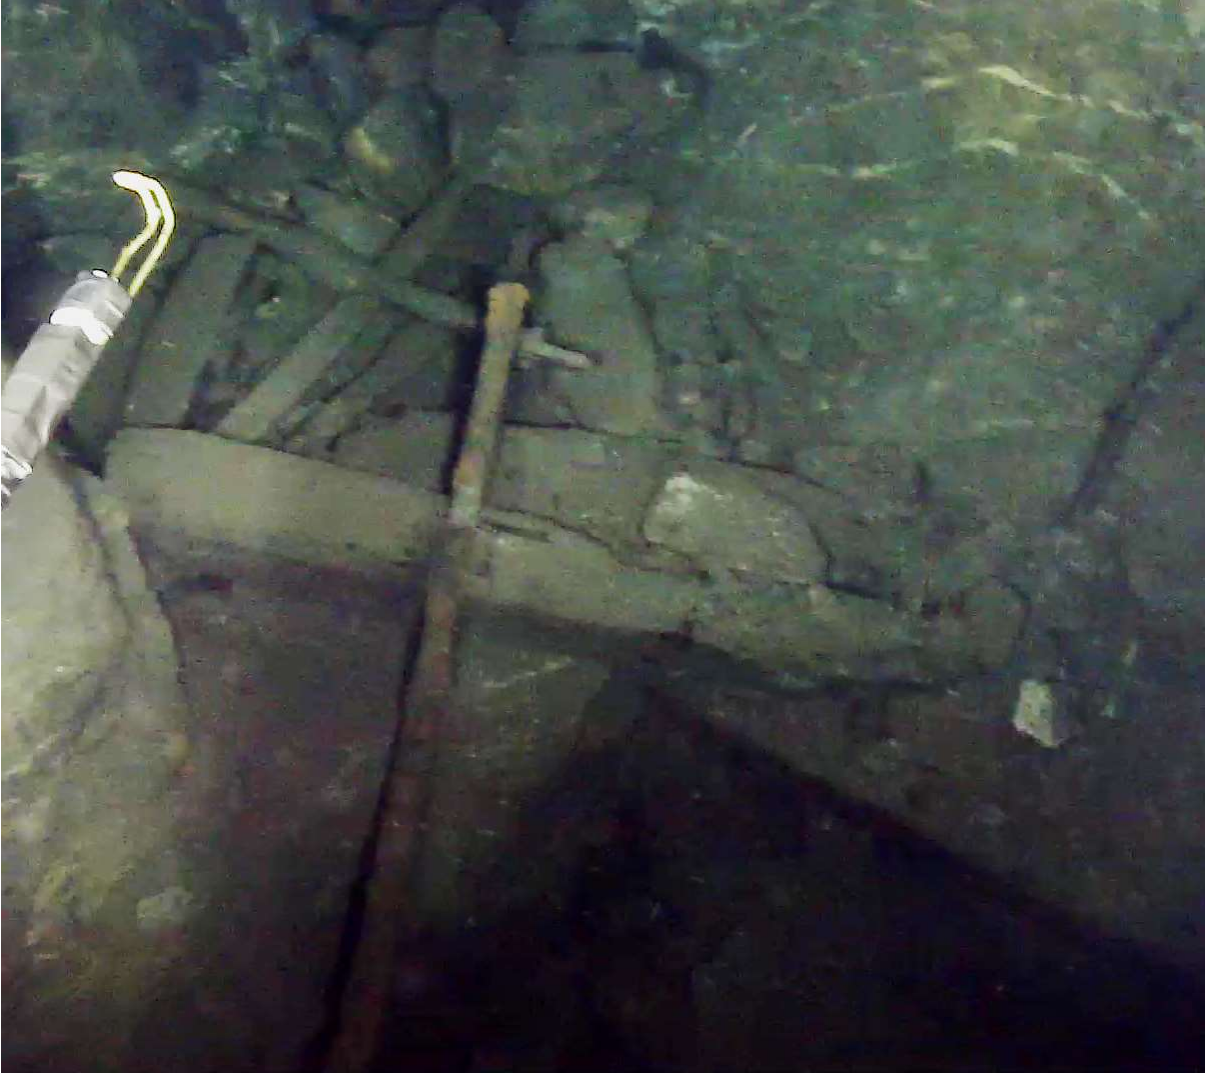
Plate 24: Displaced timberwork on the floor of the entrance to the NW4 eastern trial near the present North Winze base. This is overlain by a modern scaffold pole in the shaft. To the bottom right in the gloom is the horizontal timber that is either also displaced or was a 1790s support for a platform across the shaft at the horizon of the floors of the short NW4-5 'trials levels' leading east and west.

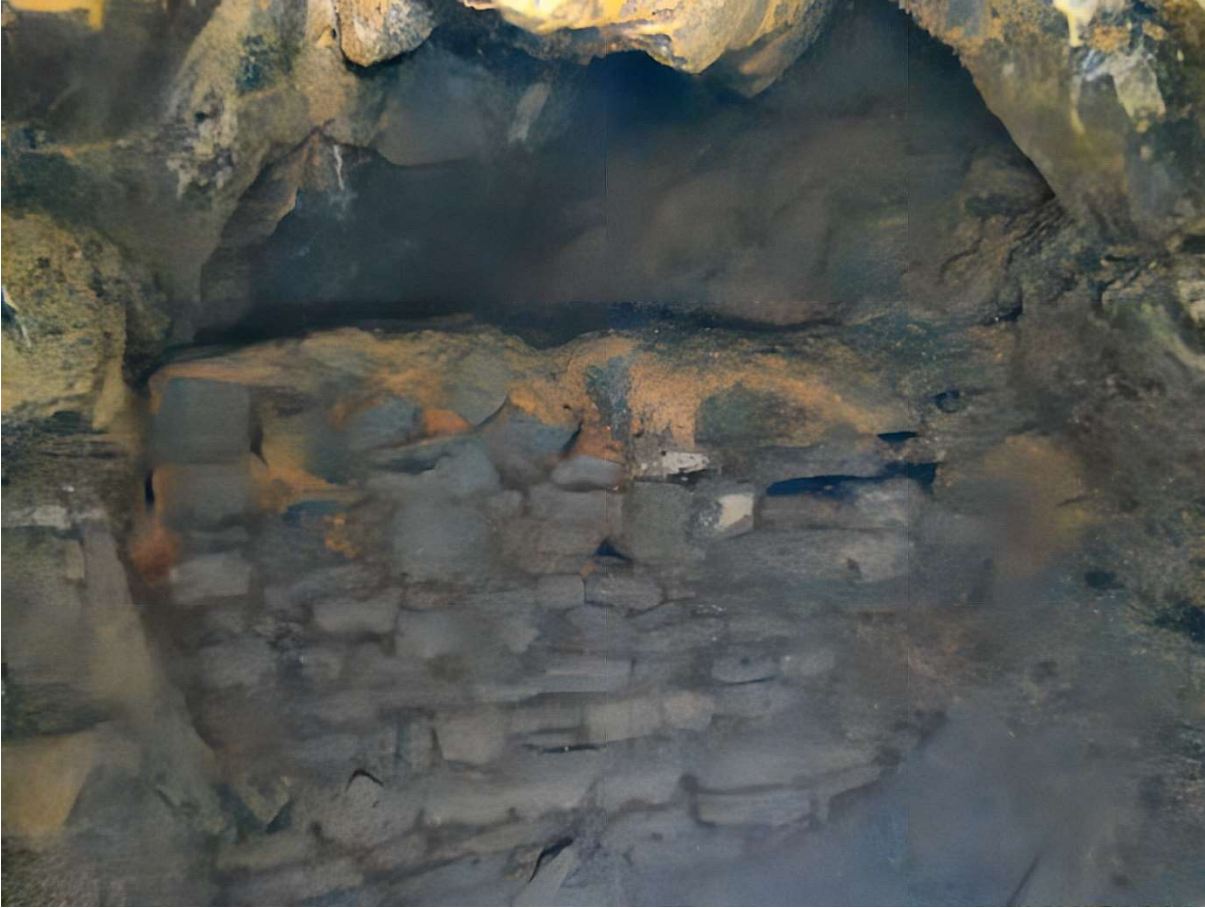
Plate 25: The dam across the PS12 possible 'level' and probable 'side pipe working' has sediments at its top to the left that could fully seal a postulated passage directly behind. The dark area here is a shadow cast by the submersible lighting. A probable 'side pipe working' to the right rises steeply upwards and presumably goes out of sight
