The Restoration of the Deep Ecton Level Entrance (List Entry Number 1021175; SMC Ref No, S00168477): Recording and Findings during the Archaeological Watching Brief (October to November 2018)

Dr John Barnatt, BA Hon, PhD, MCIfA, FSA

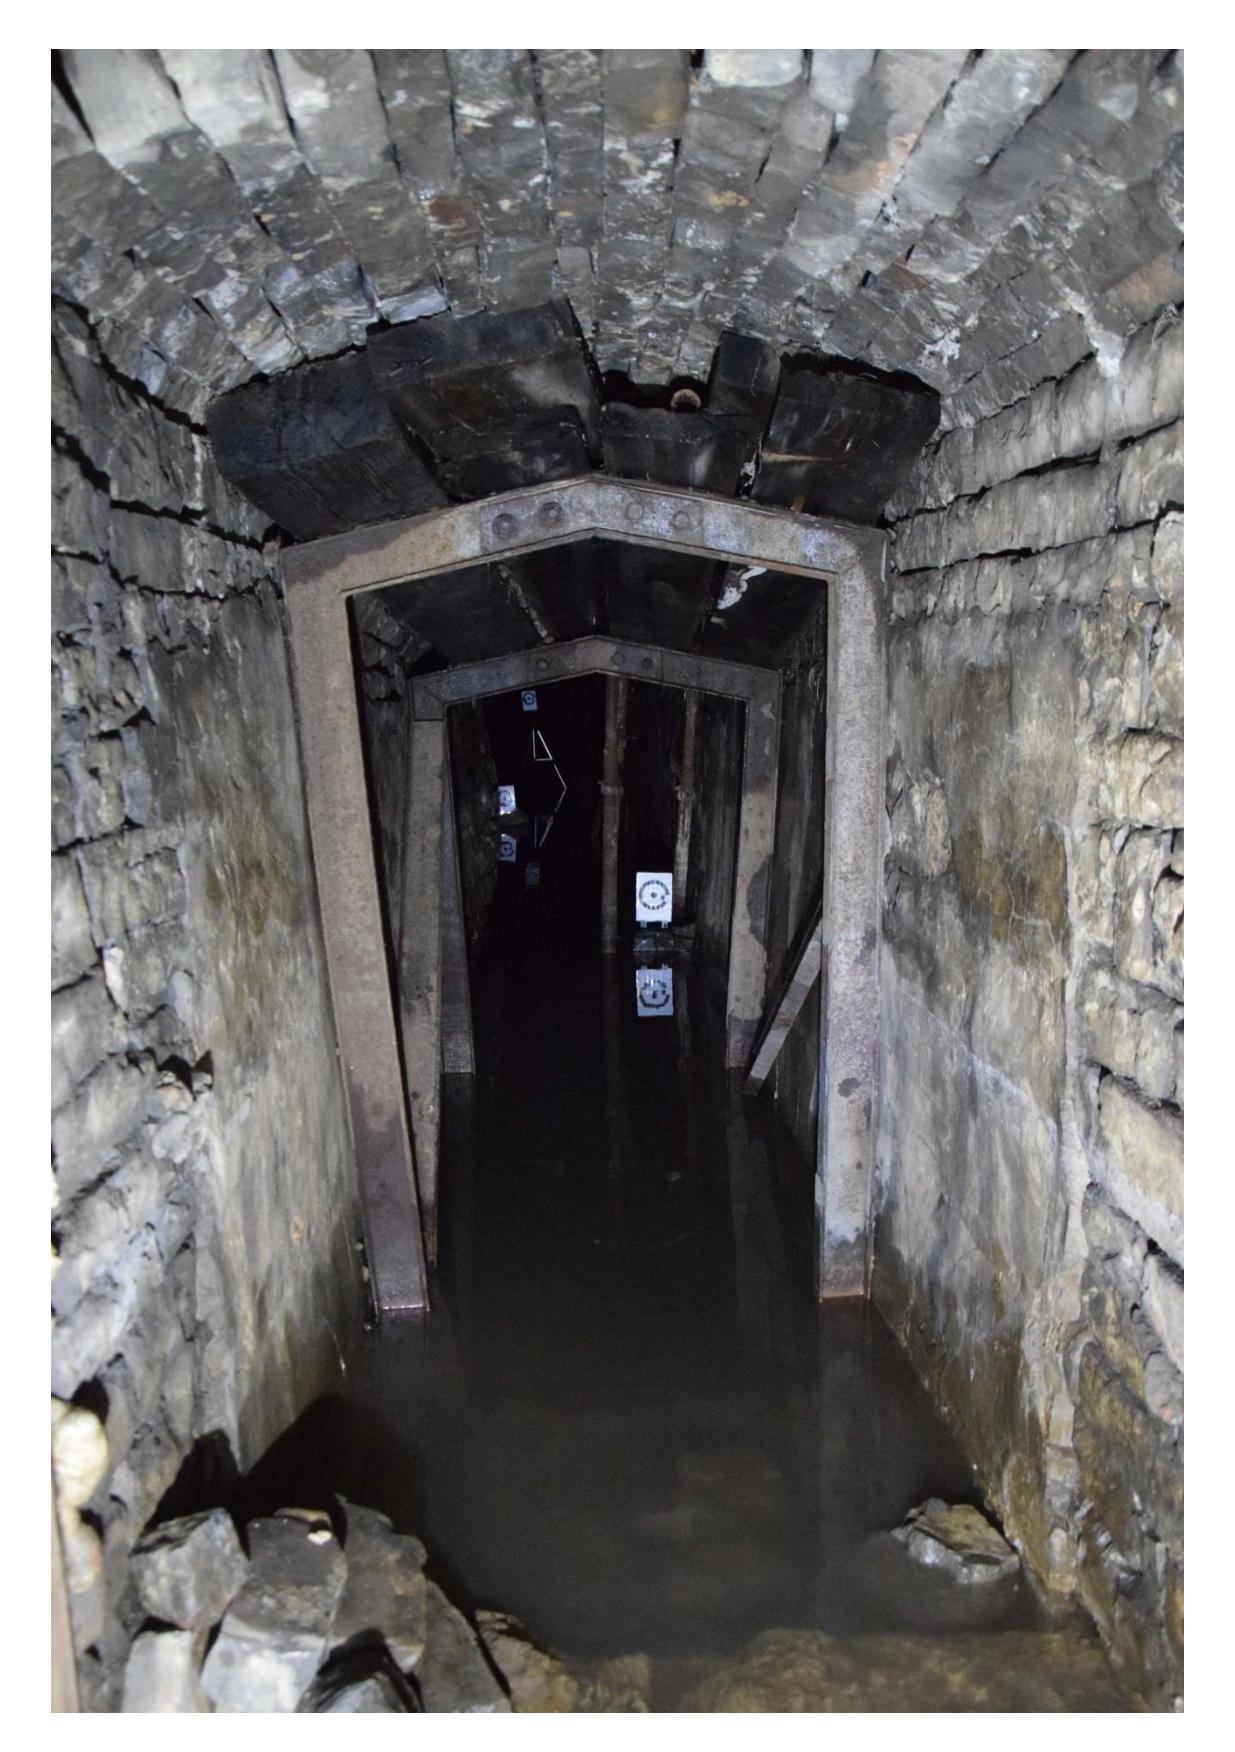
Plate 5: The 1980s support under the south-western hole in the arching, with two 'home-made' ring arches with timber beam and planks above.

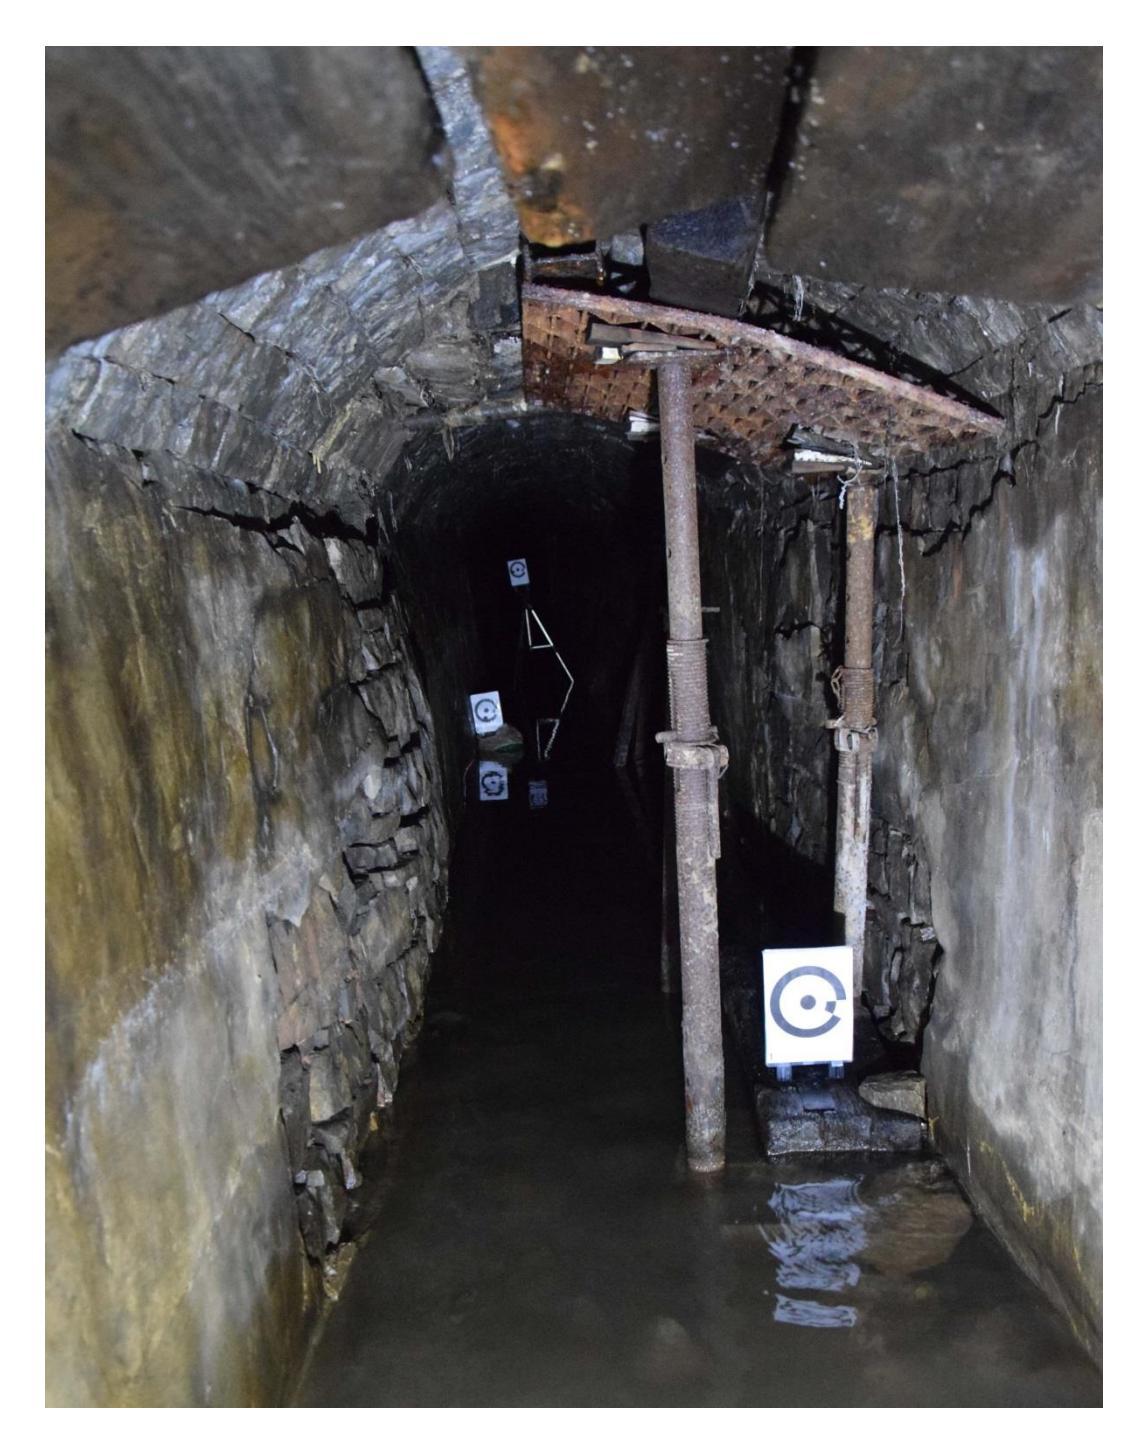
Plate 6: The 1980s support under the north-eastern hole in the arching, with three Acro-props and a metal grill. To the left is the modern bulge in the passage wall that was in danger of collapse.

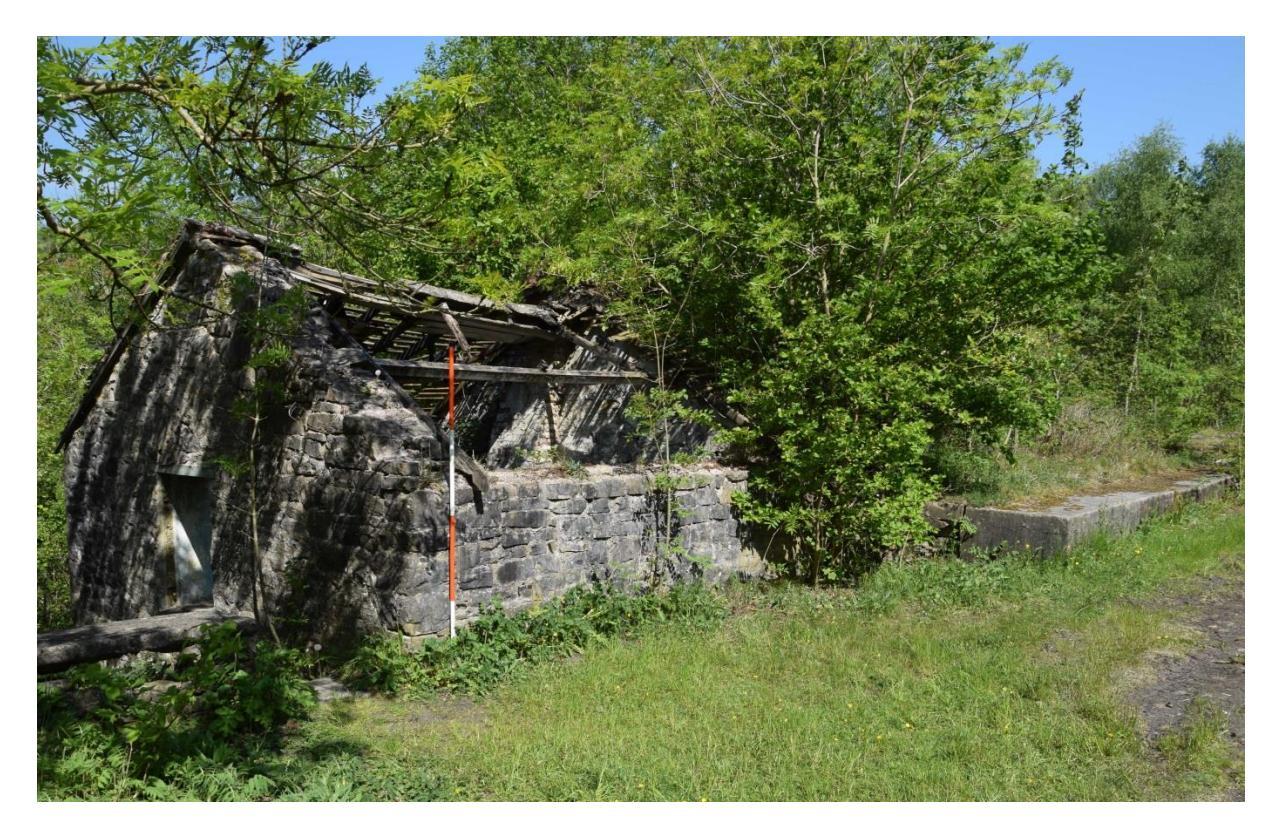
Plate 7: The dilapidated Creamery Outbuilding with a concrete unloading platform to the right, photographed from the road in May 2018.

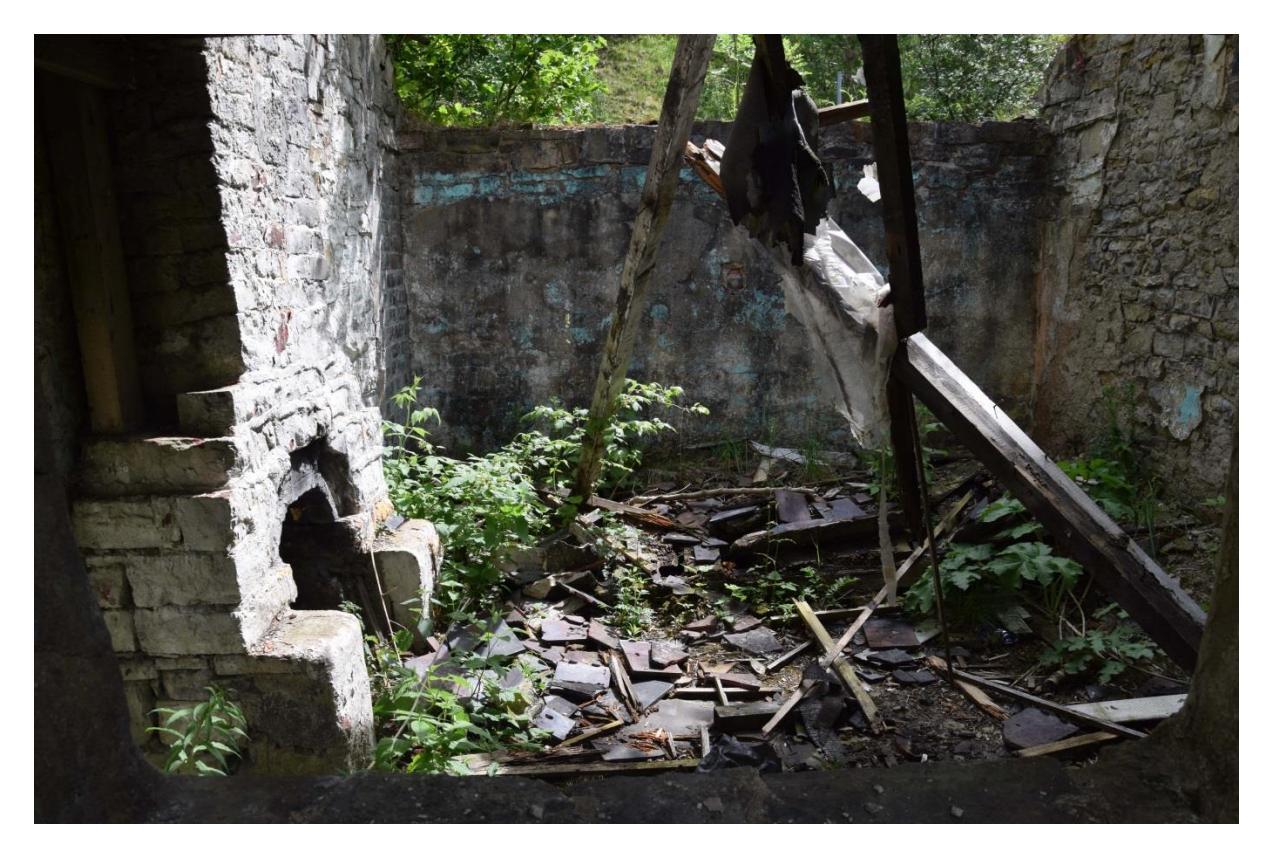
Plate 8: The inside of the dilapidated Creamery Outbuilding, photographed in July 2018 after further collapse of the roof timbers.

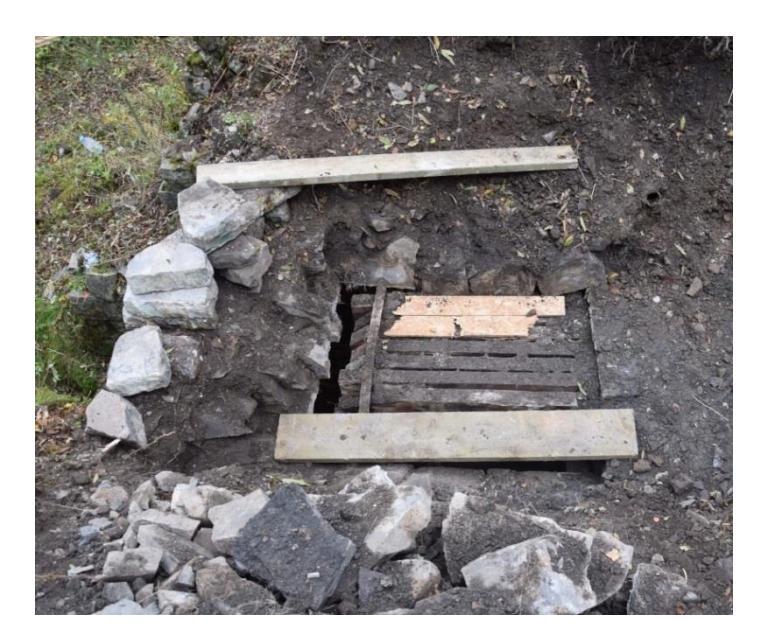
Plate 15: The outermost section of the Level after the unstable arching here had been removed to expose the 1980s timberwork that was holding this up. The 1980s portal, which incorporated arching stones, is partially buried by stones placed here shortly before the photograph was taken.

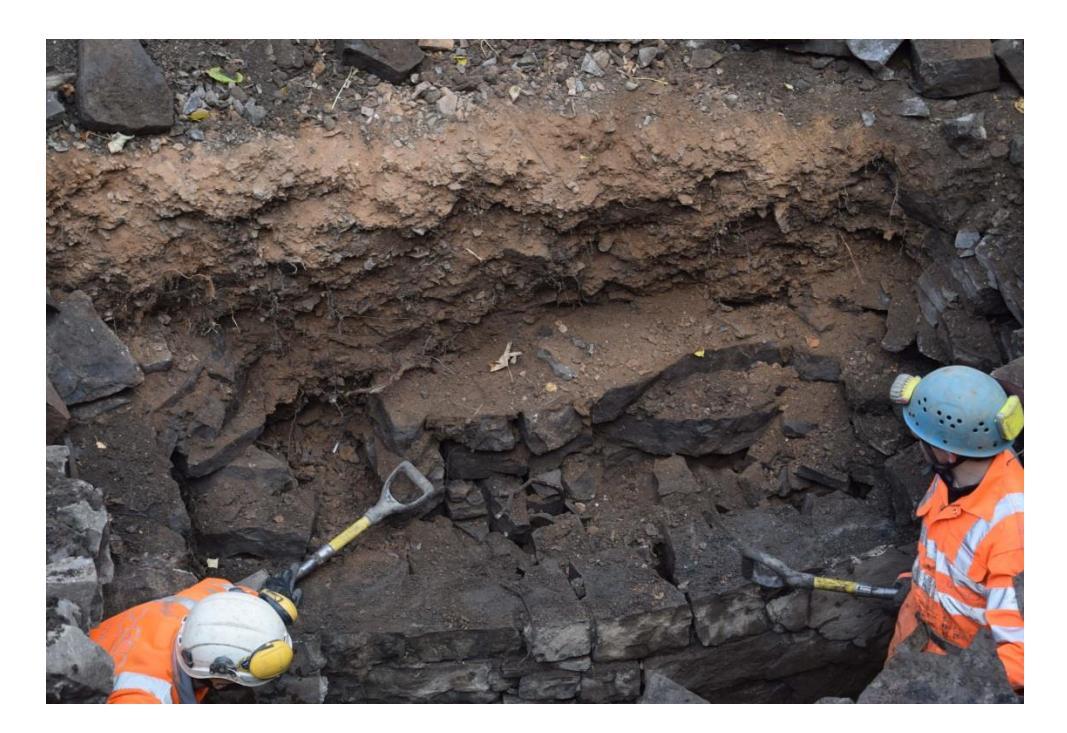
Plate 26: The wall at the bulge in the process of being taken down, with the stone fill within the 1884-85 trench being exposed, which was still fitted tightly against the natural material at the original vertical cut edge; only the facing stones of the wall had moved.

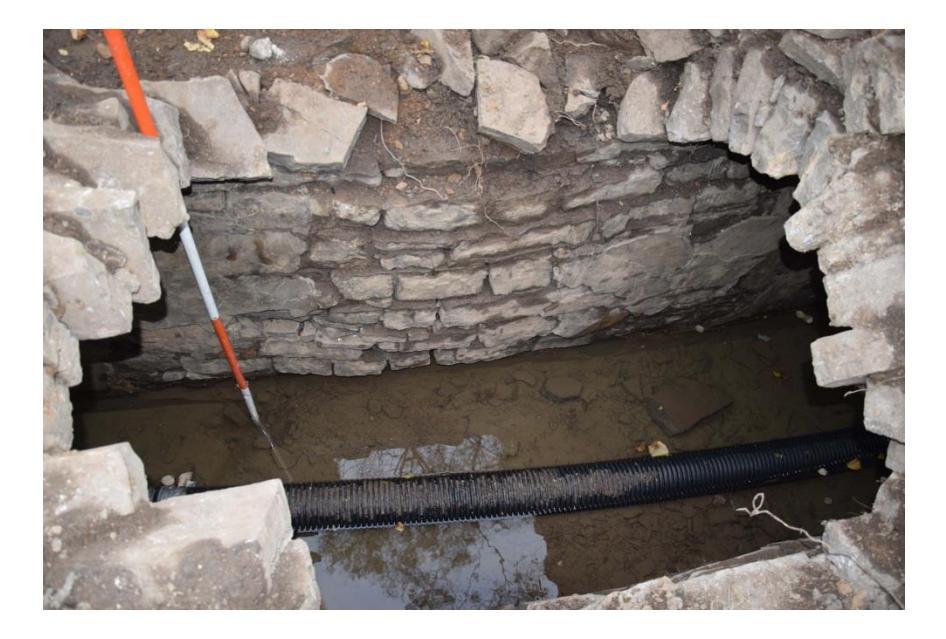
Plate 36: The bulge in the Level's north-western wall as seen through the north-eastern hole in the arching, photographed before the latter was enlarged to facilitate rebuilding.

At this one 2.5m long stretch of the Level side wall, where remedial work was necessary because it bulged, the wall was largely removed in 2018 and then rebuilt (Context 23). Here it was found that the passage walls were in a vertical-sided, c. 1.8m deep, cut in the natural subsoil (Contexts 45, 50). The material cut through comprised an orange-brown sand with many small stones, in a 2.4m thick deposit, with a layer of pale orange-brown silty clay of unknown total depth beneath. This vertical-sided trench was a little less than 2.5m wide. The sides of the Level were built within this and the void between the facing stones and the cut

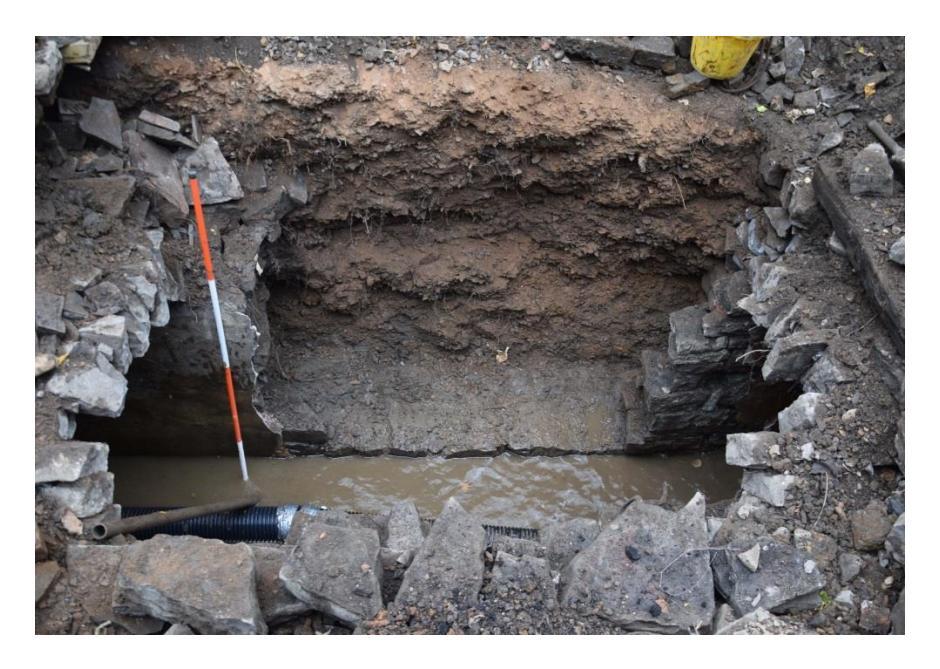
Plate 37: The area of the Level's north-western wall which bulged, photographed after the facing stones and the stonework behind had been removed and the hole in the arching enlarged to facilitate this. The bottom two courses of the passage wall had not slipped and were left *in-situ*. The vertical face of the material behind is the original 1884-85 cut into the natural; the stonework in front peeled off cleanly and thus no damage to this cut edge was sustained.

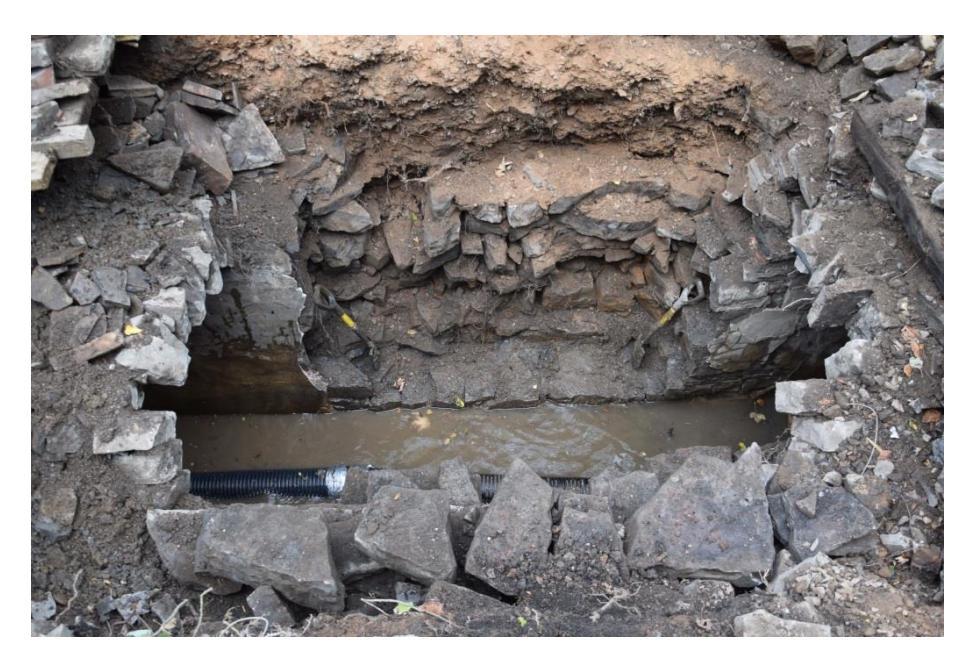
Plate 38: The area of the Level's north-western wall which bulged, photographed after the facing stones had been removed but before the *in-situ* stonework behind was taken out; the facing stones are stacked on the other side of the passage is such a fashion that they can be put back in the correct order.

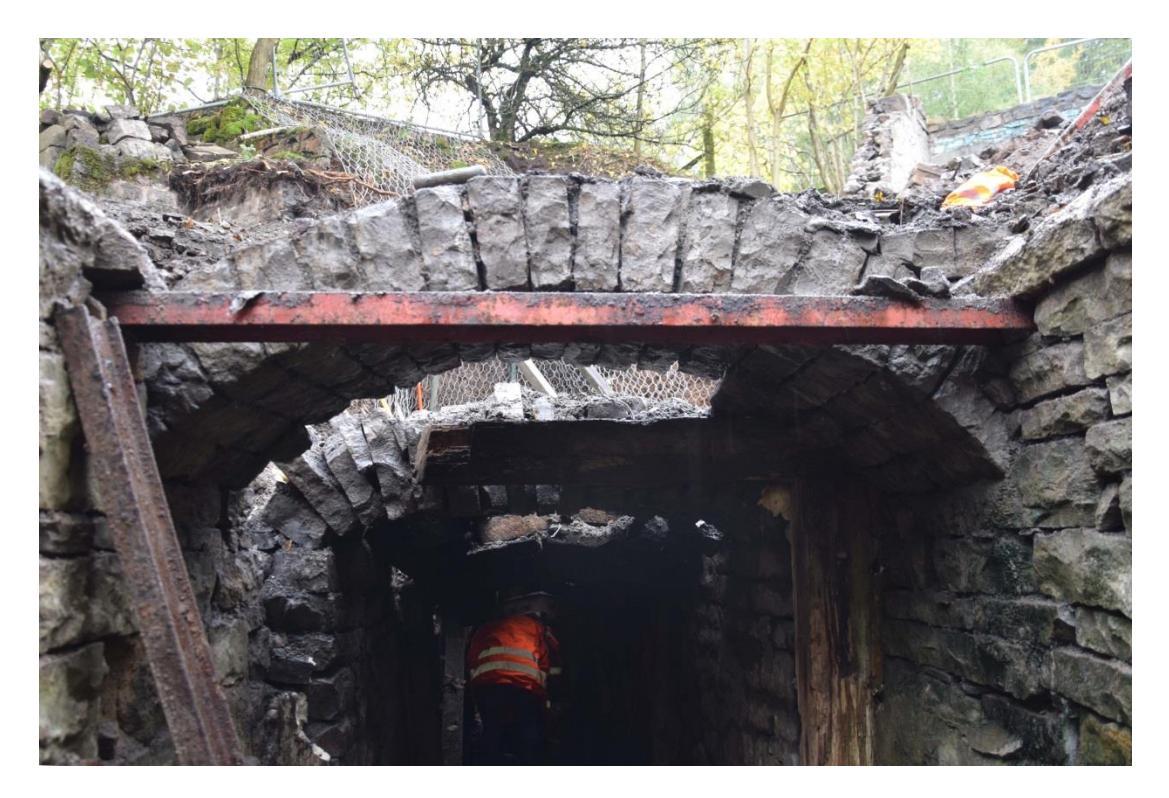
Plate 40: The original 1884-85 Level portal, discovered after the 1980s timberwork that masked it had been removed. Behind, when photographed, parts of the 1884-85 doorframe remained in place; soon afterwards it had to be removed to allow for the rebuilding of the arching behind that had dropped at the centre of the arch and was thus unstable.

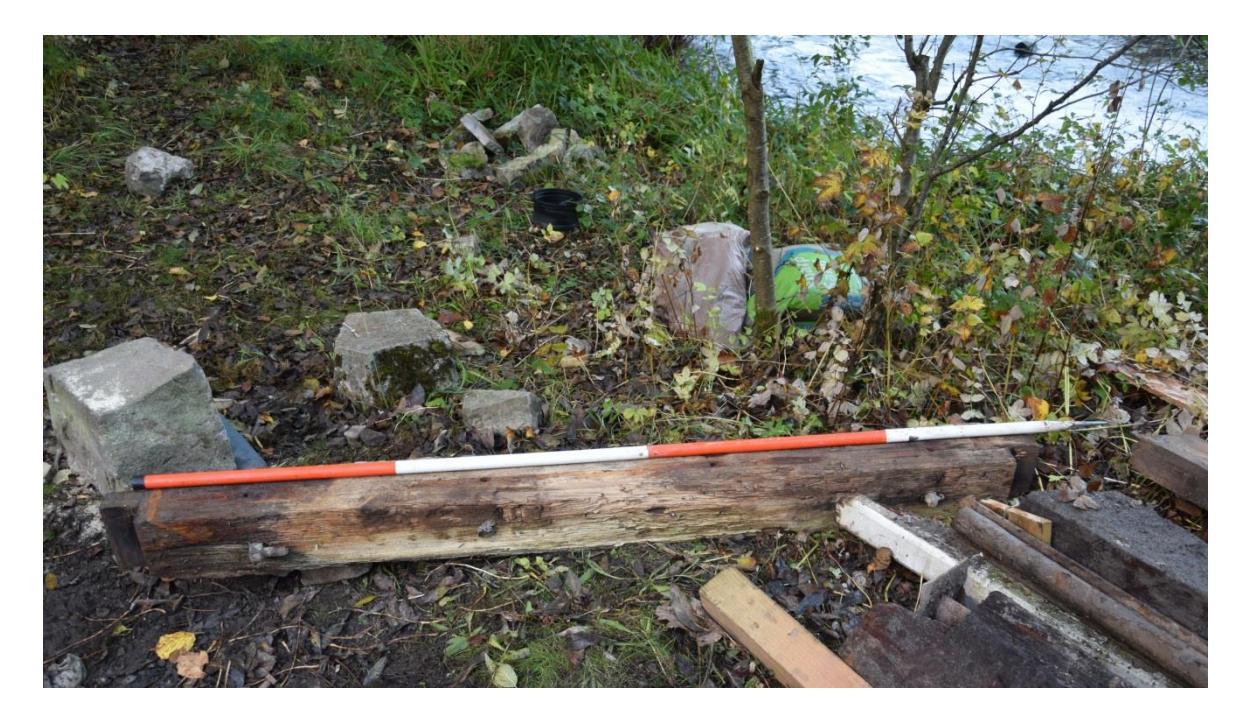
While the doors are long gone, the 1884-85 pitch-pine doorframe remained *in-situ* until 2018 (Context 27); this had to be removed to repair the arching and was too rotten to be put back. Each of the four doorframe timbers, vertically-set to the two sides, and horizontally-placed to top and bottom, measured between 0.14m and 0.16m in cross-section; they were joined together with open-tenon carpentry joints. Two door hanger pins remained to the south-eastern side.

Plate 41: The south-western doorframe side after it had been removed. Each end has an open-tenon carpentry joint and the original door hanger pins remain.

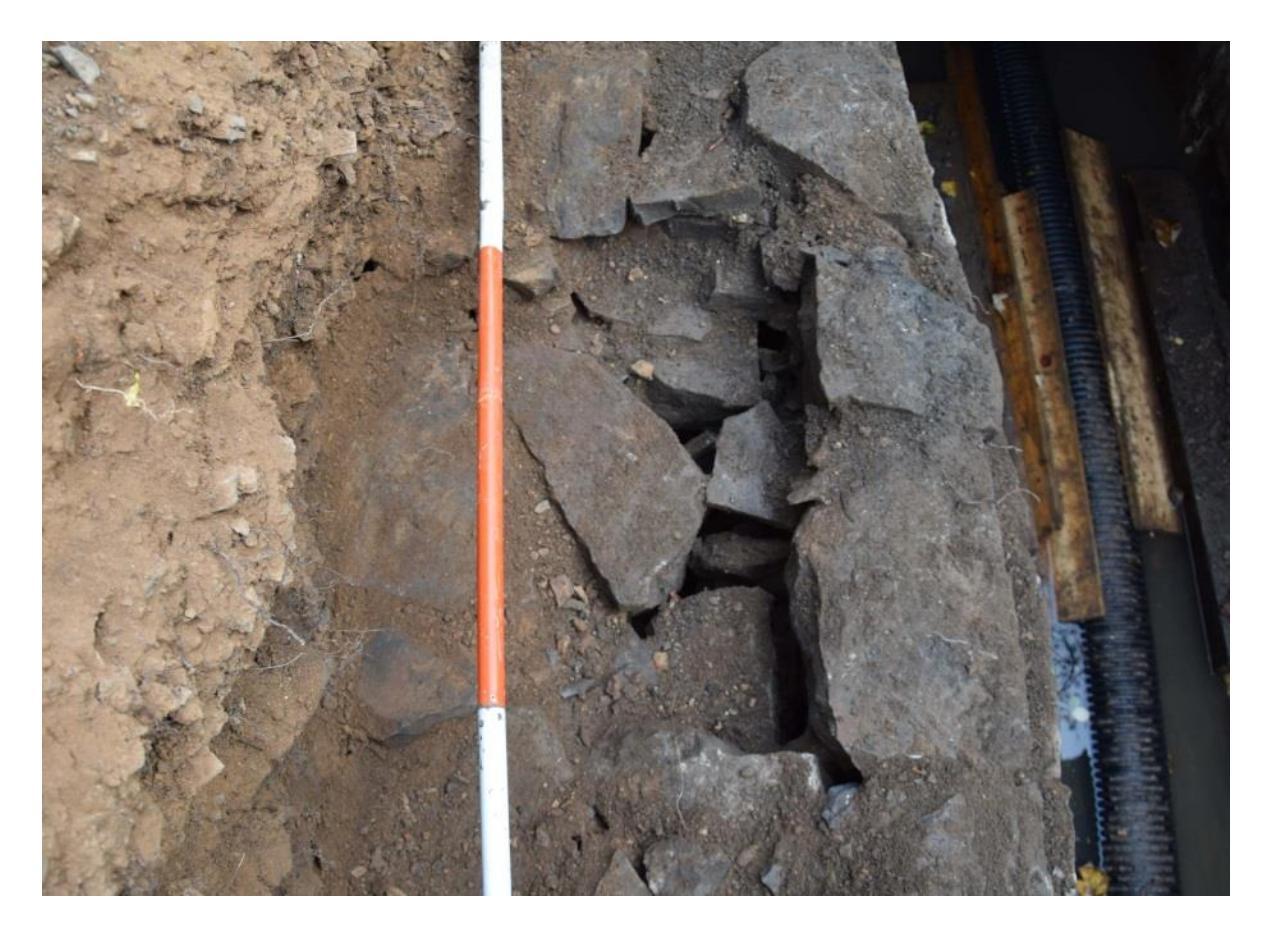
Plate 67: Looking down on the stonework of the side wall of the Level where the bulge had developed, showing how the facing stones had parted company from the rest of the stonework behind that was placed between the face and the edge of the 1884-85 vertical cut into the natural.
