The Restoration of the Deep Ecton Level Entrance (List Entry Number 1021175; SMC Ref No, S00168477): Recording and Findings during the Archaeological Watching Brief (October to November 2018)

Dr John Barnatt, BA Hon, PhD, MCIfA, FSA

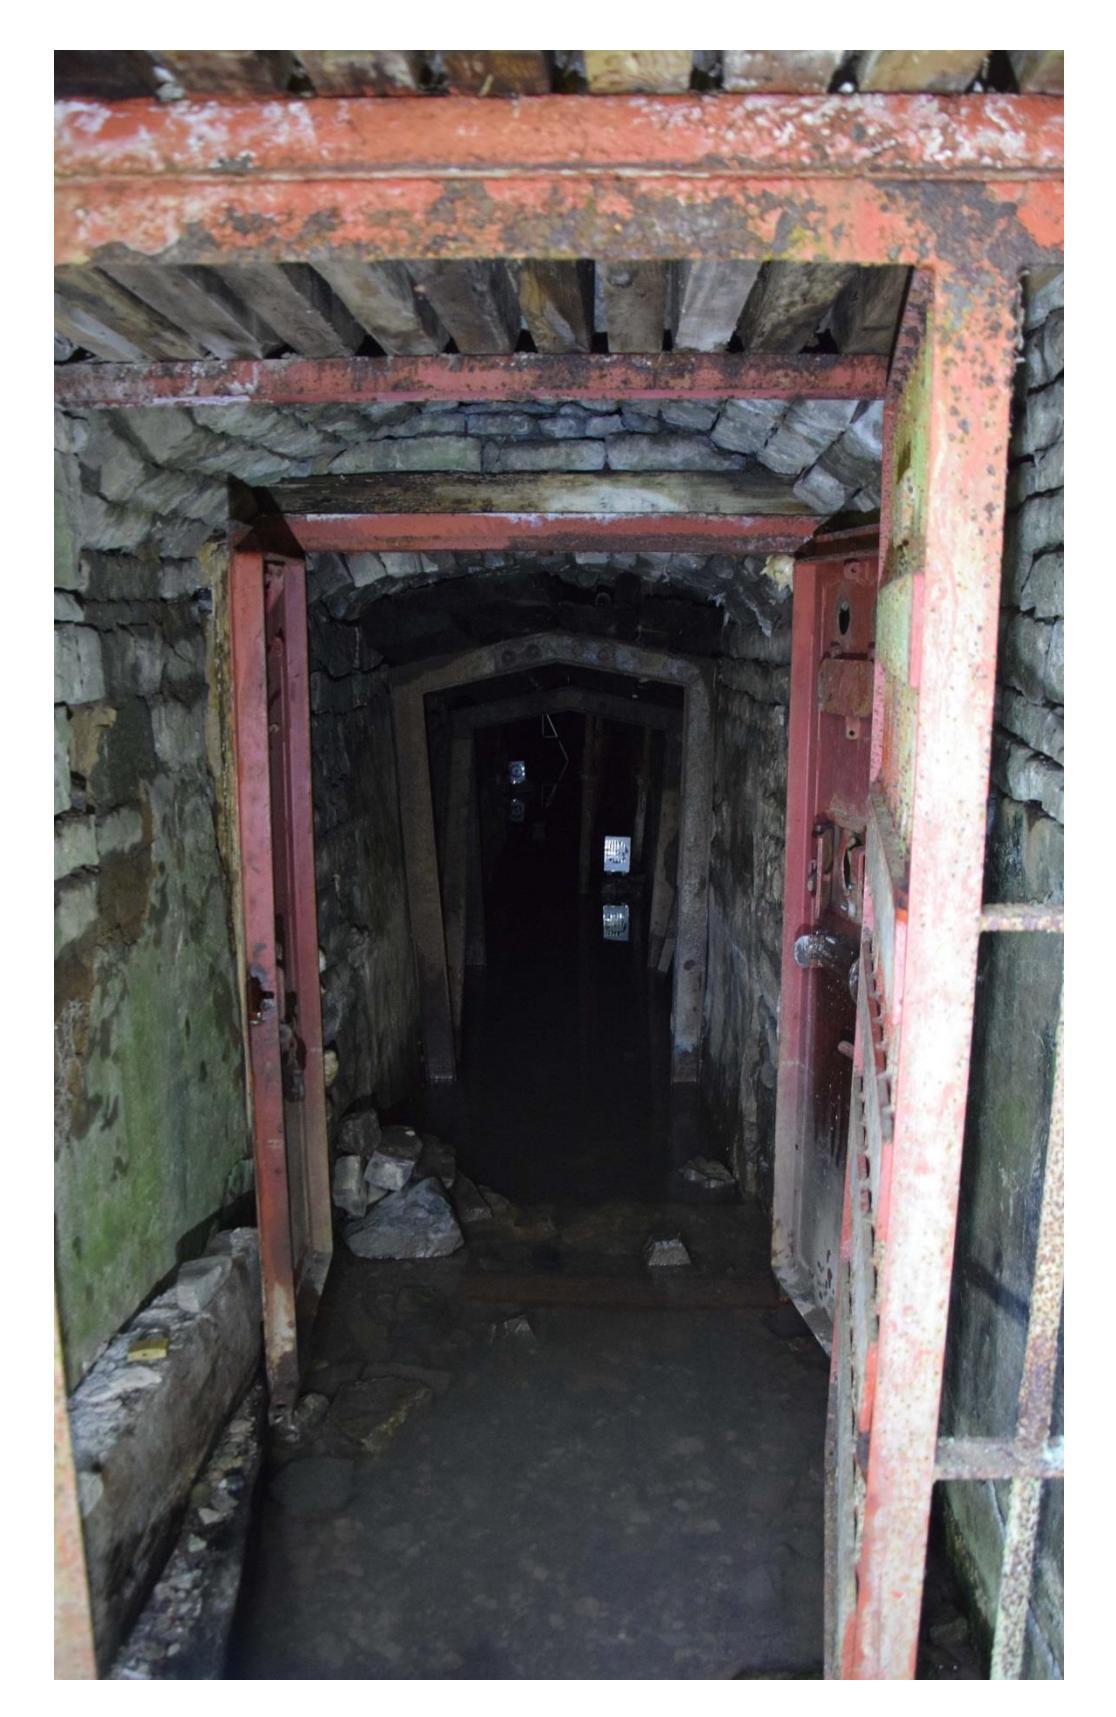
In the last five years or so it became apparent that a bulge in the north-west wall of the level, located below one of holes in the arching inside the entrance to the Deep Ecton Level, was

Plate 4: Before the work of 2018, just inside the entrance to the Deep Ecton Level there were timber beams above metal supports (top), which were designed to hold up the outermost section of arching that had dropped and was in danger of collapse. Both were added in the 1980s, as were the security doors to either side.

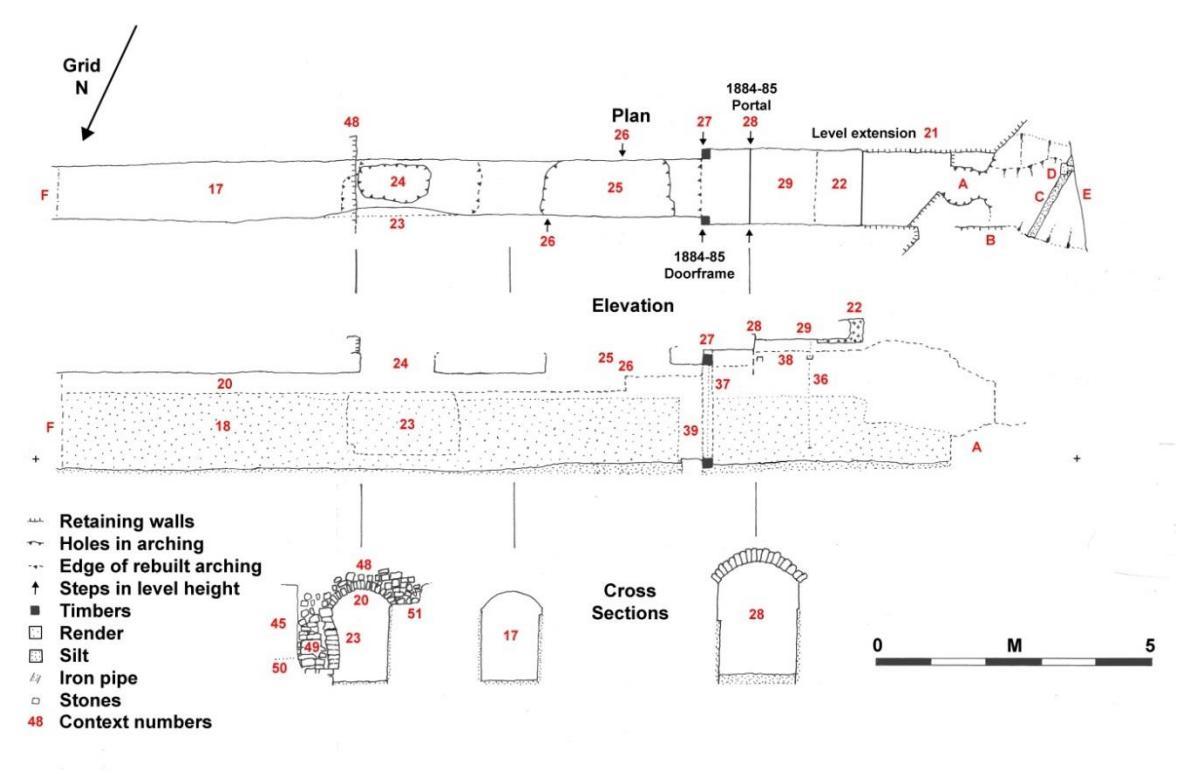
Figure 2: The outer part of the Level, with the elevation showing the roof and floor at the centre line of the passage, the wall height and render at the south-east wall of the passage and the bulge at the north-west wall; the cross-sections are drawn looking

inwards (features not given context numbers are A: creamery dam, B: low side wall,

C: iron pipe, D: ceramic pipe, E: wooden beam, F: temporary stopping).

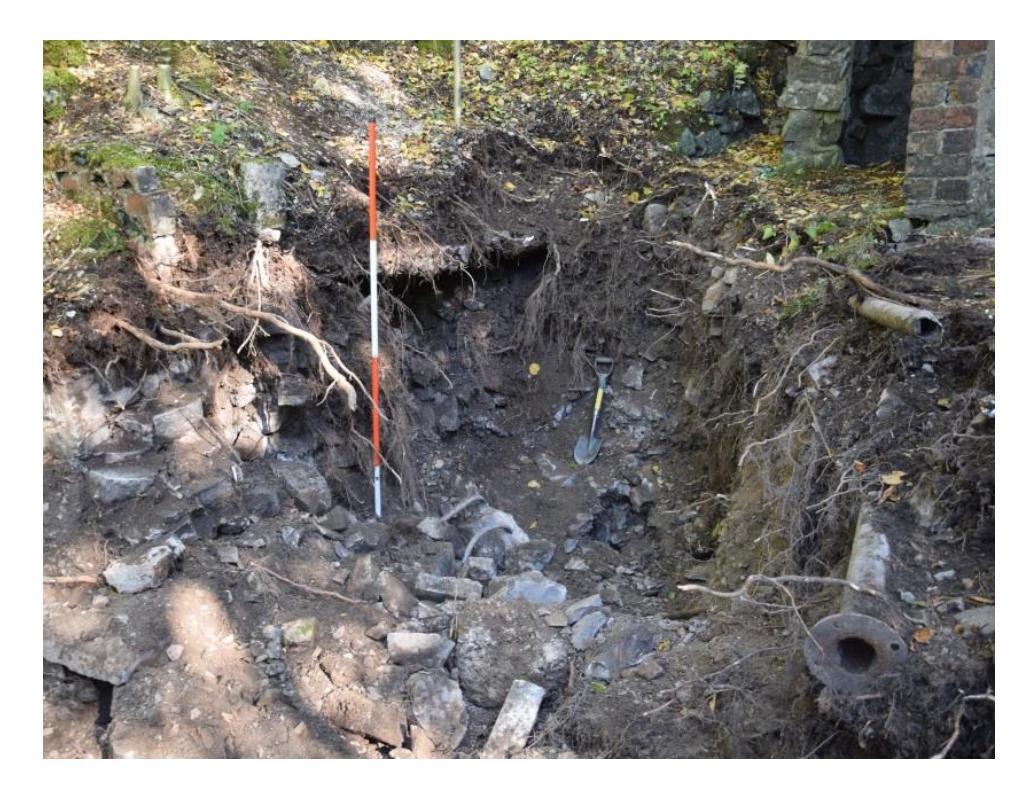
Plate 11: The 2018 excavation pit at the end of work on 9th October; part of the 1980s plug, with a lump of reused concrete with re-bars bent by the excavator, is visible in the bottom of the hole.

- **7:** Pit and plug (Drawings 4, 6; Photographs 15, 17, 34-35). A deep and largely steep-sided pit, with a mortar and metal sheet at *c*. 1.50m down (with the latter perhaps from the side of a trailer) that had been inserted to plug the material collapsing into the Level below. In the *c*. 1.5m by 1.00m hole below the plug there was loose limestone rubble and one piece of concrete incorporating two lengths of rebar; this descended to the hole in the Level arching at Context 24. The upper half of the pit fill went unrecognised during machine removal, as the surrounding deposit of Context 1 was also stony in parts; it must have been wider near the top as part of its fill was recognised retrospectively on photographs and in the vertical section left at the end of excavation on 10th October. This pit probably dates to the 1980s (or could be slightly earlier or later), dug in an attempt to investigate the nature of the collapse in the arching below and was plugged to prevent further material from entering the Level from above (late 20th century).

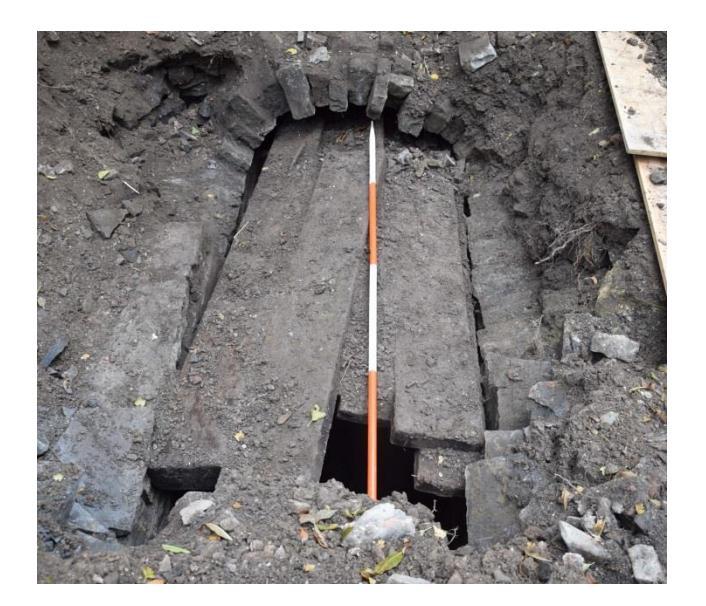
Plate 16: The south-western hole in the arching after rubble was removed to expose the 1980s timberwork beneath, which had been designed to prevent further rubble entering the Level through the hole.

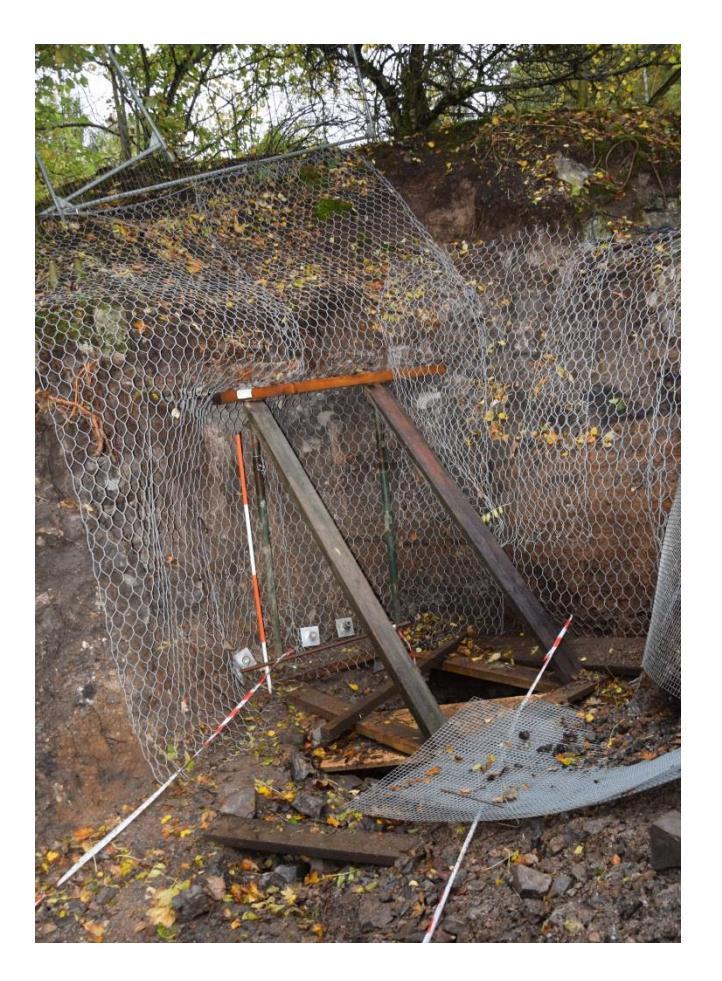
Plate 17: The netting and props placed at the north-eastern end of the excavation pit on the 12th October, designed to allow safe working below; a minor collapse nearby, after heavy rain, of the same unstable material as behind the netting, led to all being removed in advance of extending the pit to batter back its sides.

- 15th Oct: Following a minor collapse in the north-eastern corner of the excavation pit after heavy rain over the weekend, it was realised that the protection measures put in place on the 12th Oct were potentially inadequate; the excavation pit needed extending so that battered sides could be created to the north and north-east. Neil Rimmington of Historic England was contacted for permission to make the excavation pit a little larger than agreed in the original SMC; after discussion with John Barnatt, this was granted the following day by email.
- 15th-17th Oct: Work progressed in the south-eastern 'safe' half of the excavation pit, cleaning the arching stones, removal of the arching stones that needed repositioning, creation of formers and the rebuilding of the outermost section of Level arching (Context 29).

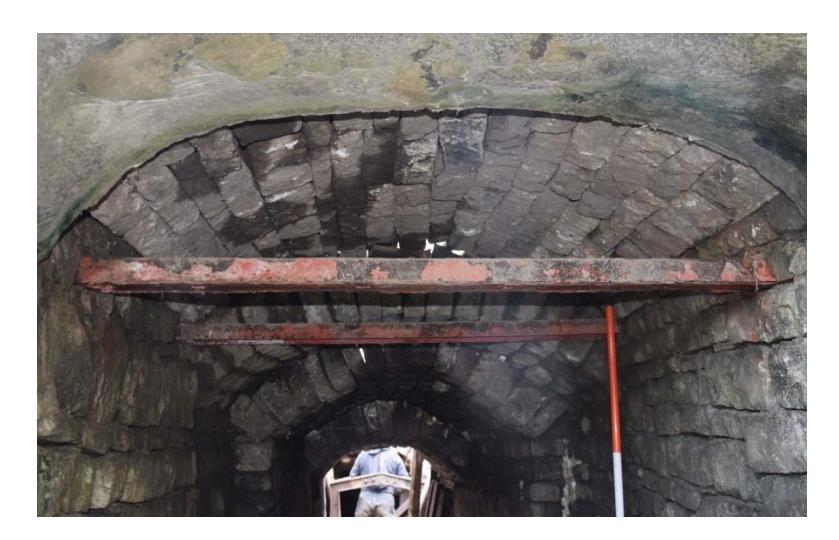
Plate 19: The outermost section of the Level arching after having been rebuilt. Immediately beyond is the 1884-85 portal behind the inner 1980s iron beam, with further steps down in the passage height beyond, photographed after they had also been rebuilt.

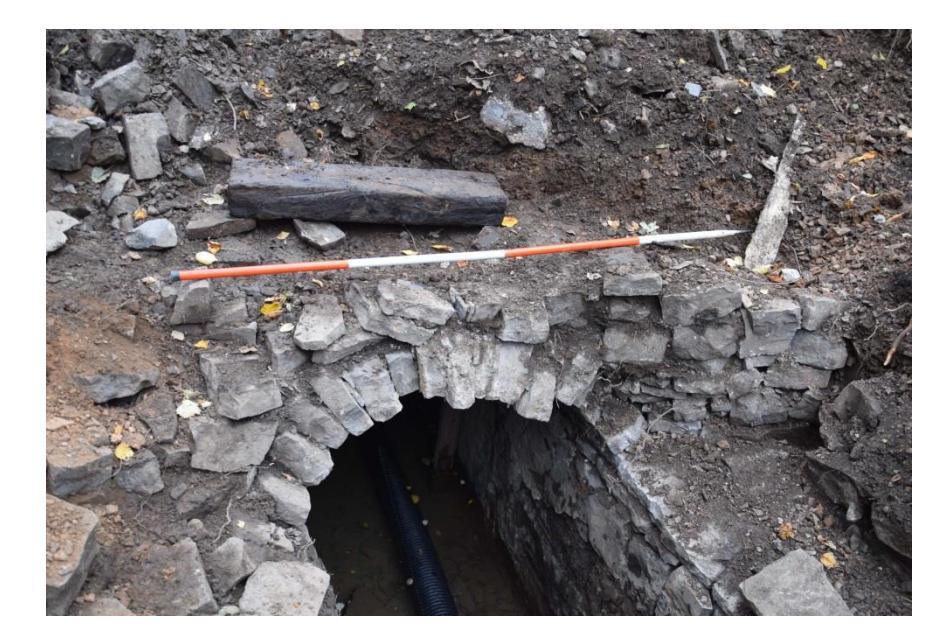
Plate 39: The 1884-85 drystone wall placed directly over the Level arching just beyond the inner end of the north-eastern hole.

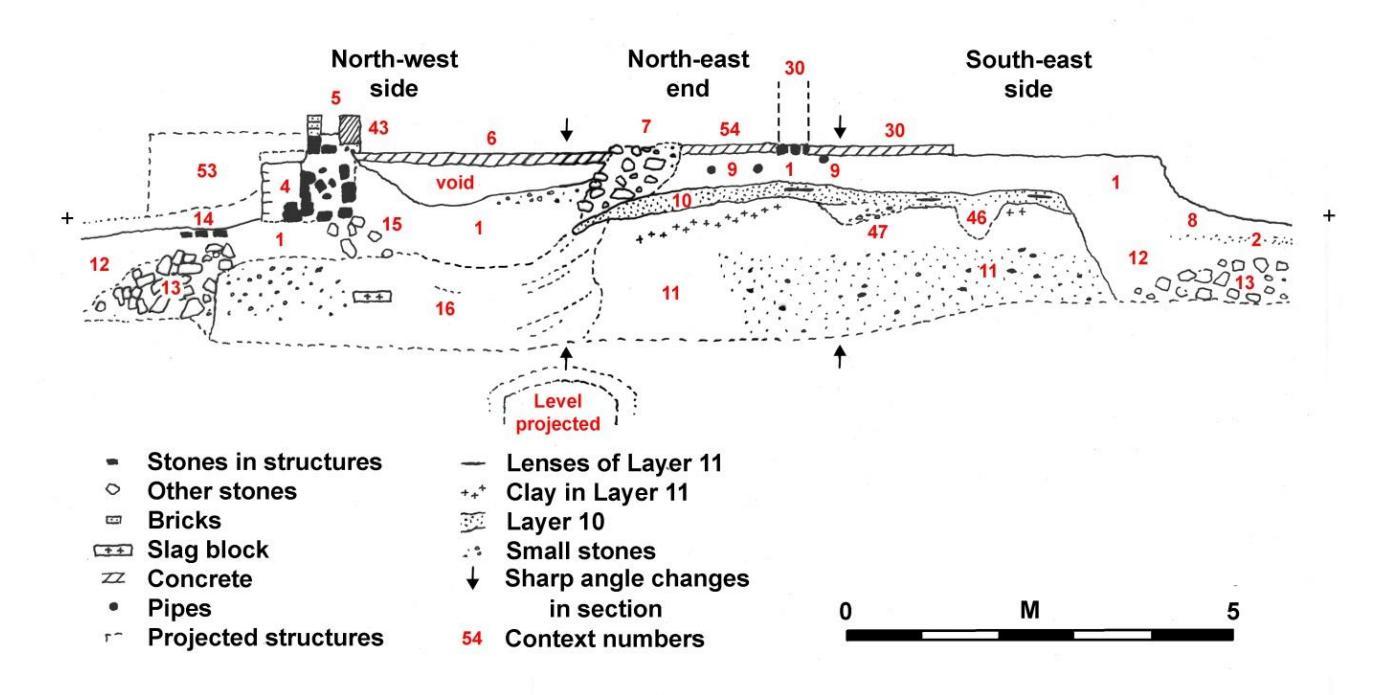
Figure 4: A section showing features and layers exposed in the near-vertical faces of the excavation pit at the end of Oct 10th.

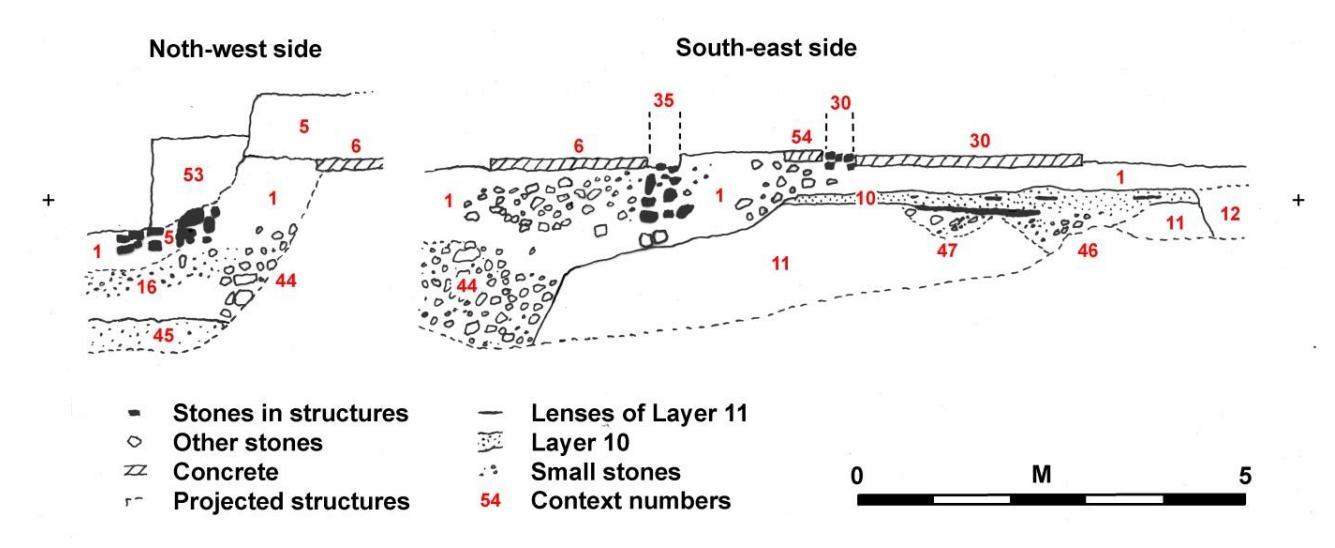
Figure 5: A section showing features and layers exposed in the near-vertical faces of the excavation pit to the north-west and south-east sides at the end of Oct 18th; the area between could not be drawn as it was battered back and the stratigraphy obscured.

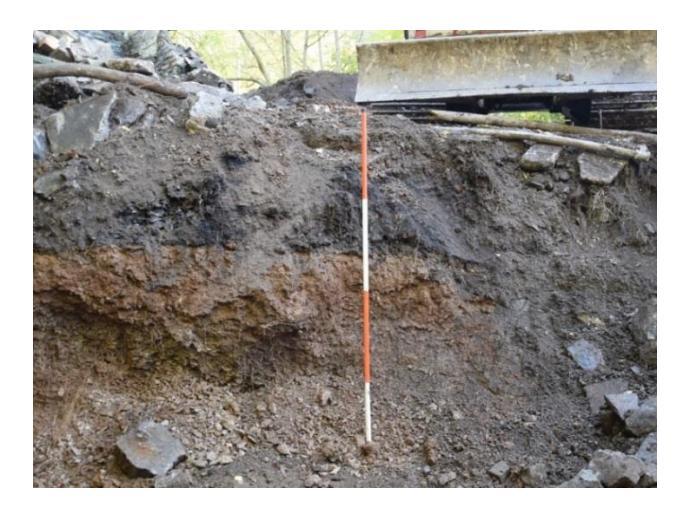
Plate 42: The redeposited orange-brown 'natural' (Context 11) in the 1880s 'cut and cover' trench above the Level, photographed during excavation on the 10th October at the south-eastern side of the excavation pit. The coal-rich layer lies above (Context 10) and the cut for the Railway Siding Terrace (Context 12) lies to the right.

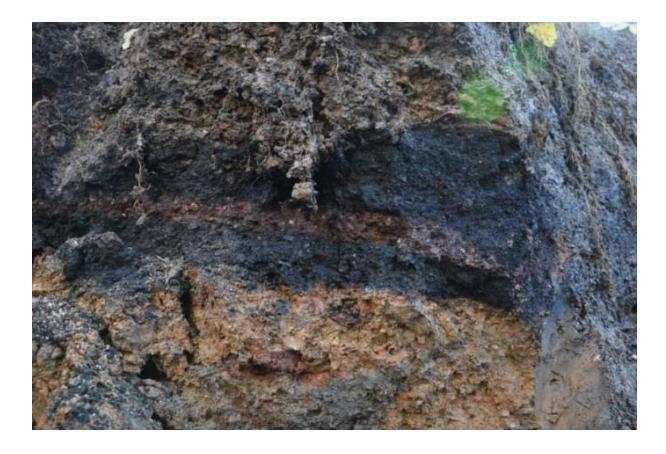
Plate 43: The small purple lens within the coal-rich layer (Context 10), at the end of the step in the section excavated on the 18th October.

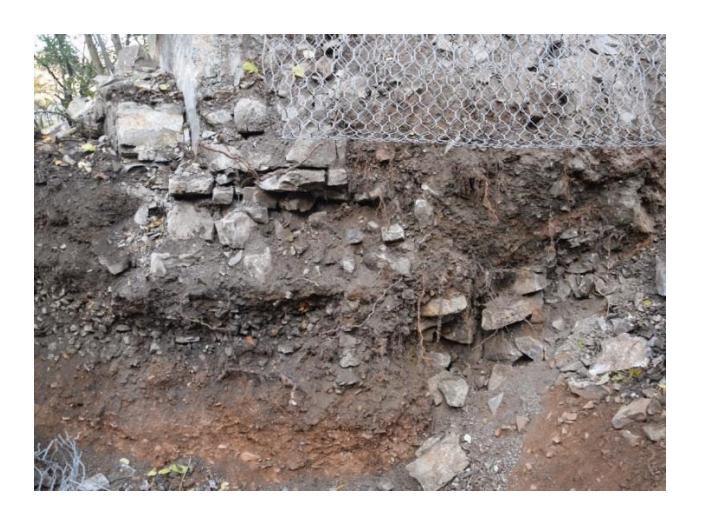
Plate 44: The layer of small stones within the redeposited material (Context 16) in the 1884-85 'cut and cover' trench above the Level to the north-western side of the excavation pit, photographed on 19th October. The *in-situ* orange-brown natural material lies below (Context 45), the footings of the Northern Creamery Building are above (Context 5), and the rubble fill (Context 44) of a pit beneath this building lies to the right.

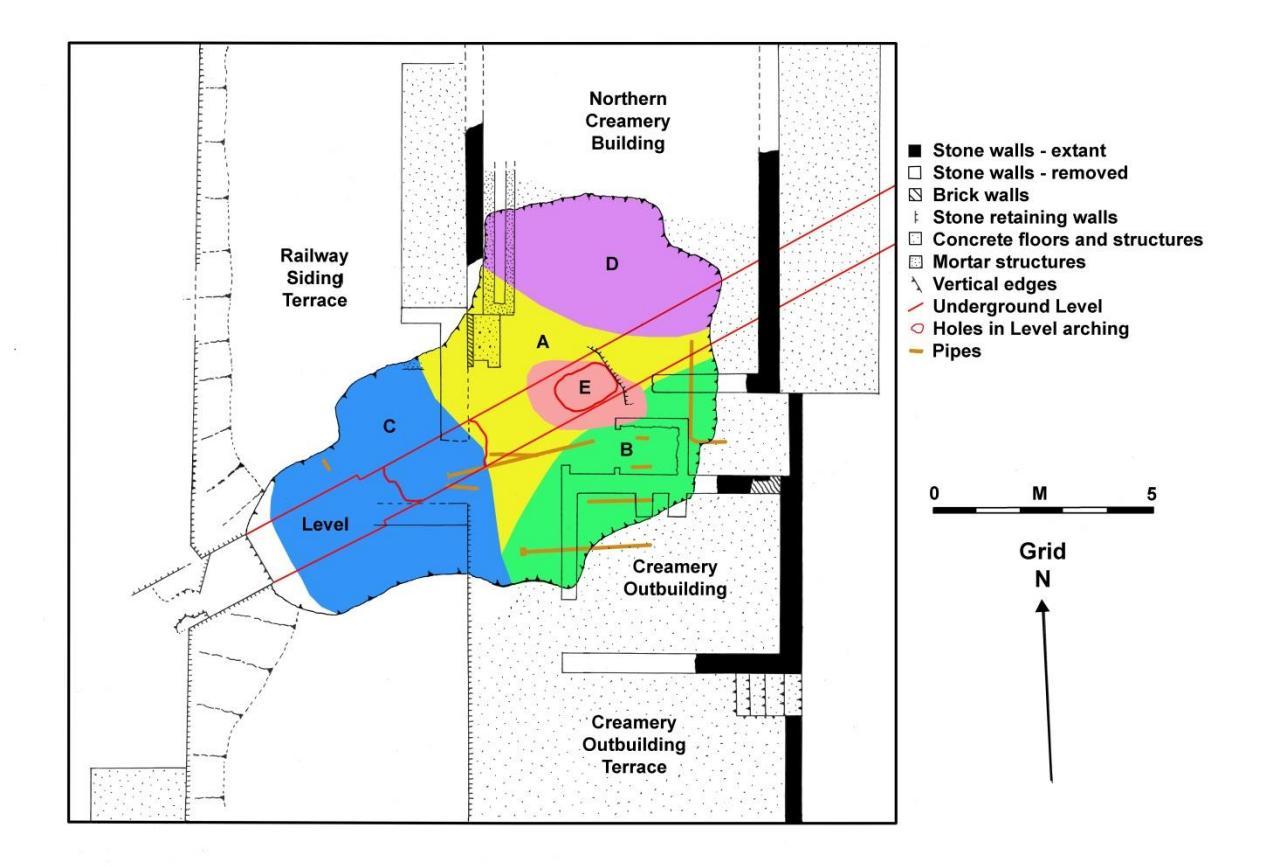
Figure 6: The site, showing the approximate extent of key layers and fills exposed within the excavation pit and also the positions of creamery pipework where known (A: 1884-85 cut and cover backfill (Contexts 11/16); B: Late 19th century coal dust deposit (Context 10), overlying the cut and cover backfill at A; C: 1919-24 cut for the Creamery Sidings Terrace filled with rubble and soil (Contexts 13/12); D: 1918-24 pit under the Northern Creamery Building (Context 44); E: 1980s pit (Context 7)).

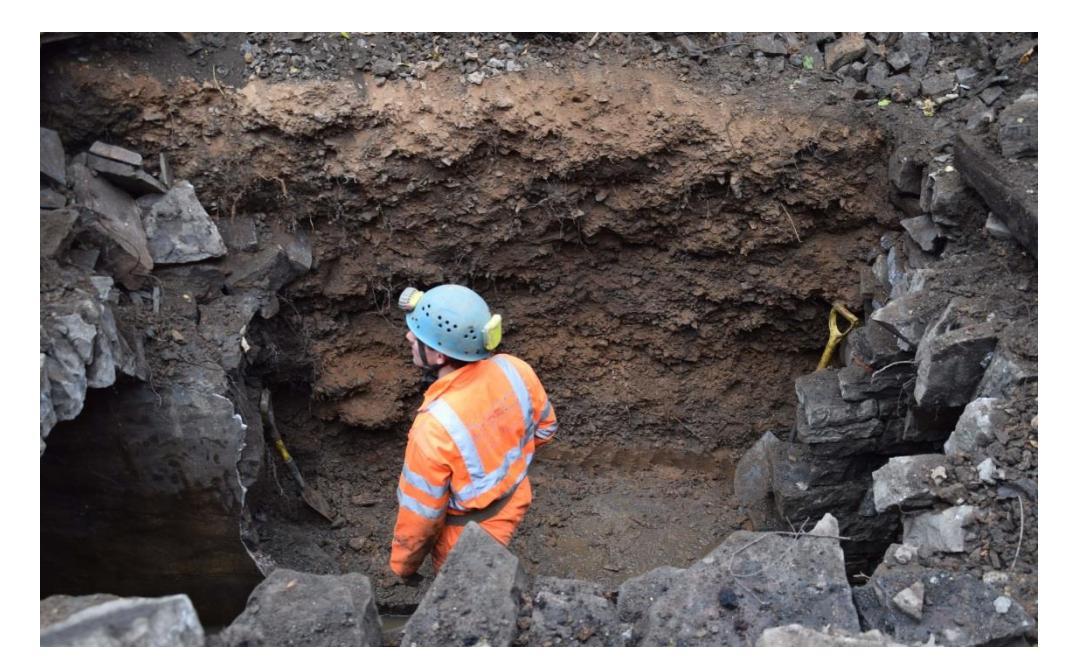
Plate 45: The edge of the 1884-85 vertical cut through natural deposits, which mostly comprises an orange-brown sand with many small stones (Context 45), but when cut back near the base of the cut, to make room for the reinforced concrete to be placed behind the rebuilt passage side, this exposed a silty clay (Context 50).

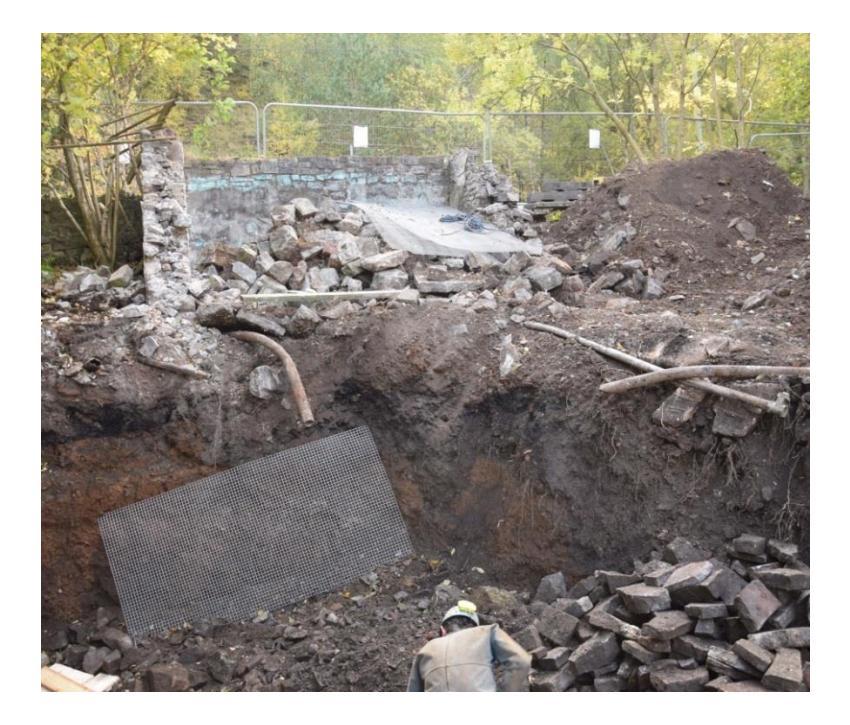
Plate 46: The north-eastern side of the excavation pit, photographed on 11th October; to the right of the reinforcing mesh a pit-like feature (Context 46) can be seen cutting the orange-brown redeposited natural (Context 11), while to the right of this the cut (Context 12) for the Railway Siding Terrace can also be seen.

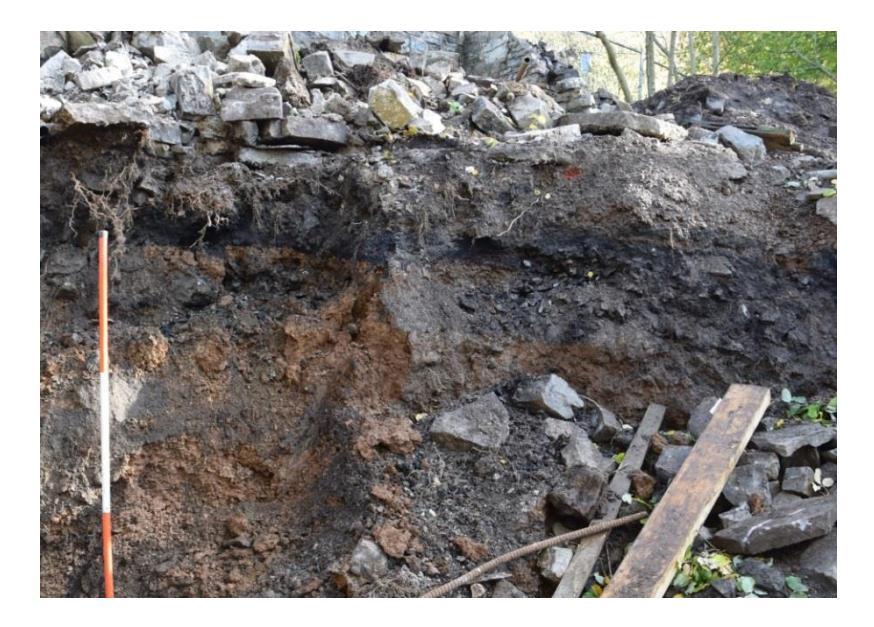
Plate 47: A detail of the north-eastern side of the excavation pit photographed on 18th October; both pit-like features (Contexts 46, 47) can be seen cutting the orange-brown redeposited natural (Context 11), each with a thick lens of this material above their fills, with the coal rich layer (Context 10) above.

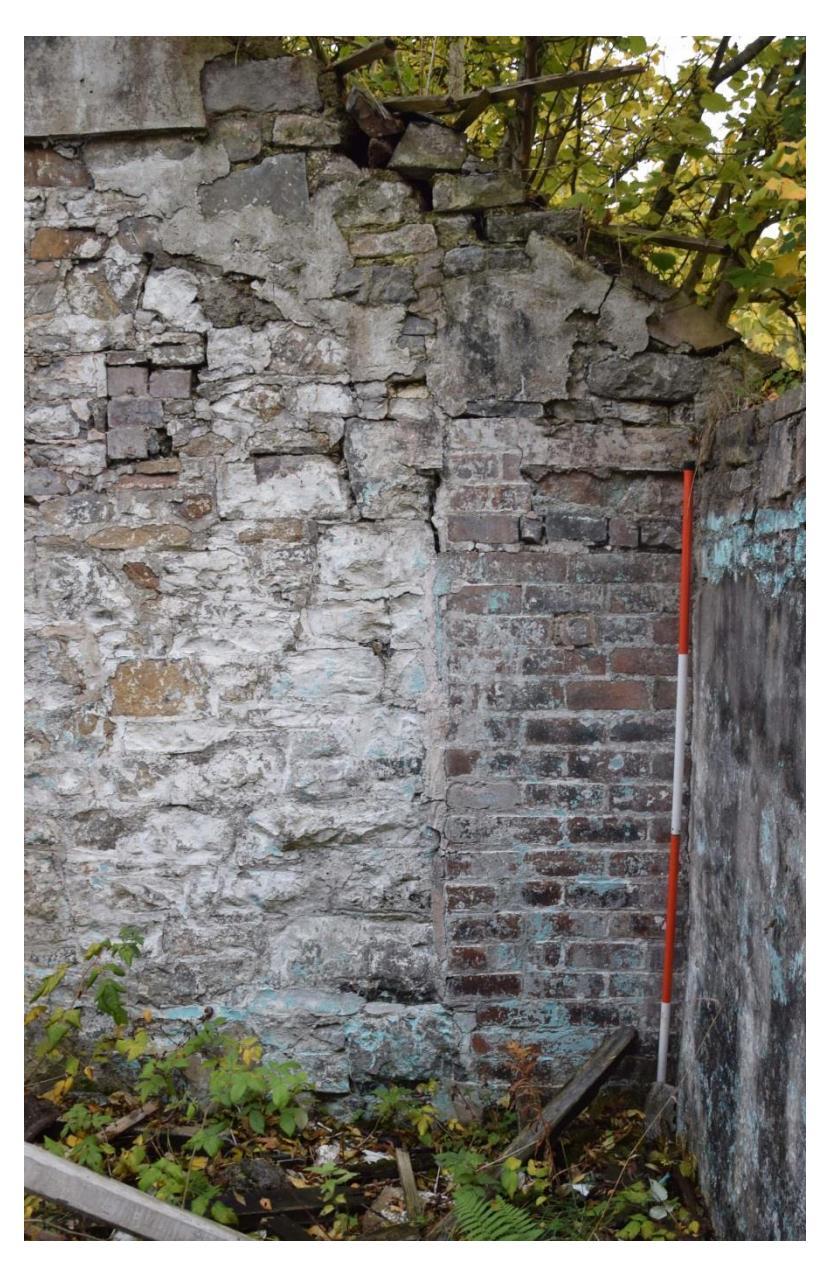
Plate 48: A brick-filled opening at the eastern end of the north wall of the Creamery Outbuilding, which was almost certainly filled when the outbuilding was erected.

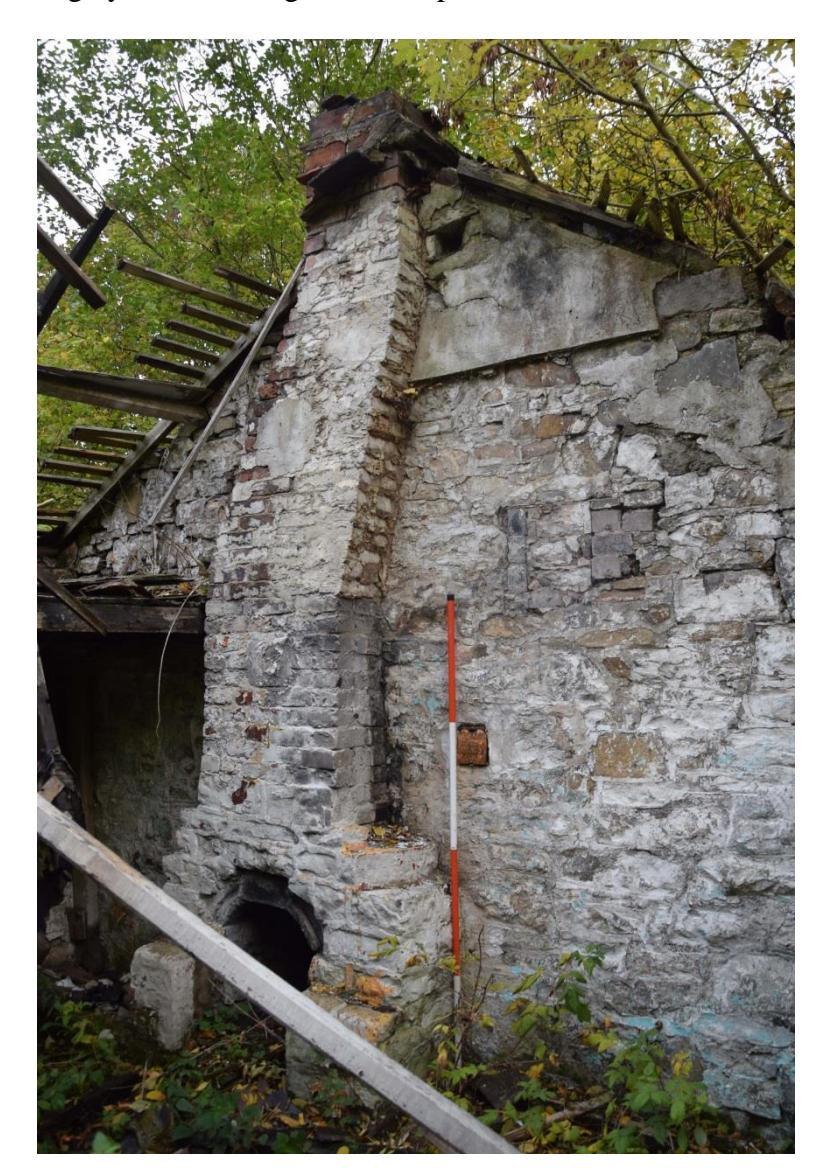
Plate 49: A stone-filled opening in the north wall of the Creamery Outbuilding, to the right and above the ranging pole; the date at which this infilling was done is unclear but it seems most likely that this took place when the Creamery Outbuilding was erected, although the bricks to the right side in their present configuration may well represent a later repair. The fireplace and chimney were added later when the building was used as a caving club hut.

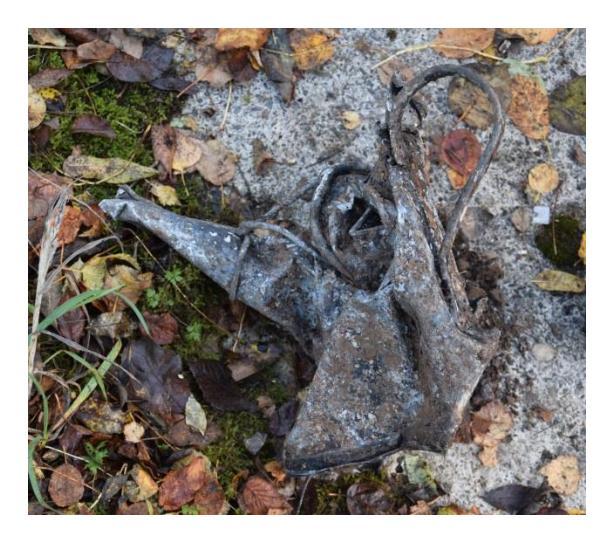
Plate 50: The crushed galvanised watering can from the demolition rubble that filled the lower part of the interior of the Northern Creamery Building.

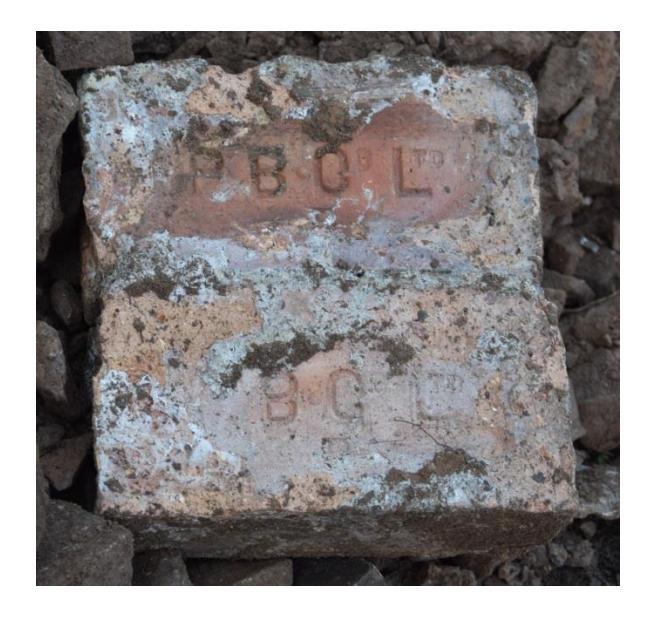
Plate 51: Bricks stamped 'PB C^o L^{td}', with a code letter 'B' below, which came from the demolition rubble filling the lower part of the interior of the Northern Creamery Building. Within the area investigated in 2018 the Northern Creamery Building had remaining lower parts of walls to both sides and at its southern end (Contexts 5, 32, 35), although part of the last had been removed in the 1980s (or had collapsed previously) when a pit (Context 7) was dug to access the north-eastern collapse of the Level from above; the southern edge of the building's concrete floor (Context 6) was also damaged here. The remaining lower mortared walls, built of limestone blocks and slabs in rough courses, were 0.40-0.42m thick and stood between 0.80m and 1.65m high, as measured from the thick internal concrete floor of the building; this floor lay 1.00m below the roadside level. The walls had all been rendered to the inside of the building. The western wall descended to the outside of the building for c. 1.00m to the Railway Siding Terrace (Context 34). The western and southern walls were partially removed by the 2018 excavation pit, where footings of limestone blocks and slabs were exposed; they were 0.65-0.90m deep.

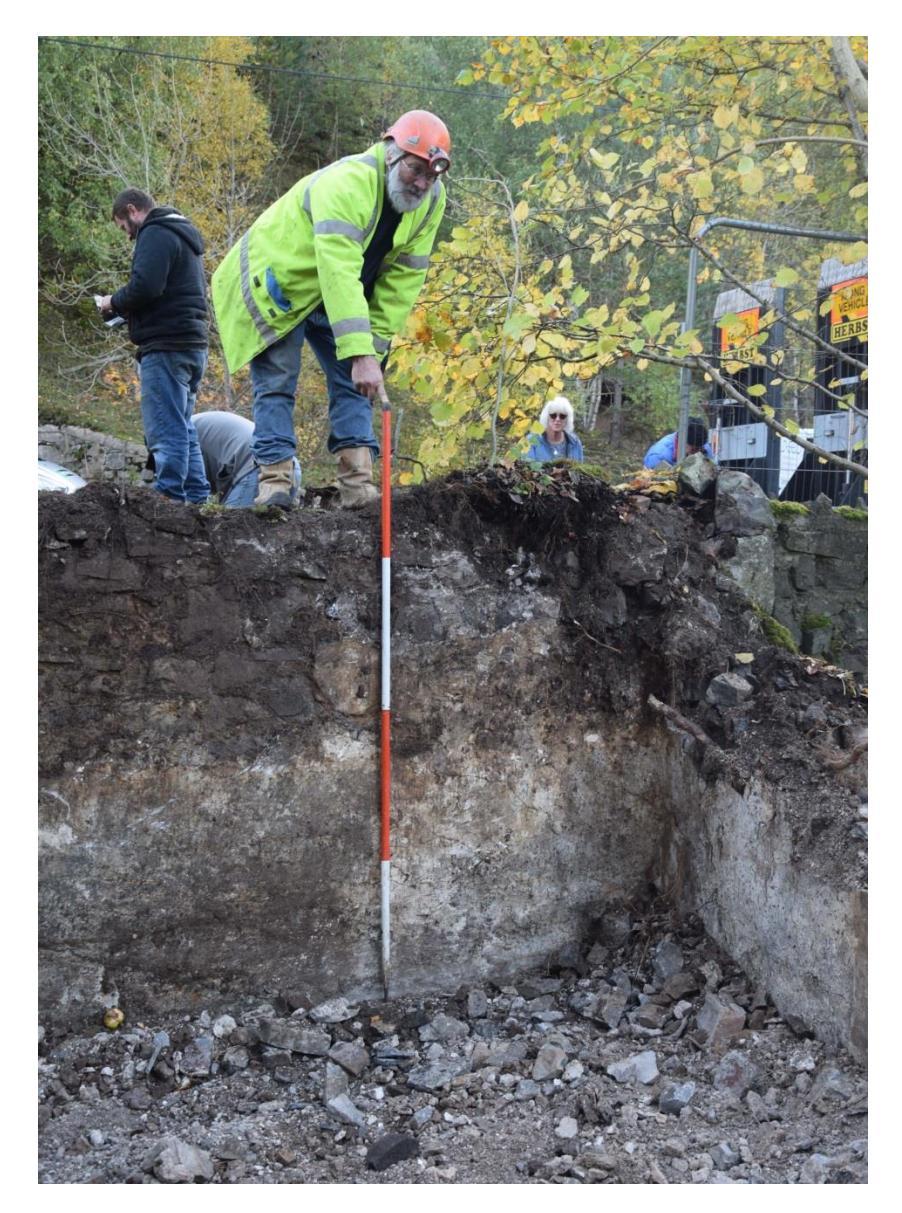
Plate 52: The south-eastern corner of the Northern Creamery Building after the demolition rubble in the interior had been removed; the point of the ranging pole is resting on the un-swept concrete floor.

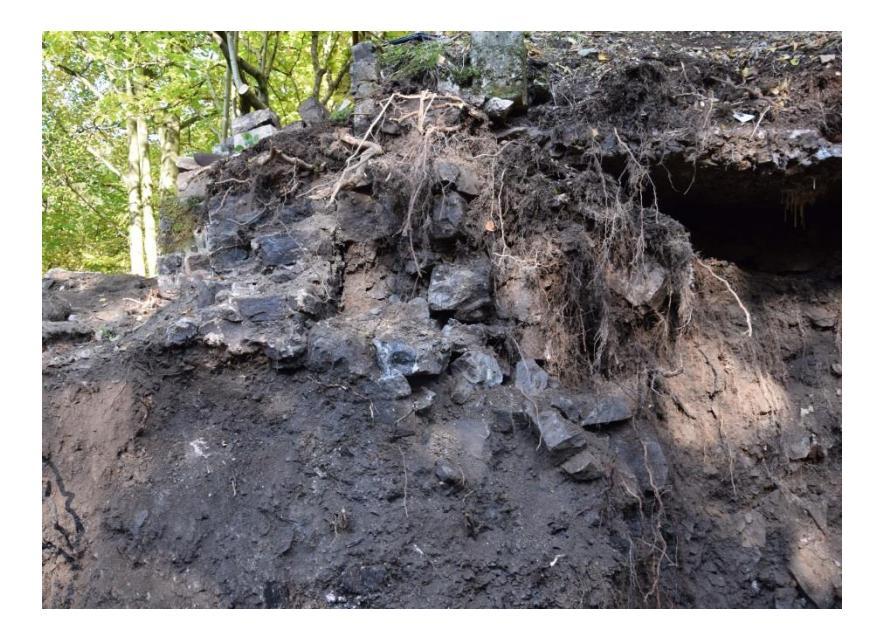
Plate 53: The footings of the western wall of the Northern Creamery Building, at the point where they were cut through by the 11 ton excavator on the 10th October.

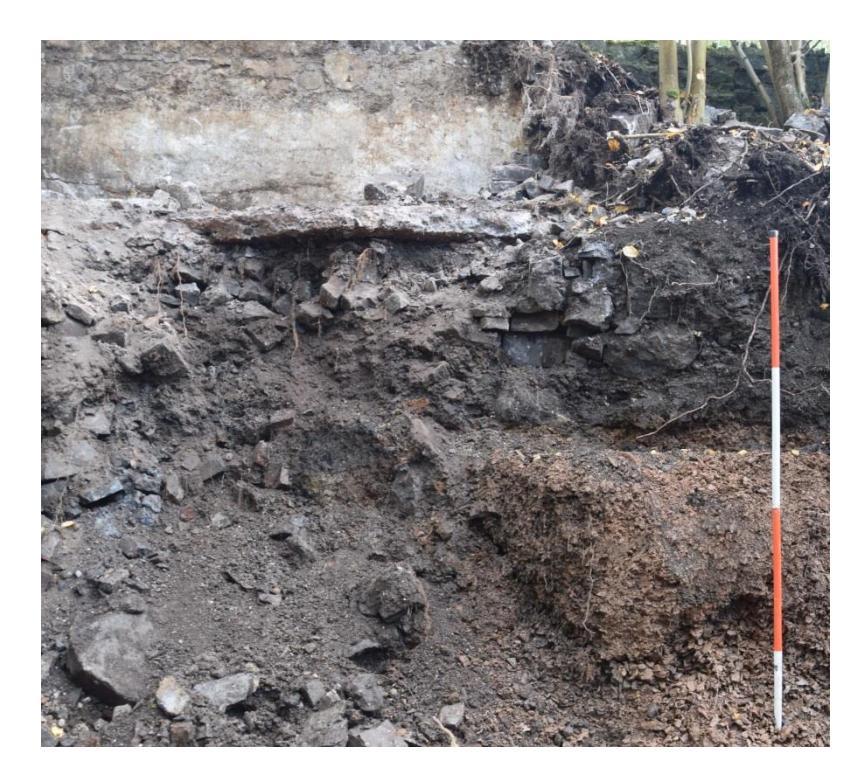
Plate 54: The footings of the southern wall of the Northern Creamery Building, with a remnant of the building's floor directly to the left, as cut through by the 21 ton excavator on the 18th October.

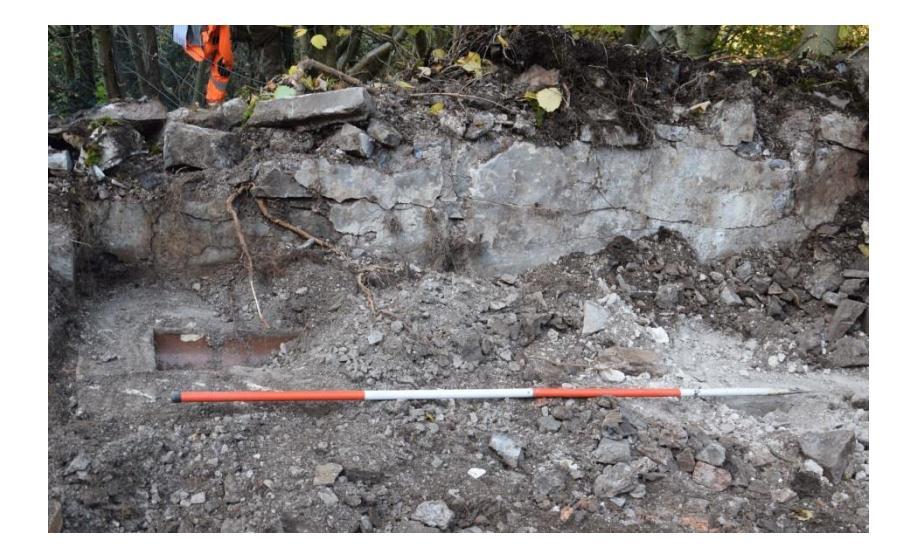
Plate 55: The ceramic trough and its low plinth within the Northern Creamery Building, set against its western wall.

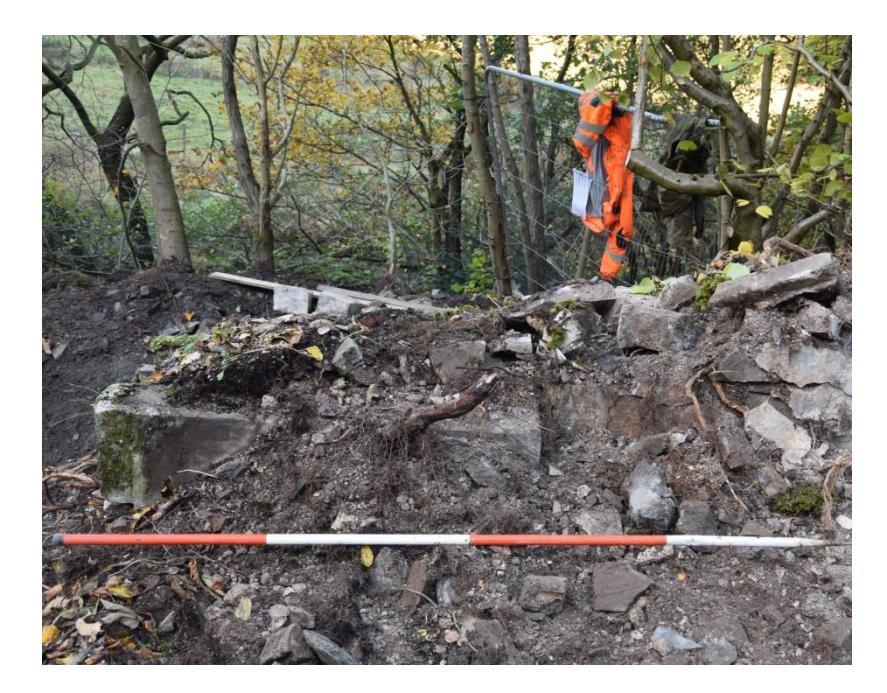
Plate 56: The machine plinth, set partially within the western wall of the Northern Creamery Building at its south-western corner, photographed when first found as the demolition rubble within the interior of the building was being stripped; the four small holding down bolts on its top were not recognised before the feature was removed. The 1918-32 Railway Siding Terrace and Deep Ecton Level Extension (Contexts 2-3, 12-13, 21, 29, 34): The flat-topped terrace here (Context 34), which terminated to the south at the same point as the southern end of the yard above, was built sometime between 1919 and 1924. It is just over 6m wide and lies between the Creamery Outbuilding Terrace above to the east, and the river level ground below to the west. There was a dilapidated c. 0.9m high retaining wall of mortared limestone blocks and slabs between the two terraces, which had already collapsed or had been removed in the area of the 2018 excavation pit, with only lessthan convincing possible remains of its basal courses seen briefly as machine stripping was in progress. The retaining wall to the west side of the Railway Siding Terrace, again built of mortared limestone blocks and slabs, was significantly higher, standing c. 2.00m above the riverside ground.

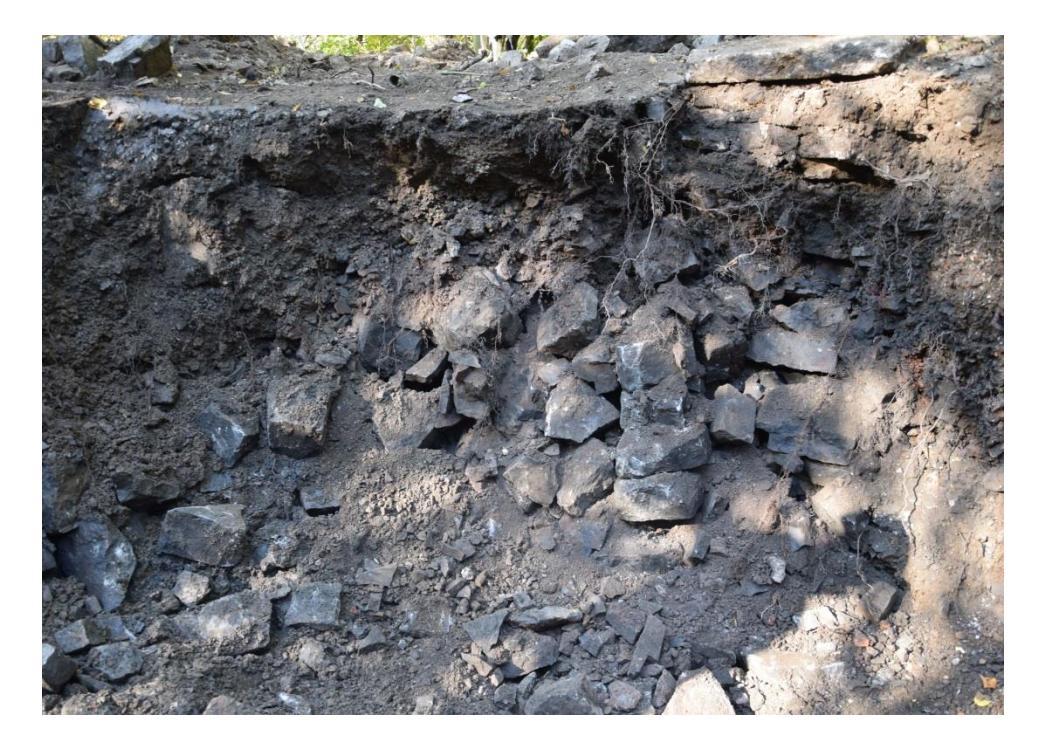
Plate 57: The rubble fill (Context 13), with soil above (Context 12), both within the cut made for the Railway Siding Terrace, as seen at the north-western edge of the 2018 excavation pit on the 10th October; to the far right is the cut edge; the wall-like feature within the rubble had no integrity and was a fortuitous arrangement of stones.

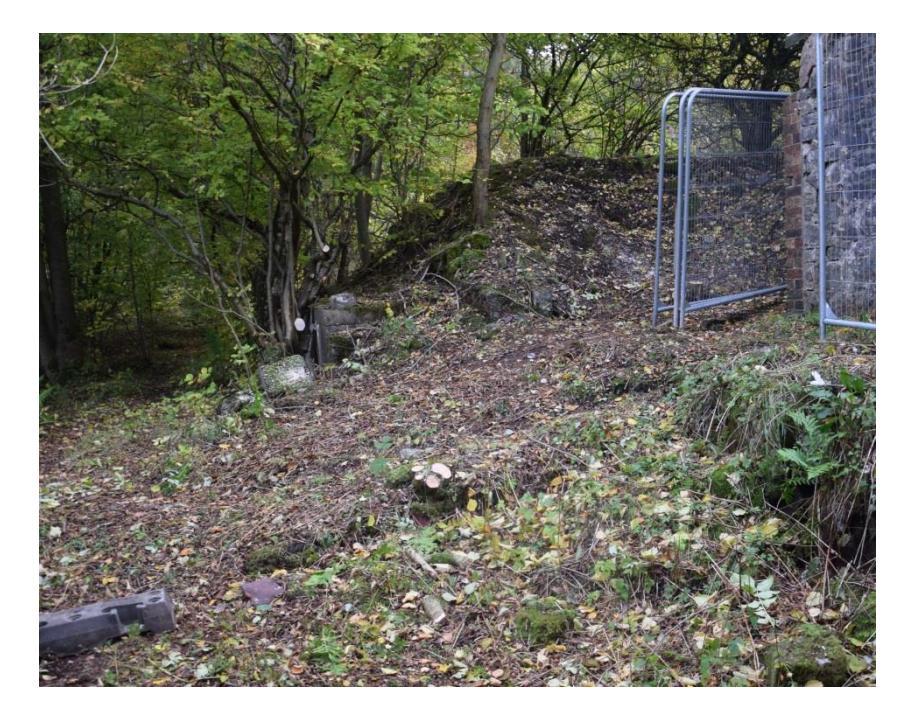
Plate 58: The base of the robbed cross wall (Context 3) on the Railway Siding Terrace, visible as a low raised linear feature (foreground centre), photographed shortly before the 2018 excavation pit was started.
