The Restoration of the Deep Ecton Level Entrance (List Entry Number 1021175; SMC Ref No, S00168477): Recording and Findings during the Archaeological Watching Brief (October to November 2018)

Dr John Barnatt, BA Hon, PhD, MCIfA, FSA

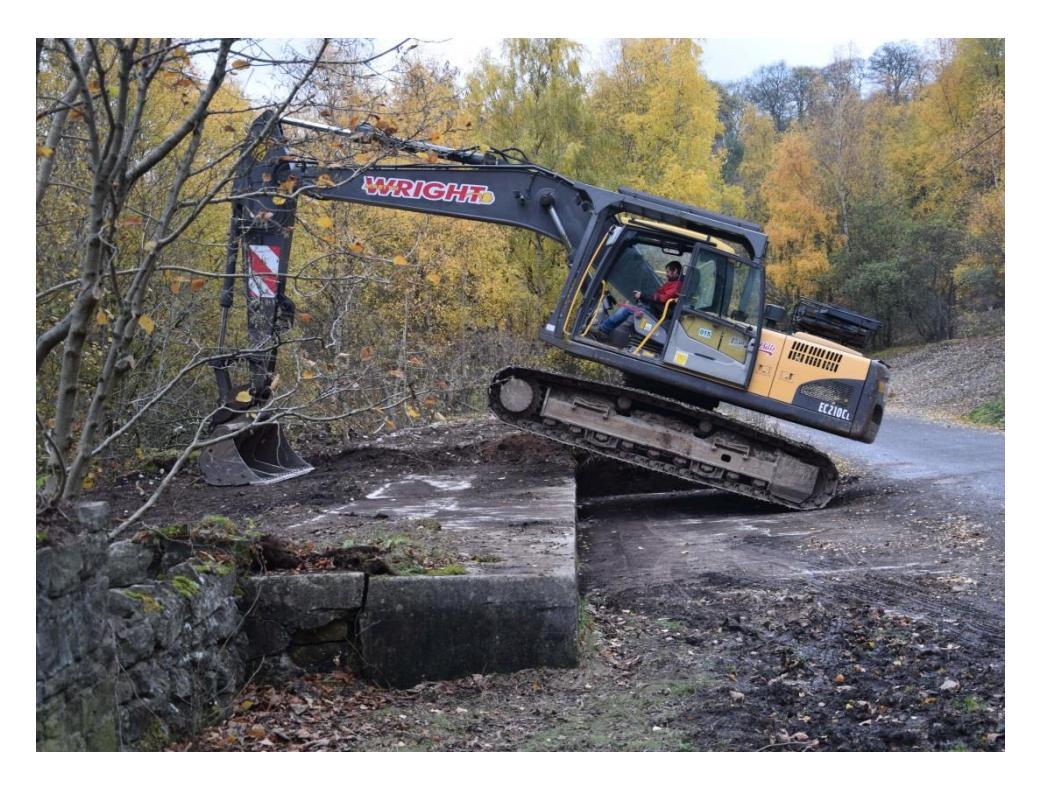
Plate 59: The roadside concrete unloading platform (Context 40) after it was stripped of turf and topsoil on the 6th November. The excavator driver is skilfully leaving the site after backfilling the 2018 excavation pit in a way that avoided damaging the platform.

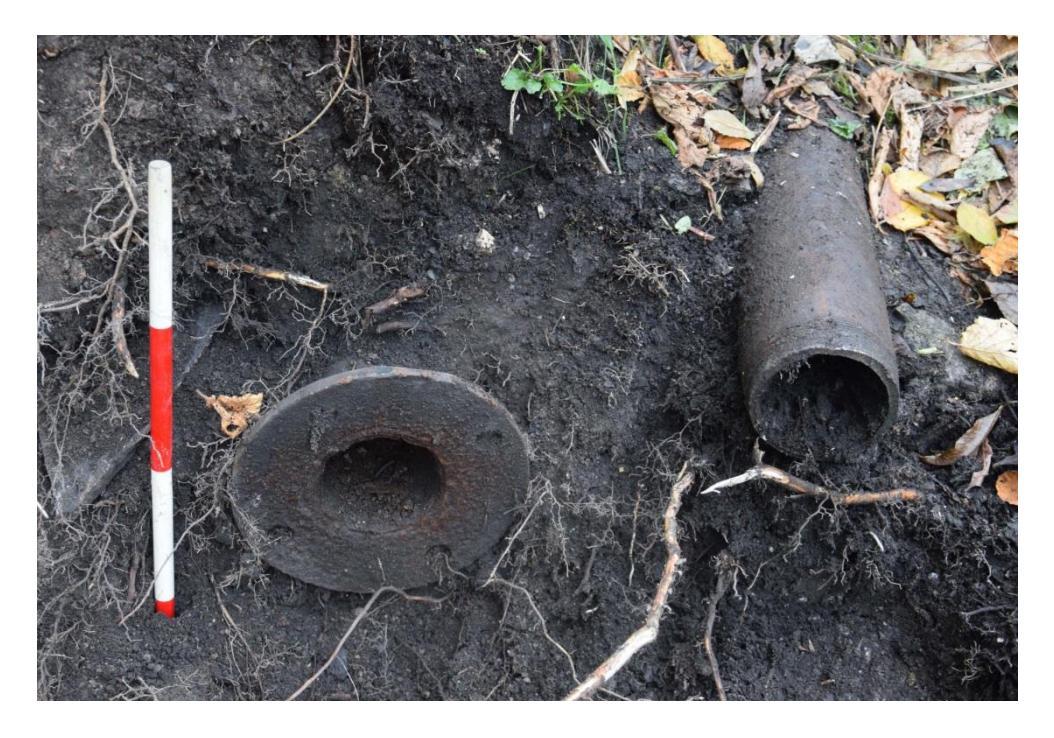
Plate 60: Two *in-situ* iron pipes (Context 9) at the eastern edge of the Railway Siding Terrace, as first seen when the excavation pit was started on 9th October.

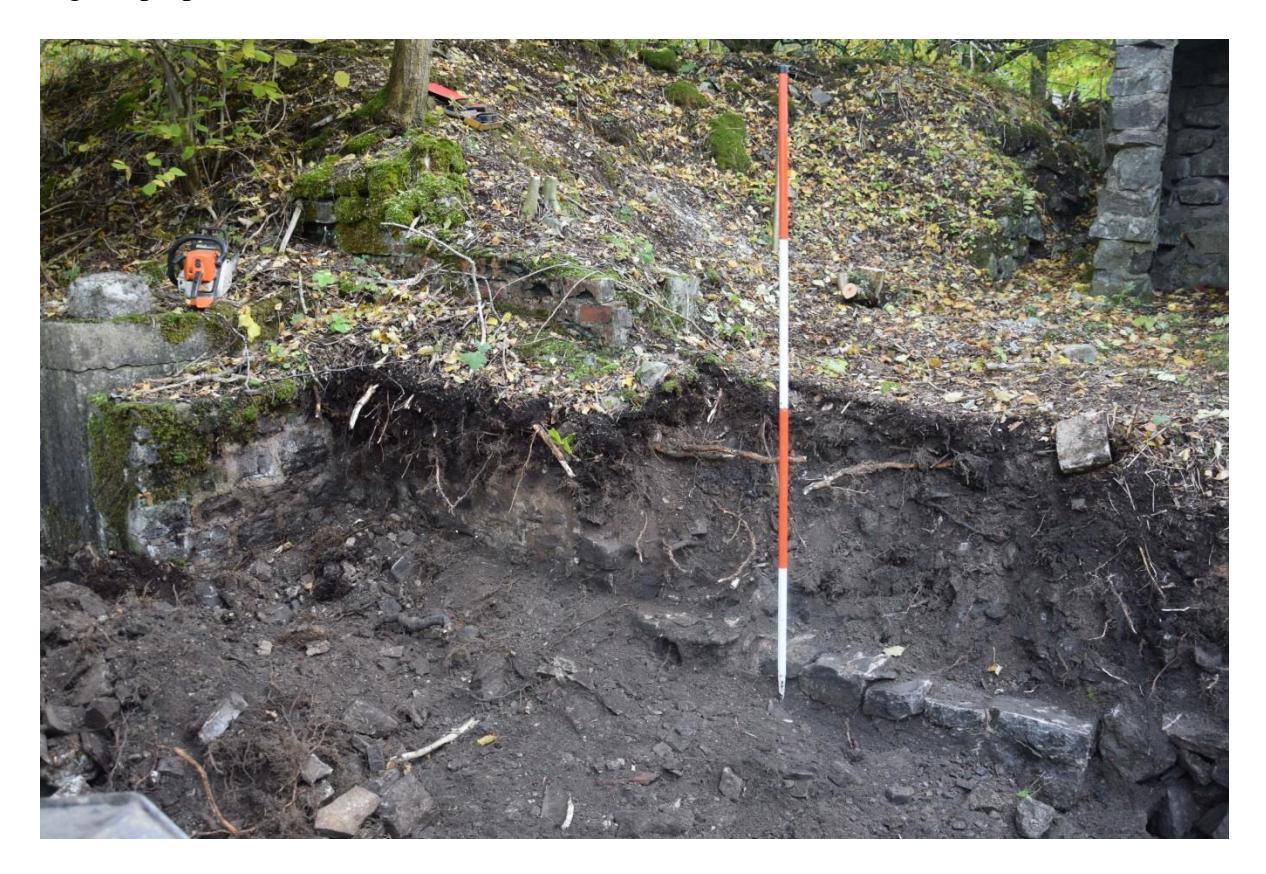
Plate 61: The remaining courses of the low wall (Context 4) at the eastern edge of the Railway Siding Terrace; its southern end had been robbed or collapsed, as first seen when the excavation pit was started on 9th October.

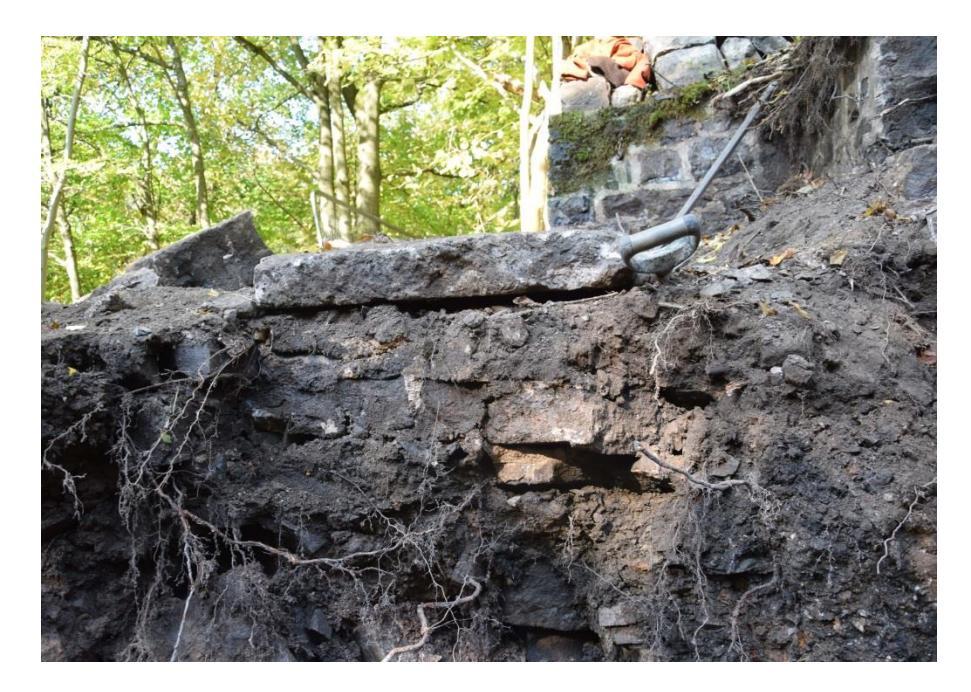
Plate 62: The small fragment of stone floor (Context 14), below the recently placed concrete slab at surface with topsoil between, as seen in the north-western edge of the 2018 excavation pit on 10th October.

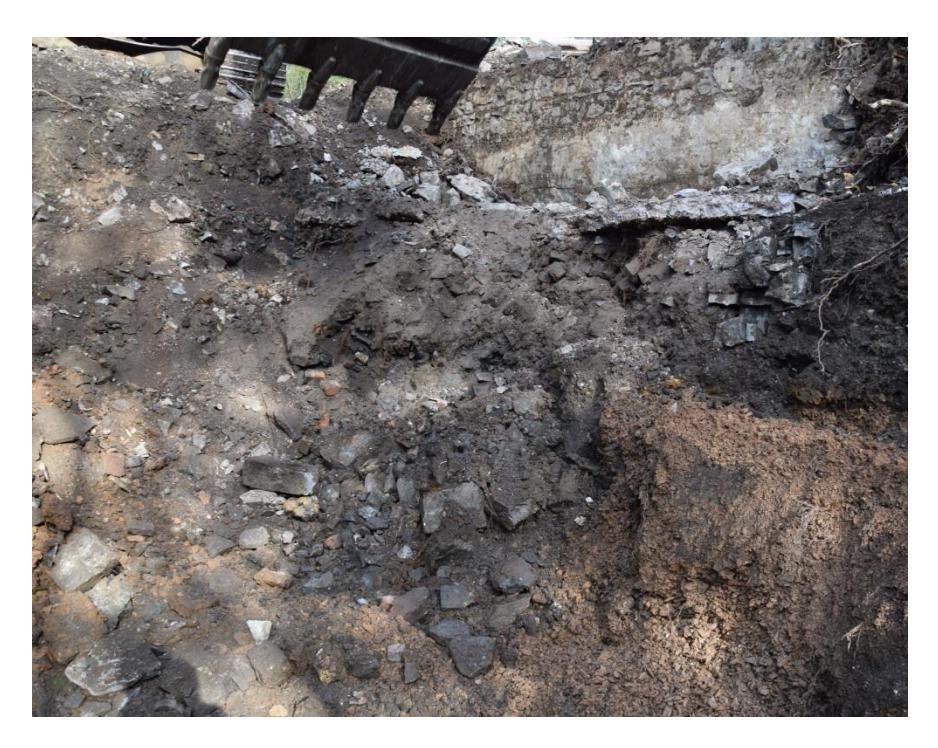
Plate 63: The rubble fill (Context 44) of a pit (bottom centre) beneath the Creamery Northern Building (above). The steep cut side was made into the redeposited material (Context 11) (right) in the 1884-85 'cut and cover' trench above the Level. This was first seen and photographed to the south-eastern side of the excavation pit on the 18th October as machine stripping was underway.

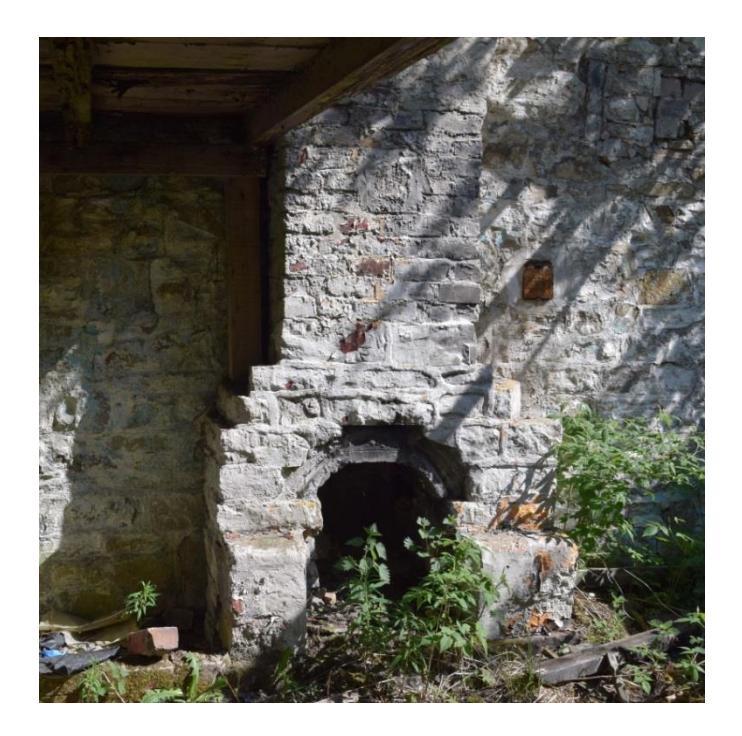
Plate 64: The fireplace and chimney, with small money box in the wall to the right, within the Creamery Outbuilding, which were added when the building was used as a caving club hut.

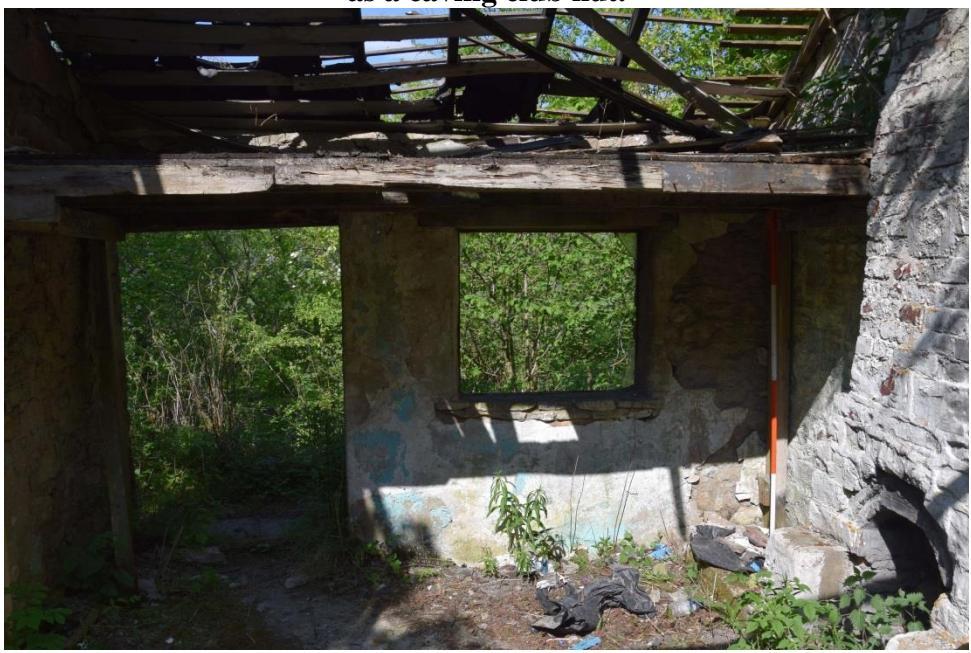
Plate 65: The sleeping platform within the Creamery Outbuilding, which was added when the building was used as a caving club hut.

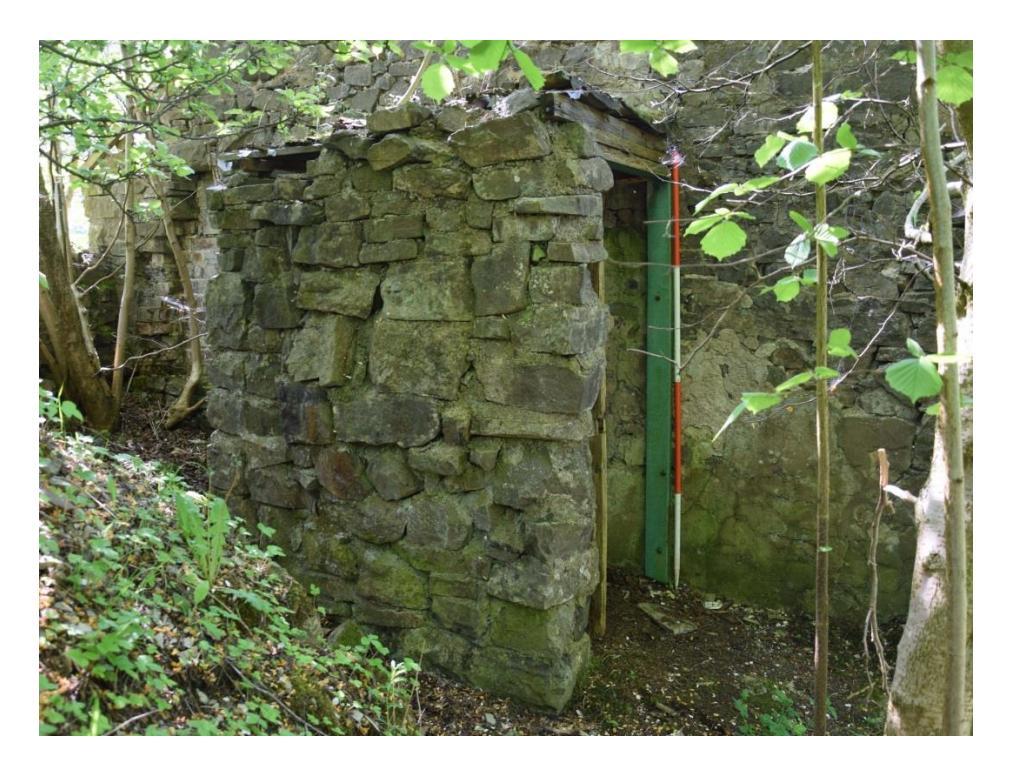
Plate 66: The outside toilet attached to the northern wall of the Creamery Outbuilding that was added when the building was used as a caving club hut. A limestone block found in the rubble after the building had been demolished in 2018 is crudely carved 'Jan 1960'; this may relate to when the building was first taken over and it is known that the club's activities continued into the 1970s.

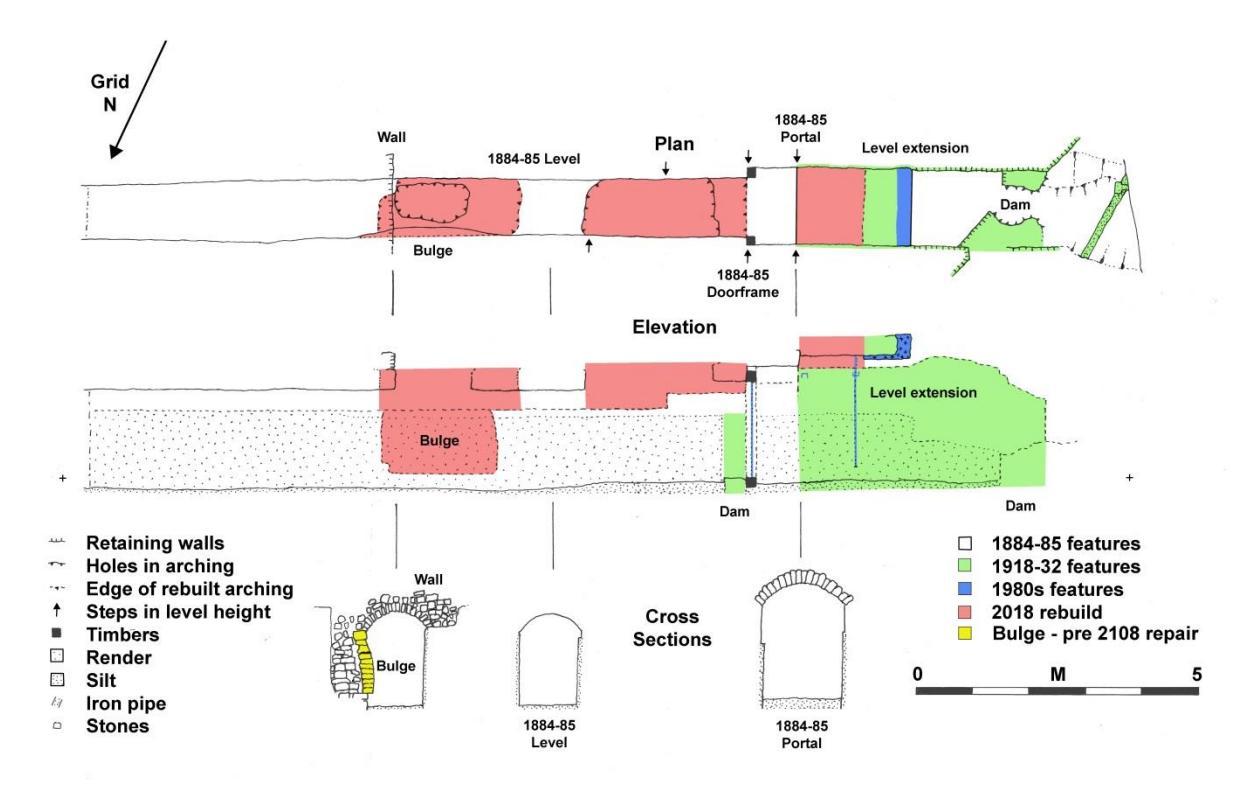
Figure 7: The Level, showing late 19th century, early 20th century and 1980s features, together with parts rebuilt in 2018.

The remaining 1919-24 arching was rebuilt in 2018 with stronger arching stones than the original and without the mortar, but with grout later poured from above to fill the voids between the stones to increase the arch stability; reinforced concrete was then placed above.

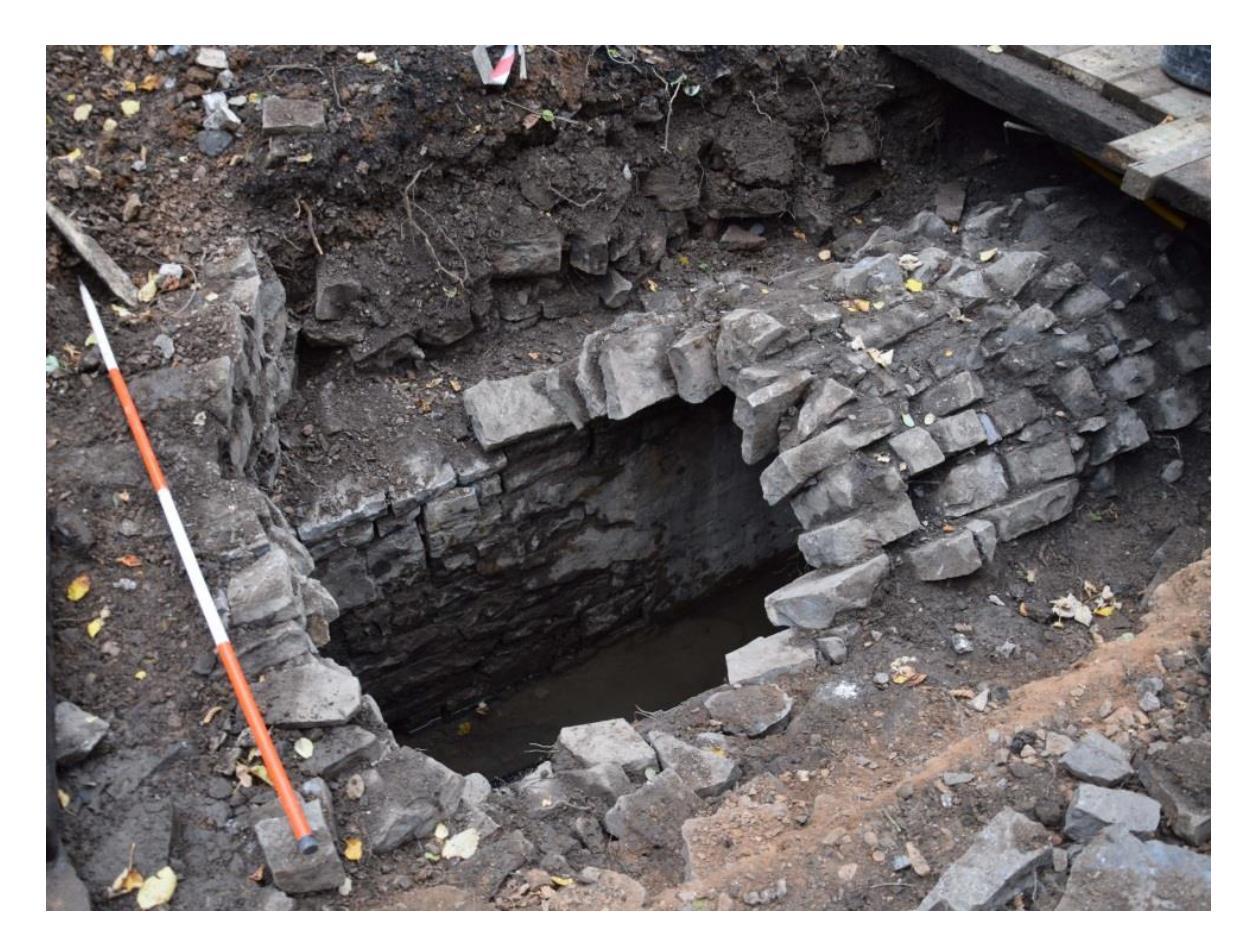
Plate 68: The drystone wall (left), placed directly above the Level arching by the north-eastern hole in this, with intact arching (right), which is interpreted as designed to hold back the backfill of the 'cut and cover' trench as this was being

put back behind the wall.

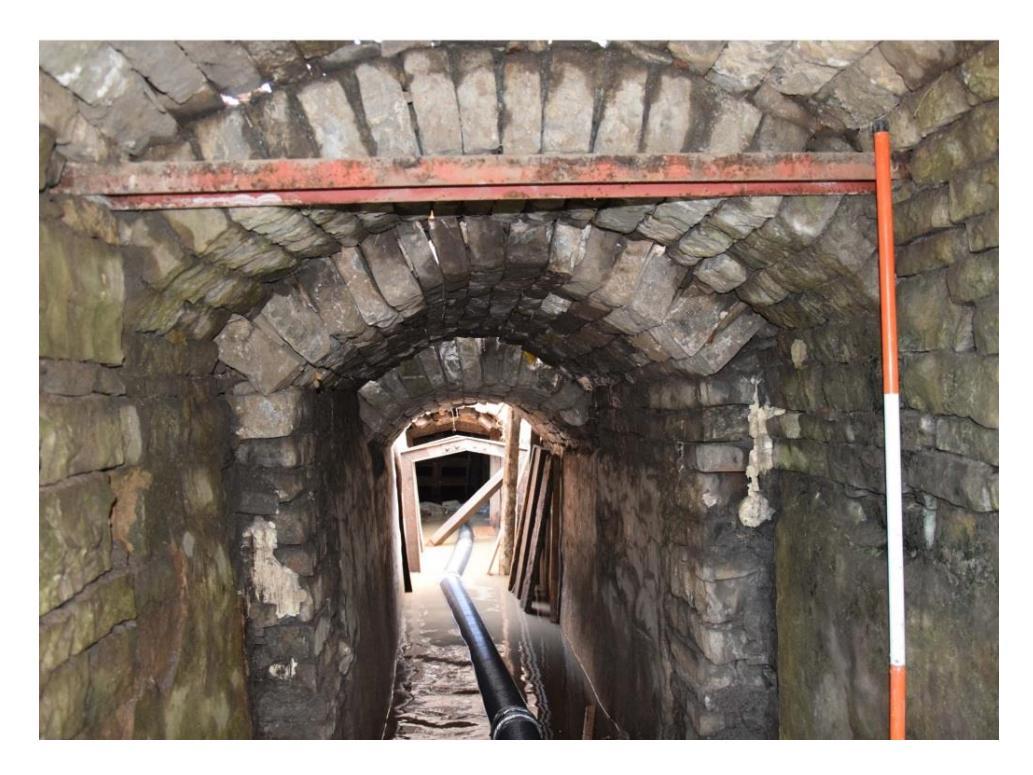
Plate 69: The original 1884-85 portal to Deep Ecton Level at the top of the photograph, which between the 1980s and 2018 was hidden by timberwork holding up the 1918-32 period arching of the extension built under the Railway Siding Terrace. Behind, the next step down in the arching is where the 1884-85 doorframe and doors were placed. The arching beyond here has been rebuilt, while the arching at the back, behind the north-easternmost step down in height is original.

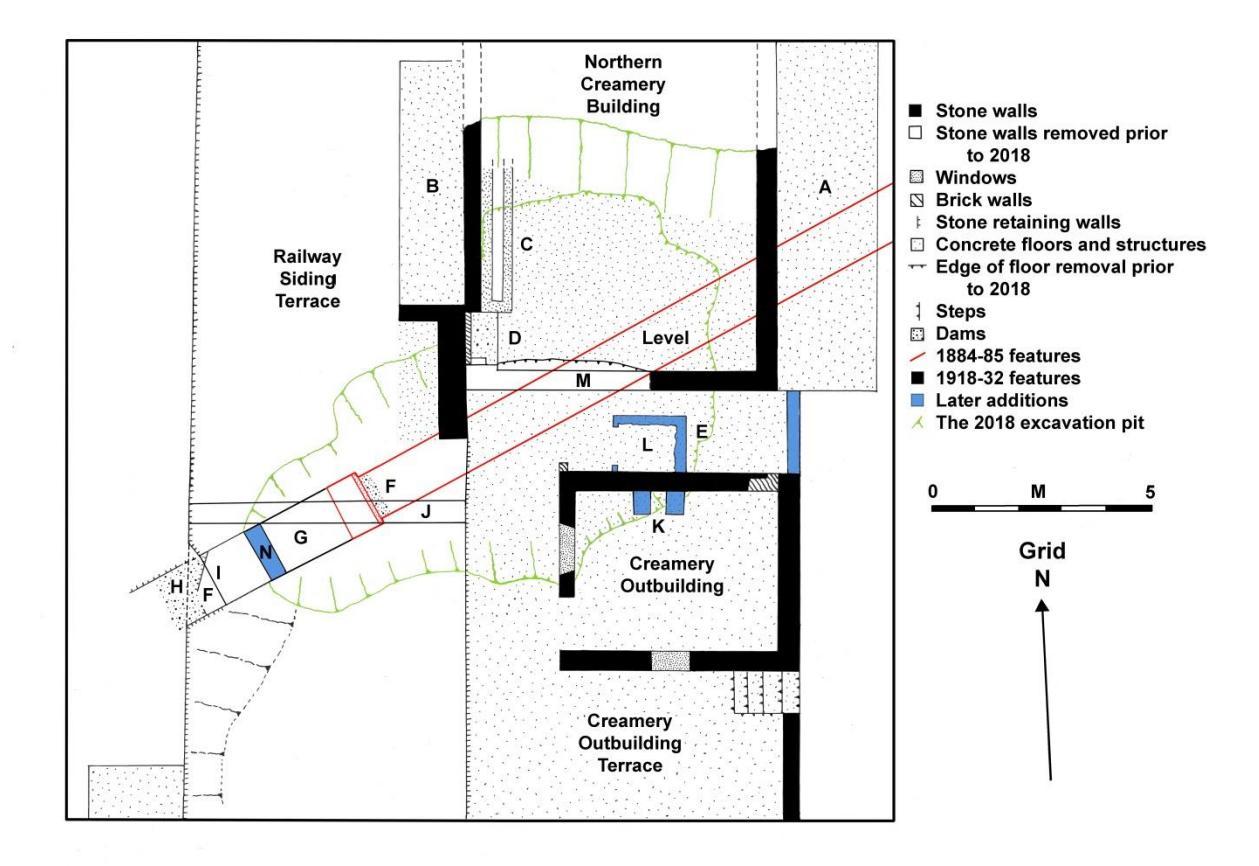
Figure 8: The site, showing late 19th century, early 20th century and later features (A: unloading platform, B: loading platform, C: ceramic trough, D: machine plinth, E: site of water tank; F: creamery dams, G: Level extension, H: postulated original 1919-24 portal, I: rebuilt creamery portal, J: Railway Siding blocking wall, K: fireplace, L: outside toilet, M: wall and floor probably removed in 1980s, N: 1984 portal).

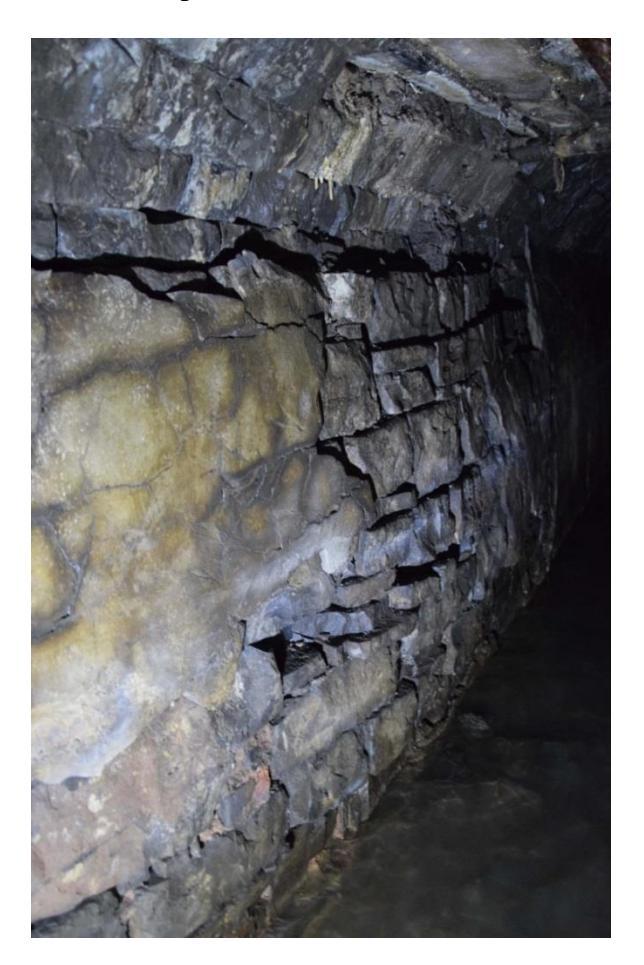
- Repairs were made to the outermost section of Deep Ecton Level in the 1980s after two previous collapses had helped blocked access. Two holes in the arching were supported from inside the passage, the innermost primarily by three Acro-props with a metal grill above, and the other using two ring arches supporting planks. The first collapse had a 3m deep pit dug above it from surface, probably removing the lower part of the southern wall of the Northern Creamery Building, which was plugged to help prevent further material from descending into the passage. The previously fallen material that had dropped into the Level, and perhaps the creamery dams, were removed. A third section of unstable arching, immediately adjacent to the 1980s end of the passage roof, was supported on timber baulks. A concrete portal at the then outer end, with an inscription dated 1984, was cast *in-situ*. While the various repair measures within the Level were found to be still sound in 2018, they were getting old and would not have lasted forever. The bulge in the passage's side wall beneath the innermost remediated collapse, which had developed in recent years and in 2018 was

on the move, meant that action was essential to maintain access to the important underground remains in Deep Ecton Mine.

Plate 70: The bulge in the Level side wall as it appeared in May 2018.

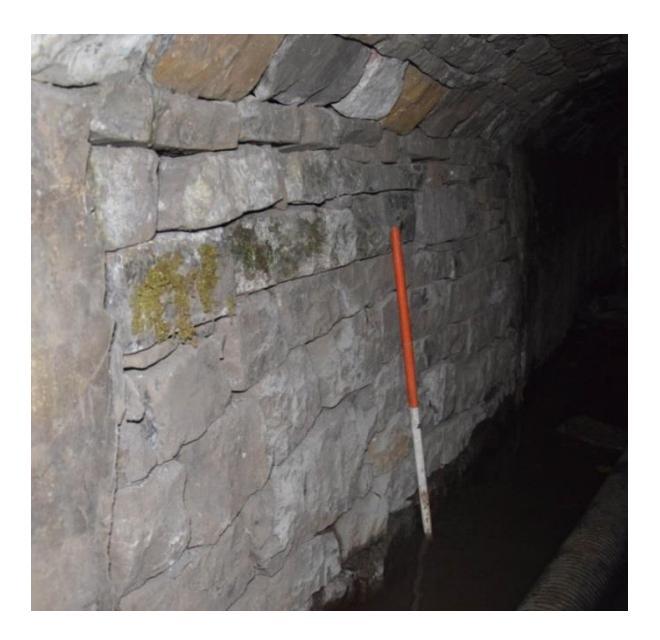
Plate 71: The Level wall after the bulge had been taken down and the wall rebuilt in October 2018.
