EITRM116871: D2.3 Geoscientific evaluation of pilots

KAVA Reference (Number, Acronym, Full Title): 19160, UNEXUP, UNEXMIN Upscaling

Name of the author/Responsible partner: Hilco van Moerkerk, Zorana Milosevic, Steve Henley (RCI), Richard Papp (UGR), John Barnatt (Ecton Mine Educational Trust), Richard Shaw (Ecton Mine Educational Trust)

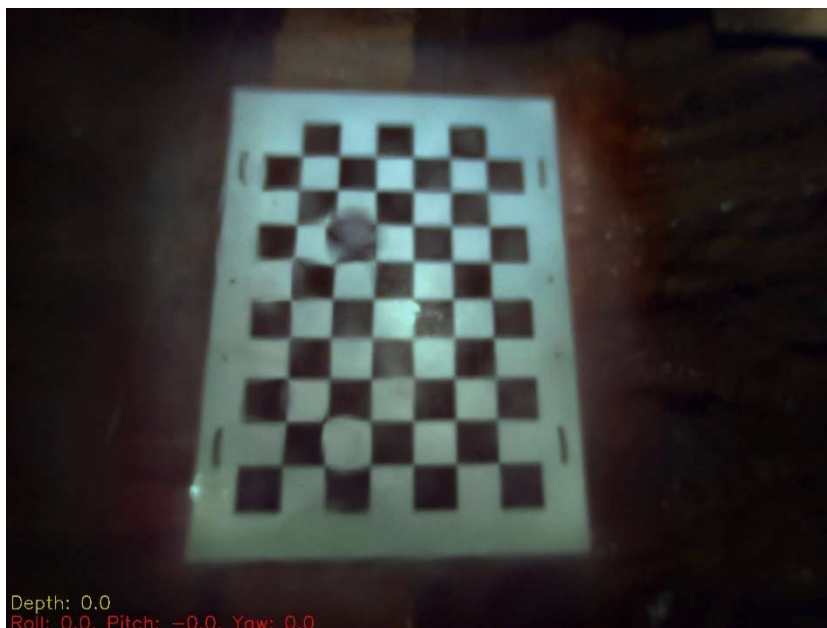
At the New Cooks Kitchen Shaft, a checkerboard was placed 12 m above the water surface to provide accurate georeferenced coordinates for the UX-1Neo robot (**Figure 1**). Before and after each dive, this table was identified in order to collect as accurate data as possible.

2. Figure - The view of the checkerboard on the surface with the right camera

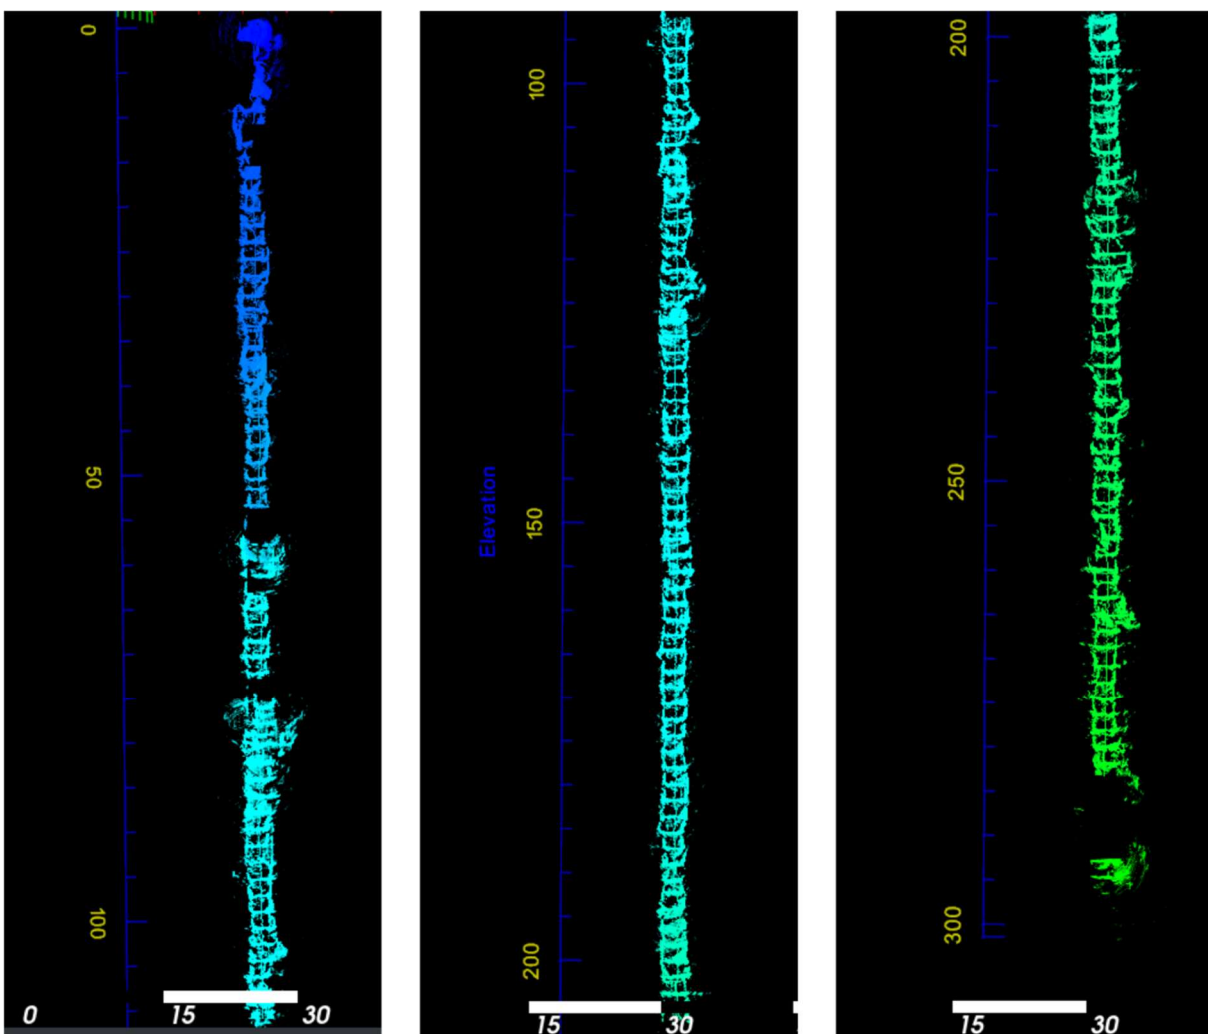
In the New Cooks Kitchen Shaft, in the section between the water surface and the pump station, a continuous 3D scan was performed using the M3 sonar (Figure 5). Due to the opacity of the water, the robotic lasers (SLS) did not provide usable data, so the use of lasers was avoided, thus reducing the amount of data collected for easier handling.

6. Figure - Continuous M3 sonar measurement in the New Cooks Kitchen Shaft

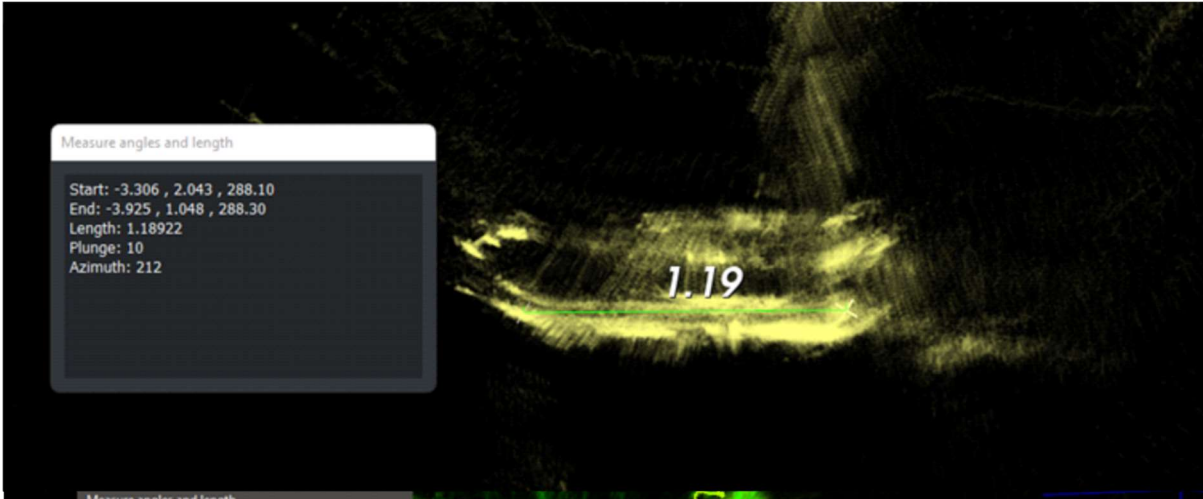
13. Figure - Measurement of the approximate width of the gate in metre - top view

With the help of the UX-1Neo robot, the “195 fm pumping station” was surveyed according to local conditions. Access to the level of the pumping station is not possible because the metal gate at the entrance is closed. In order to collect as much data as possible, the robot was used to explore the entrance and its immediate surroundings. Photographs and sonar images taken of the gate and the results of other measurements are included in this report.

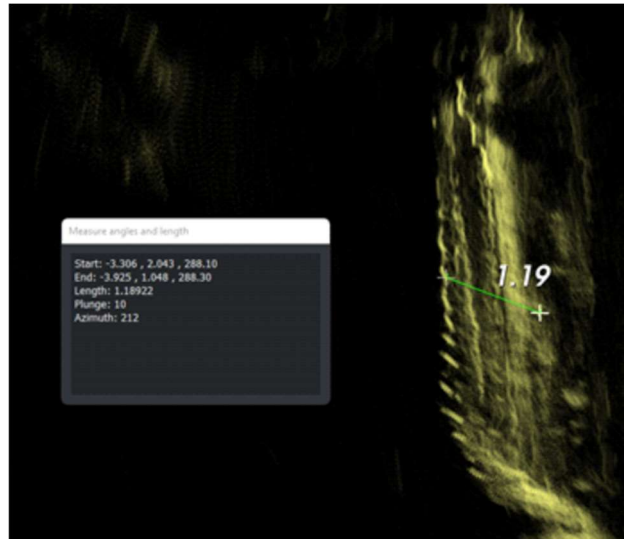
14. Figure - Measurement of the approximate width of the gate in metre - angle view

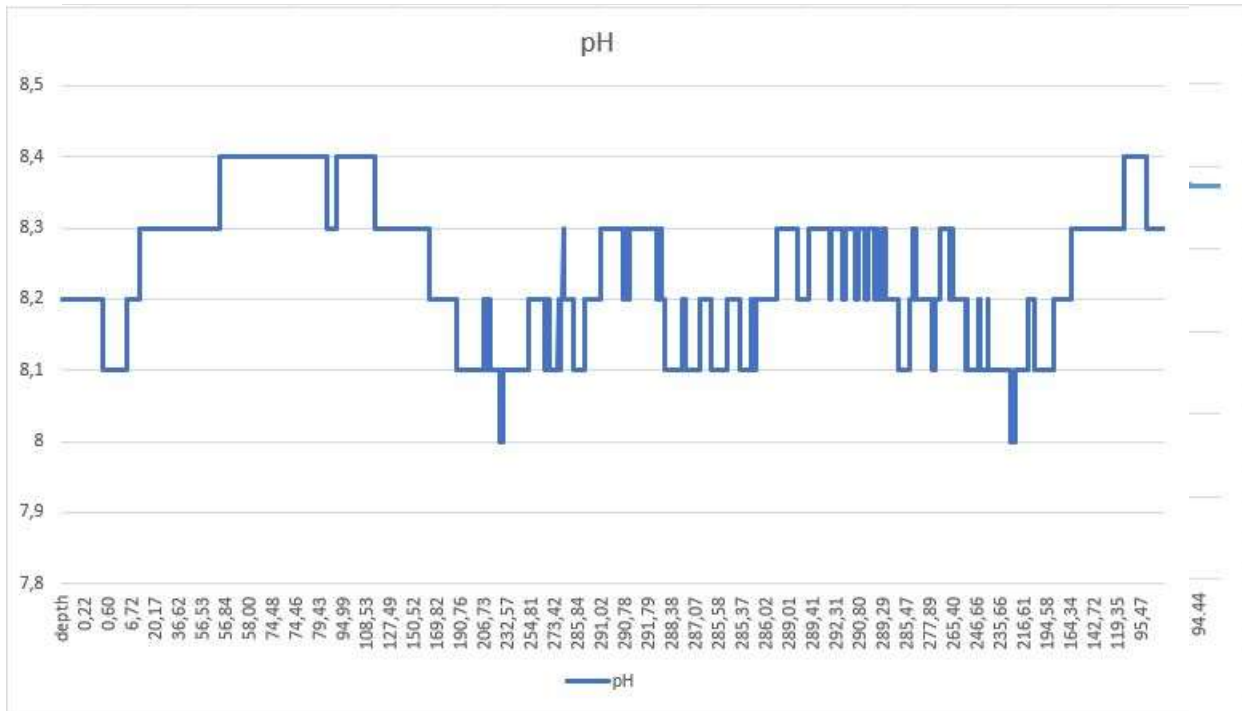
Continuous water parameter measurements were taken during the dive. The water parameter measuring sensor collected data on temperature, pH, depth and electrical conductivity every second. The collected raw data and the calculated electrical conductivity values (in $\mu\text{S}/\text{cm}$) are also uploaded.

16. Figure - Graph of the pH of the water during the dive

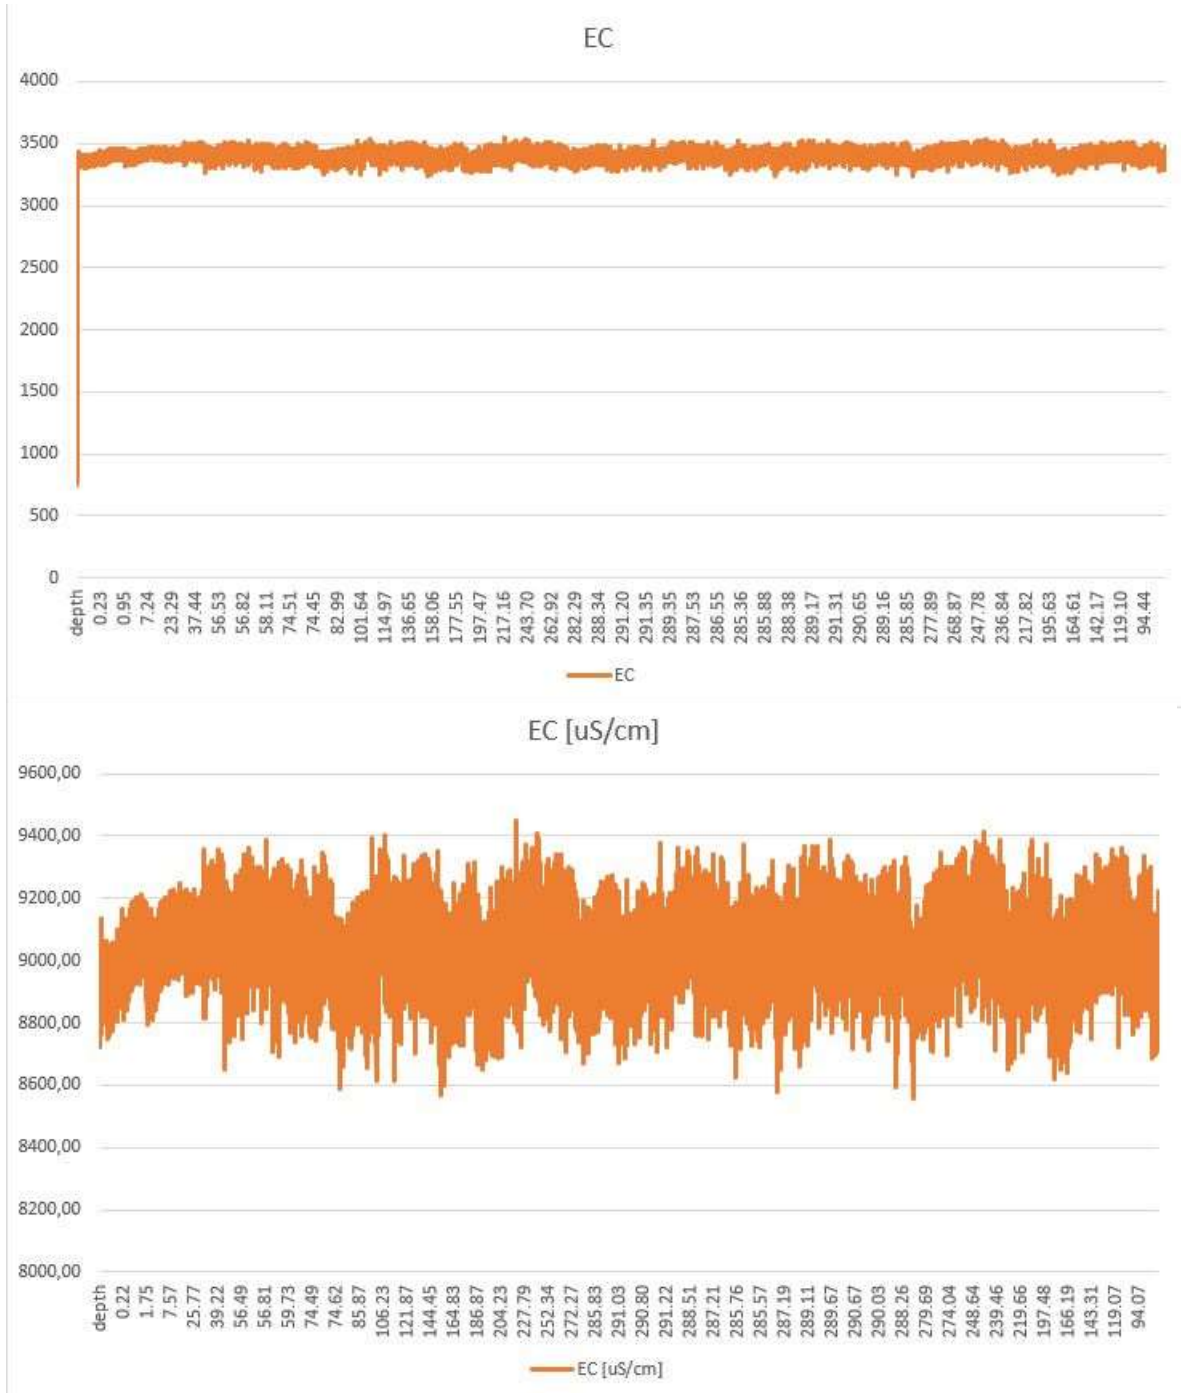
17. Figure – The change of the electrical conductivity (in $\mu\text{S/cm}$) during the dive (without the first value)

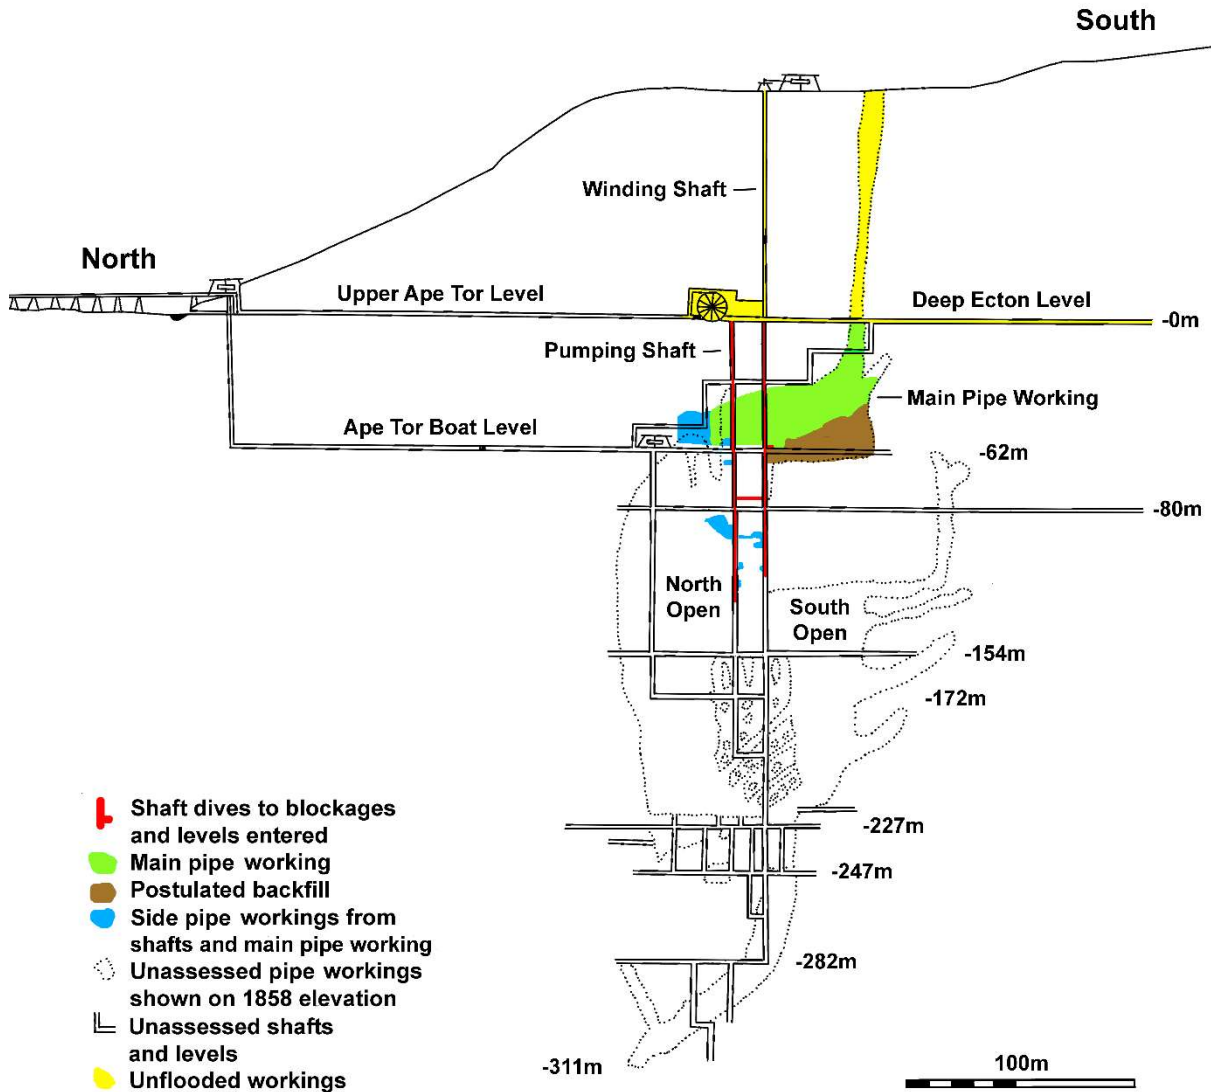
Figure 21 The approximate extent of passages explored and/or plotted by the sonar survey during the 2019 dives at Deep Ecton Mine (with the depiction of the 'side pipe workings' revised from the 2000 report to match the 2022 discoveries). These are superimposed on the schematic 1858 mine section drawn by Meads, with feature names, recorded depths of 'levels' and a metric scale added.

The main pumping shaft was explored down to a blockage at *c.* -124m to -127m, while the winding shaft was choked at *c.* -112.5 to -113.5m. These shafts are sunk through contorted bedrock, where the bedding was often near-vertical, but with the tops and bottoms of folds also seen. Both shafts had horizontal miners' 'levels' leading off their sides at various depths, some as 'cross cuts'

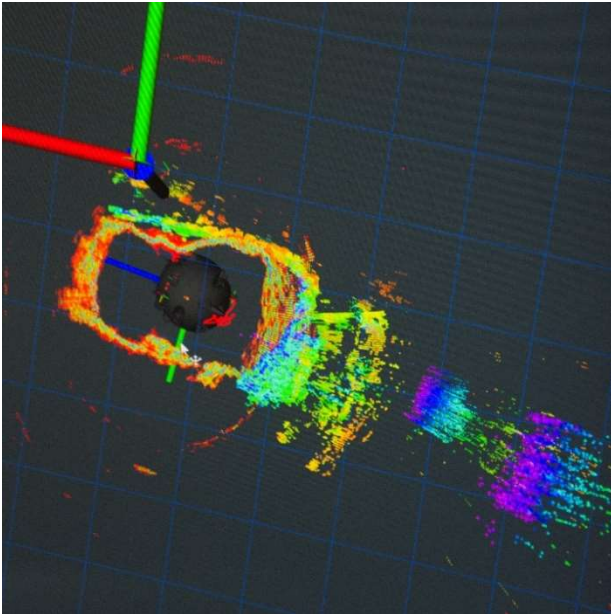
Figure 22 An example of sonar plotting at the winding shaft in 2022, photographed from a monitor in the control room during the dive

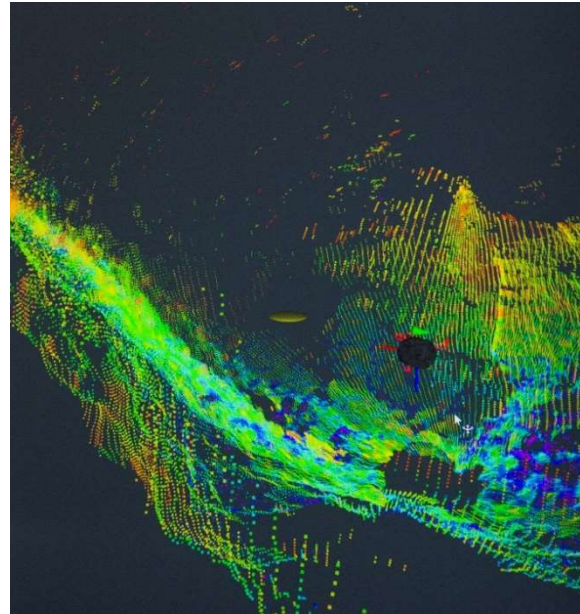
Figure 23 Sonar plotting in the 'main pipe workings' in 2022, photographed from a monitor in the control room during the dive

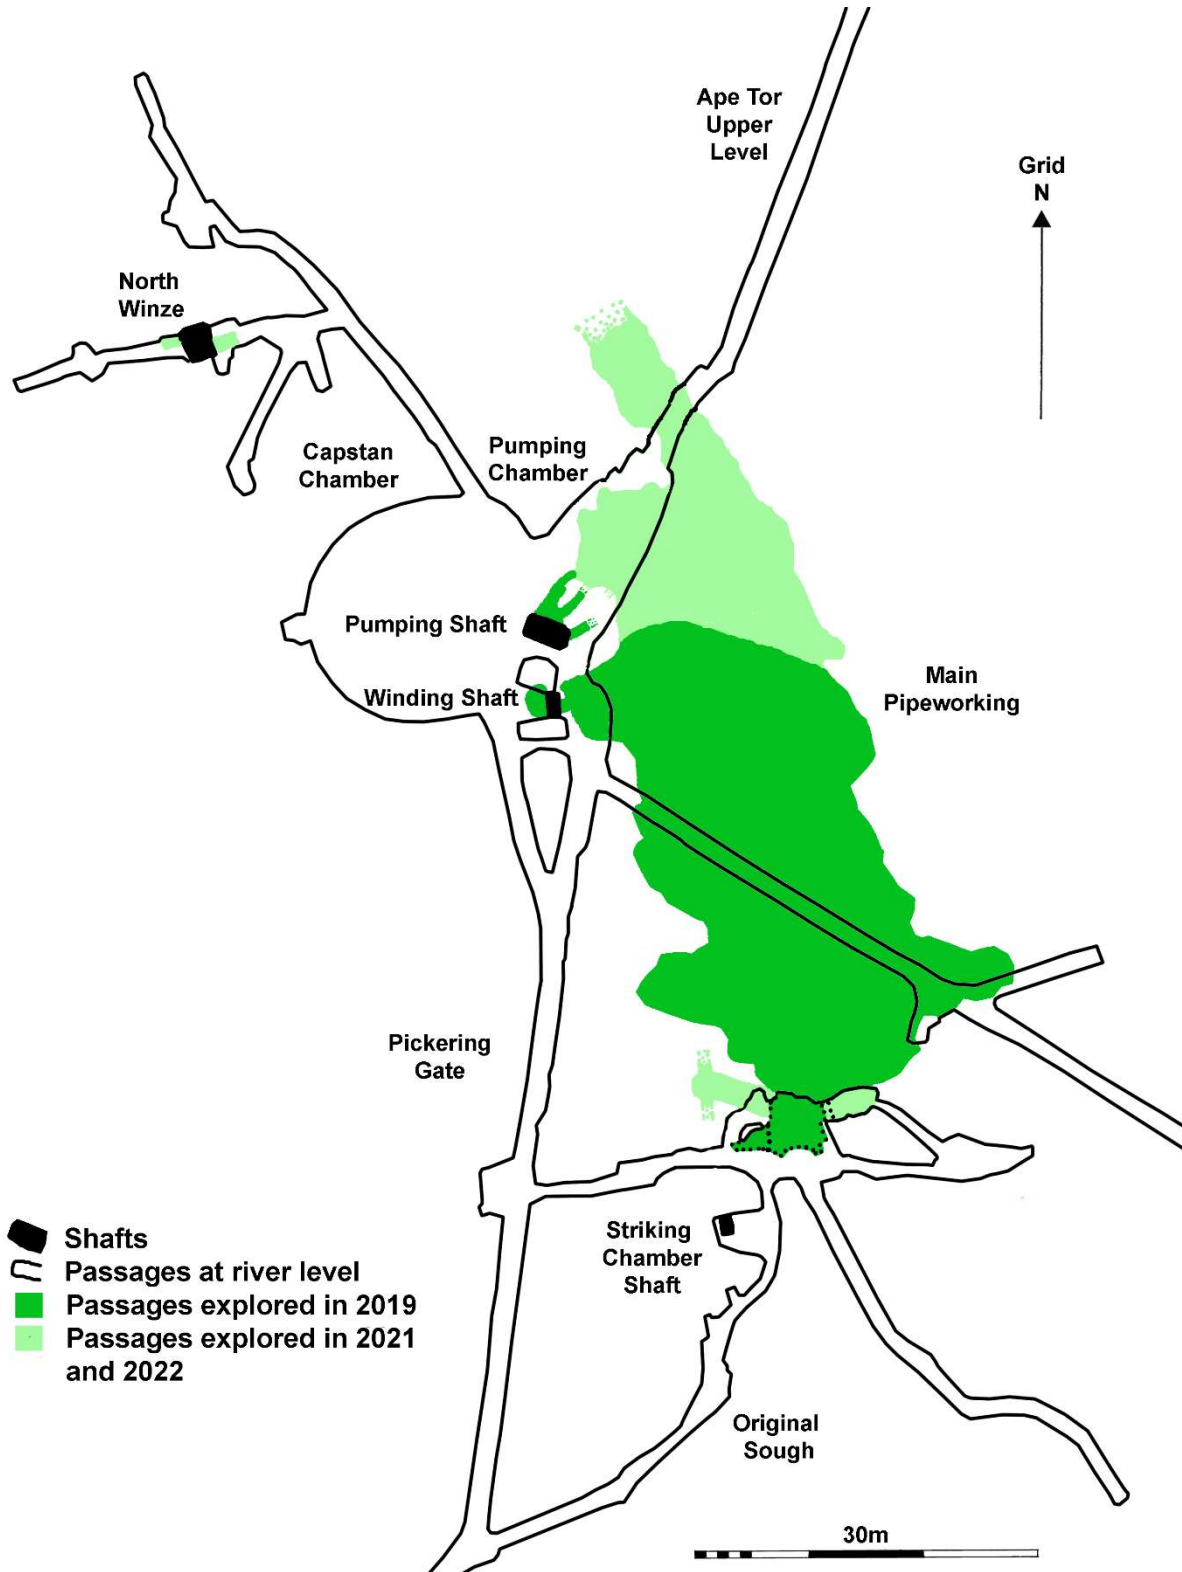
Figure 24 Plan showing the new discoveries made under water in 2019 and 2021-22 down to about -60m, including those in the flooded 'main pipe workings', those at the 'side pipe workings' at PS8/9 and WS6, and those at the North Winze. The plan of the 'main pipe working' was generated from the sonar point-cloud plots. These workings are shown in relation to the pumping and winding shafts, the 'cross cut' WS7/PW10 at the base of the 'main pipe workings' that was explored in 2019 and the 'side pipe workings' at PS8/PS9 assessed in 2019 and 2022.

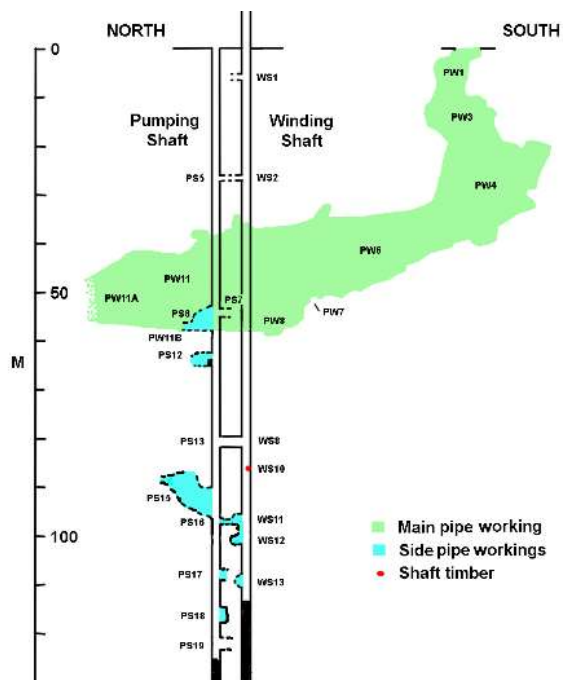
Figure 25 North-south schematic elevation through the explored workings drawn to include revisions made in 2022 after the new dives here. This shows the inter-relationship between shafts and the 'main pipe workings', with 'side pipe workings', 'cross cuts' and other 'levels' also shown (note: the orientation of the pumping shaft is skewed to show the shaft sides on the same axis as the other shaft)

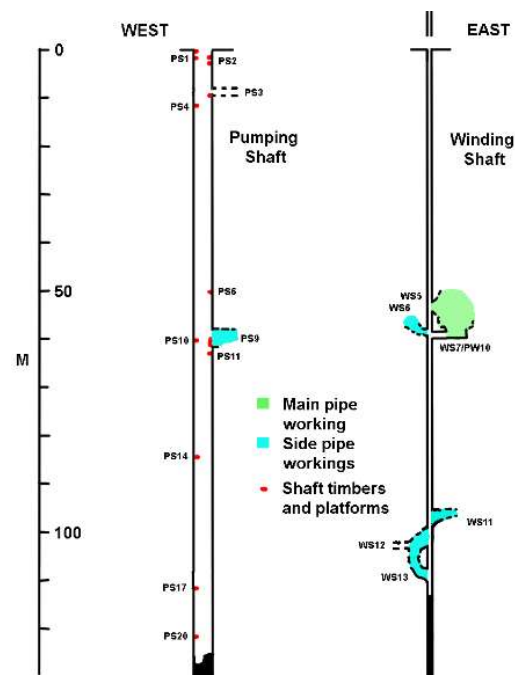
Figure 26 East/west schematic elevations through the pumping and winding shafts as two separate images, drawn to include revisions made in 2022 after the new dives here. This shows the explored 'pipe workings', 'cross cuts', 'levels', and shaft timbers (note: the orientation of the pumping shaft is skewed to show the shaft ends on the same axis as the other shaft)

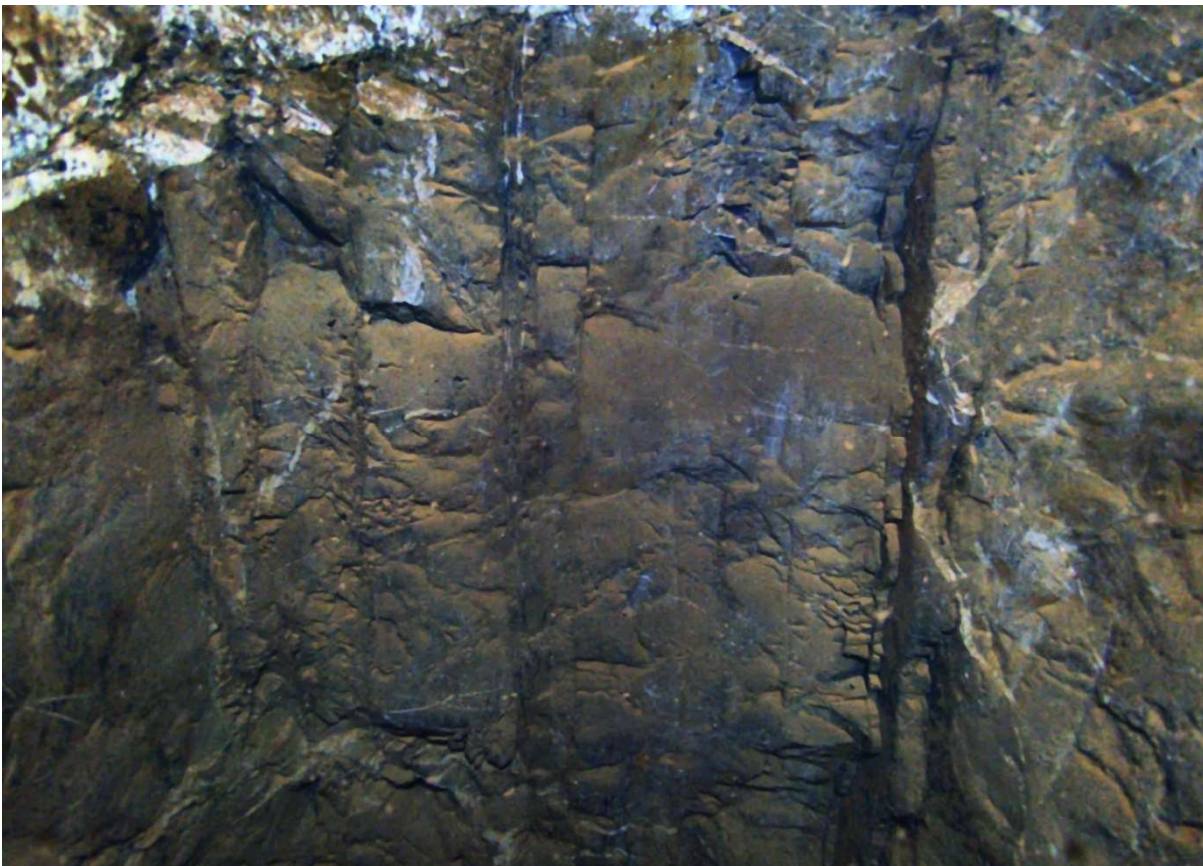
The top part of the Pumping Shaft appears to be sunk through thick- bedded limestones, with near-vertical dip, from the water-level horizon to the first main pipe vein workings at a depth of about 50-55m (Plate 4). Individual beds can be followed over much of this distance. These beds strike approximately north-south. Below this depth the limestones are generally more thinly bedded with frequent evidence of folds or crumpled bedding and with more evidence of jointing and minor faults (as seen on Plates 5-9). For example there are synclines at depths of about -78.5m, -92.0m and -97.0m and anticlines at about -69.3m and -87.9m. These are acute and usually have an axial joint or minor fault. The folds have an approximately north-south trend but plunge, if any, has not been ascertained.

Plate 4 Thickly bedded limestone in the winding shaft at c. -36.5 down, with the dip near-vertical because of folding

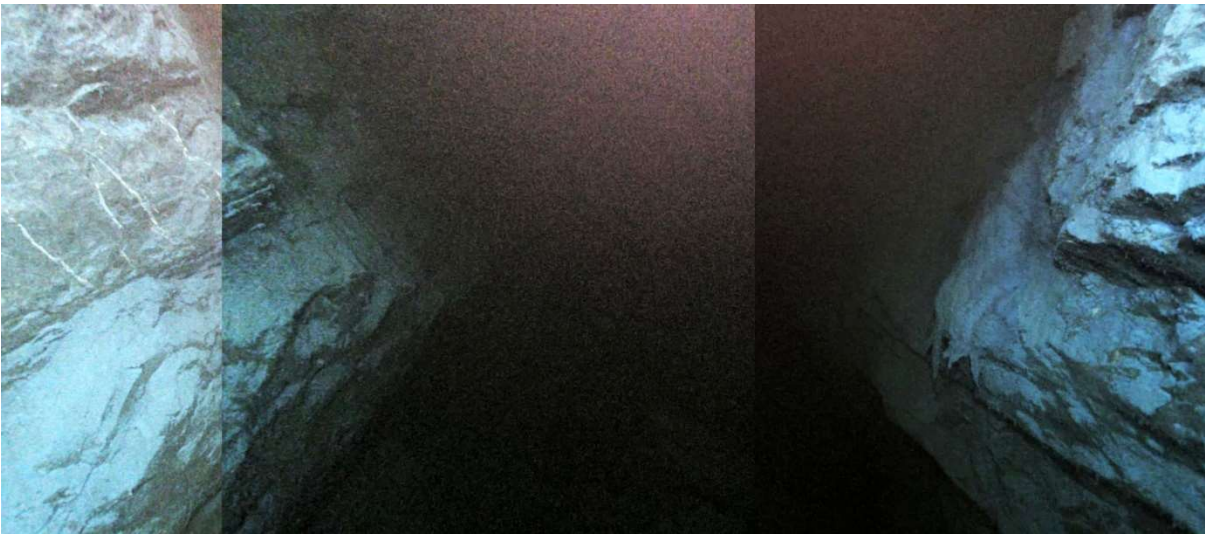
New understanding has been found on the structural control of mineralisation. The ‘stope-like’ opening at the northern end of the ‘main pipe working’ was driven along the axial plane of an anticline (Plate 5), suggesting that there was significant structural control of mineralisation. This is part of an inferred larger structure, as there is an asymmetric syncline immediately to the west of

Plate 5 Composite image showing the vertical ‘stope-like’ passage at the NNW end of the large chamber in the ‘main pipe working’ that was entered for the first time in 2022. This passage occupies the axial plane of an asymmetric anticline.

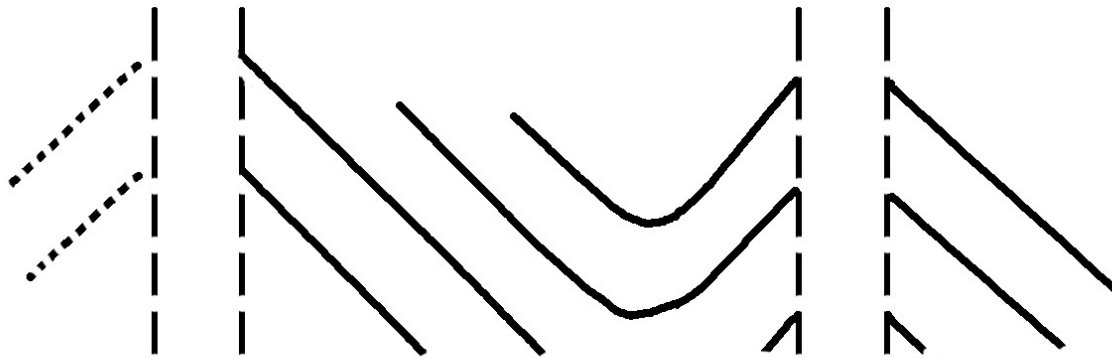
this stope, and much of the western wall of the ‘pipe working’ is on the long eastward-dipping limb of this syncline. Although the geological structure is not easily seen, it is surmised that the opening (a ‘side pipe-working’ adjacent to the pumping shaft) trending approximately north-south, sub-parallel to the main pipe-working, also occupies another anticlinal axis. Fig. 9 shows a schematic W-E section through the postulated structure.

Figure 27 Schematic west/east section through the postulated structure at c. -55m depth in the 'stope-like' passage at the NNW end of the 'main pipe working', the west wall of the 'Main pipe working' and the 'side pipe workings' next to the pumping shaft

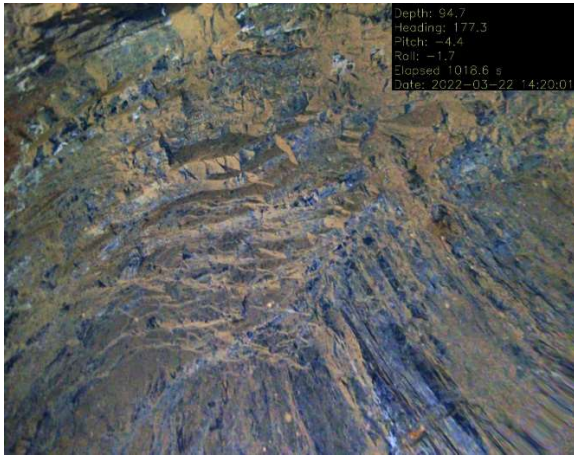
Plate 6: A fracture in the axial plane of a small-scale anticline in the wall of the pumping shaft at -94.7m depth

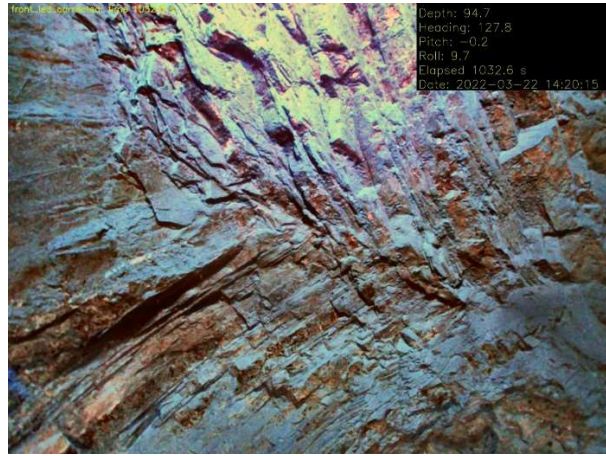
Plate 7: Another fracture in the axial plane of a small-scale syncline in the wall of the pumping shaft at -94.7m depth

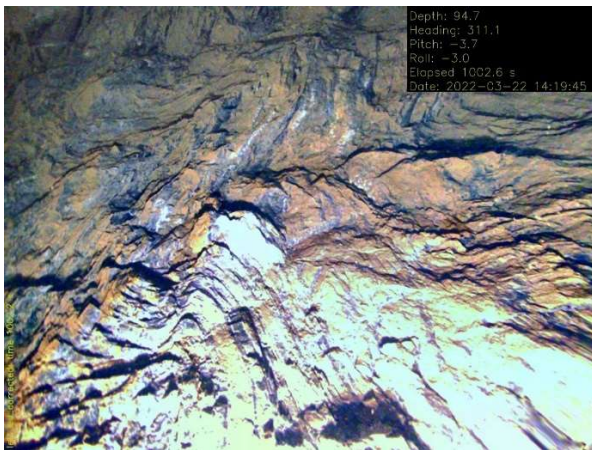
Plate 8: Disharmonic folding in thinly bedded limestones in the wall of the pumping shaft at -94.7m depth

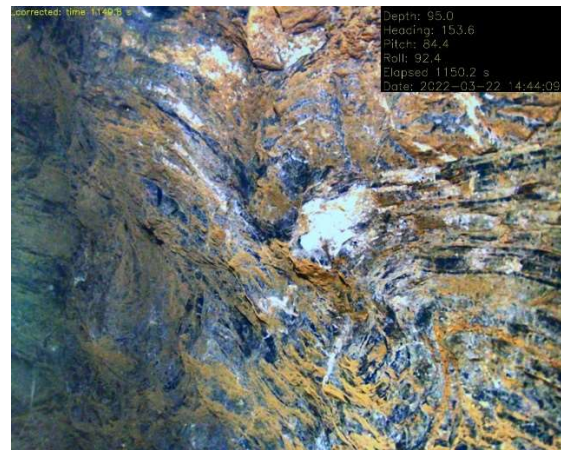
Plate 9: Further disharmonic folding in thinly bedded limestones in the wall of the pumping shaft at -95.0m depth

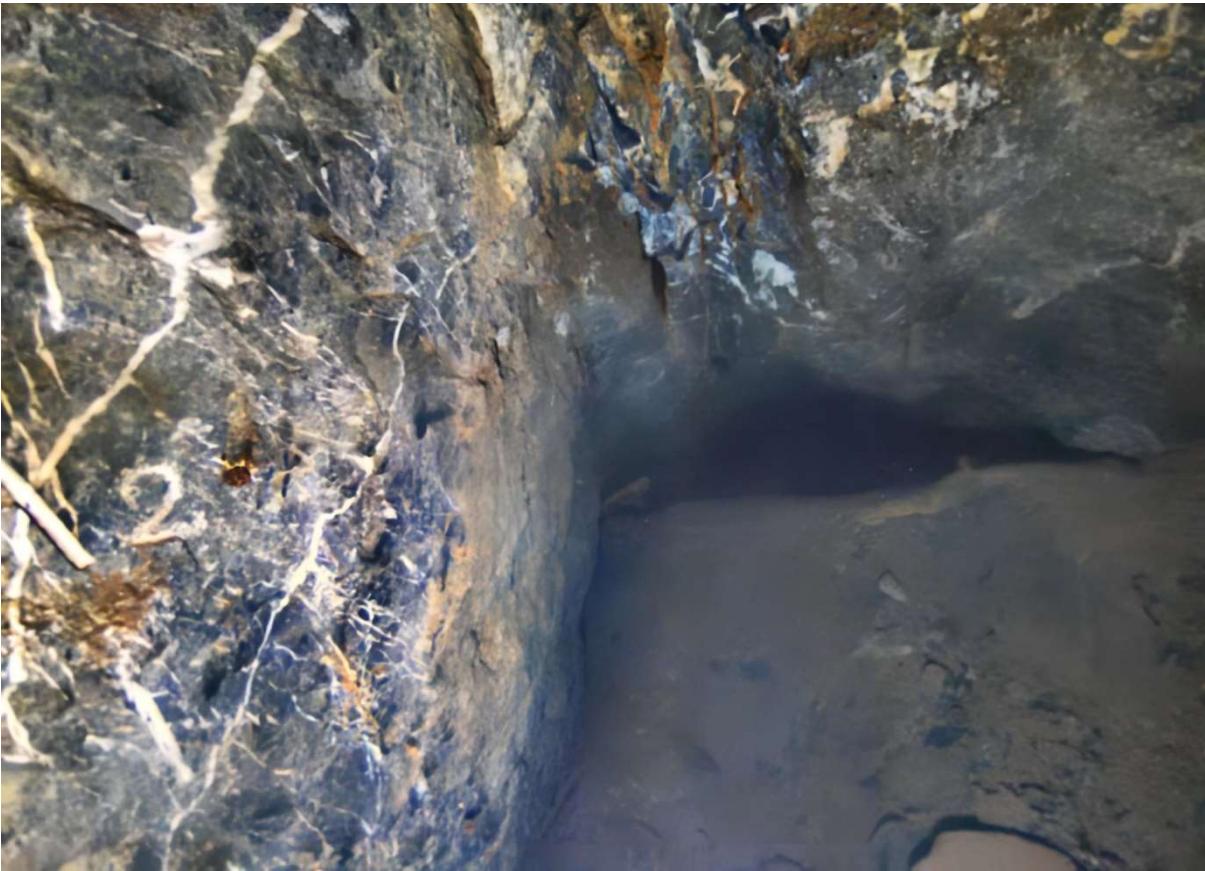
Plate 10: To the left is the PS19A number 2 inscribed with a pick by a miner for reasons unknown in the side wall of the pumping shaft. To the right is the largely backfilled probable PS19 'level' or possible 'side pipe working'. In the left wall of this passage there is an iron 'eye'

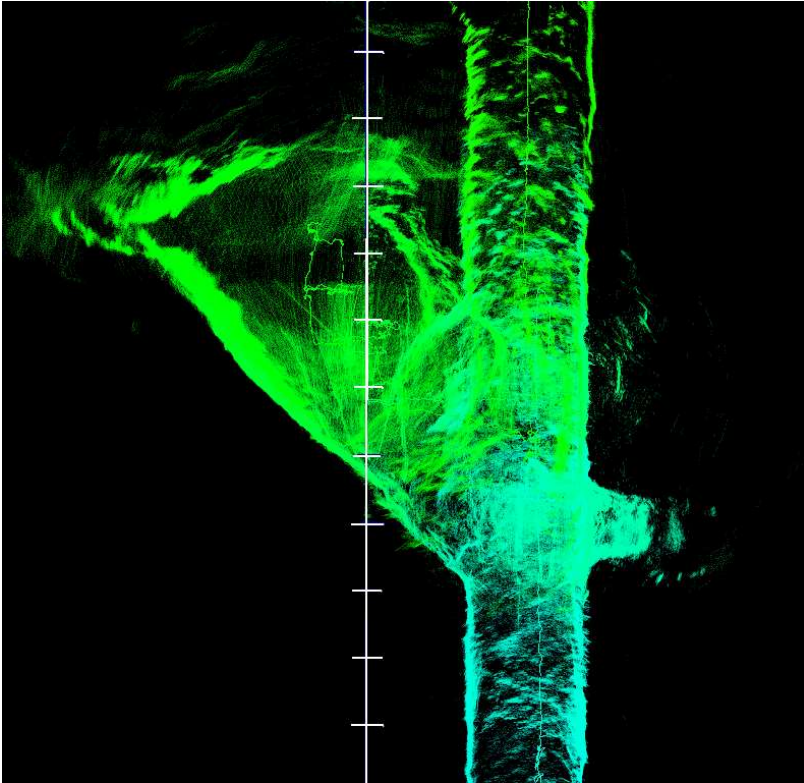
Figure 30 Sonar plot of large pipe-workings at PS15, here to the left of the pumping shaft, explored in 2022. The two intersect each other at -90.3 to -96.5m down (the vertical scale is at 2m intervals). PS16 lies to the right of the shaft, where the sonar plot shown here did not include one or possibly two continuations as they run away at angles from the orientation of the plot.

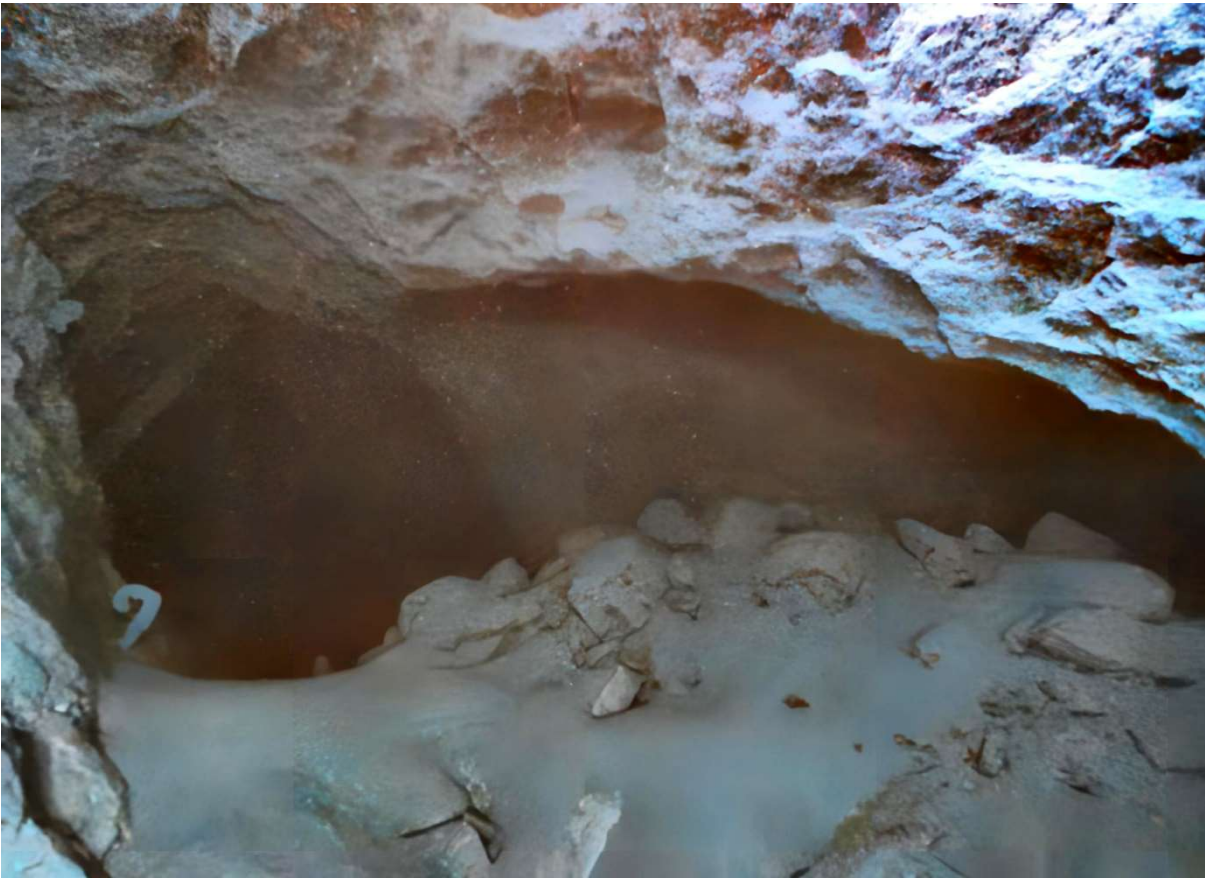
Plate 11: The PS 16 ‘side pipe working’ at c. -95.5m to -99.0m down the pumping shaft in its south-western side. To the left there is a passage with an in-situ timber rising diagonally from the wall and also an iron hook placed not far from the shaft. Both the floor and the rubble heap are partially covered by a fine sediment. This may be the same ‘side pipe working’ as that leaving the winding shaft at WS11. To the right side of the image there may be another passage running off but the dark area is perhaps just a shadow.

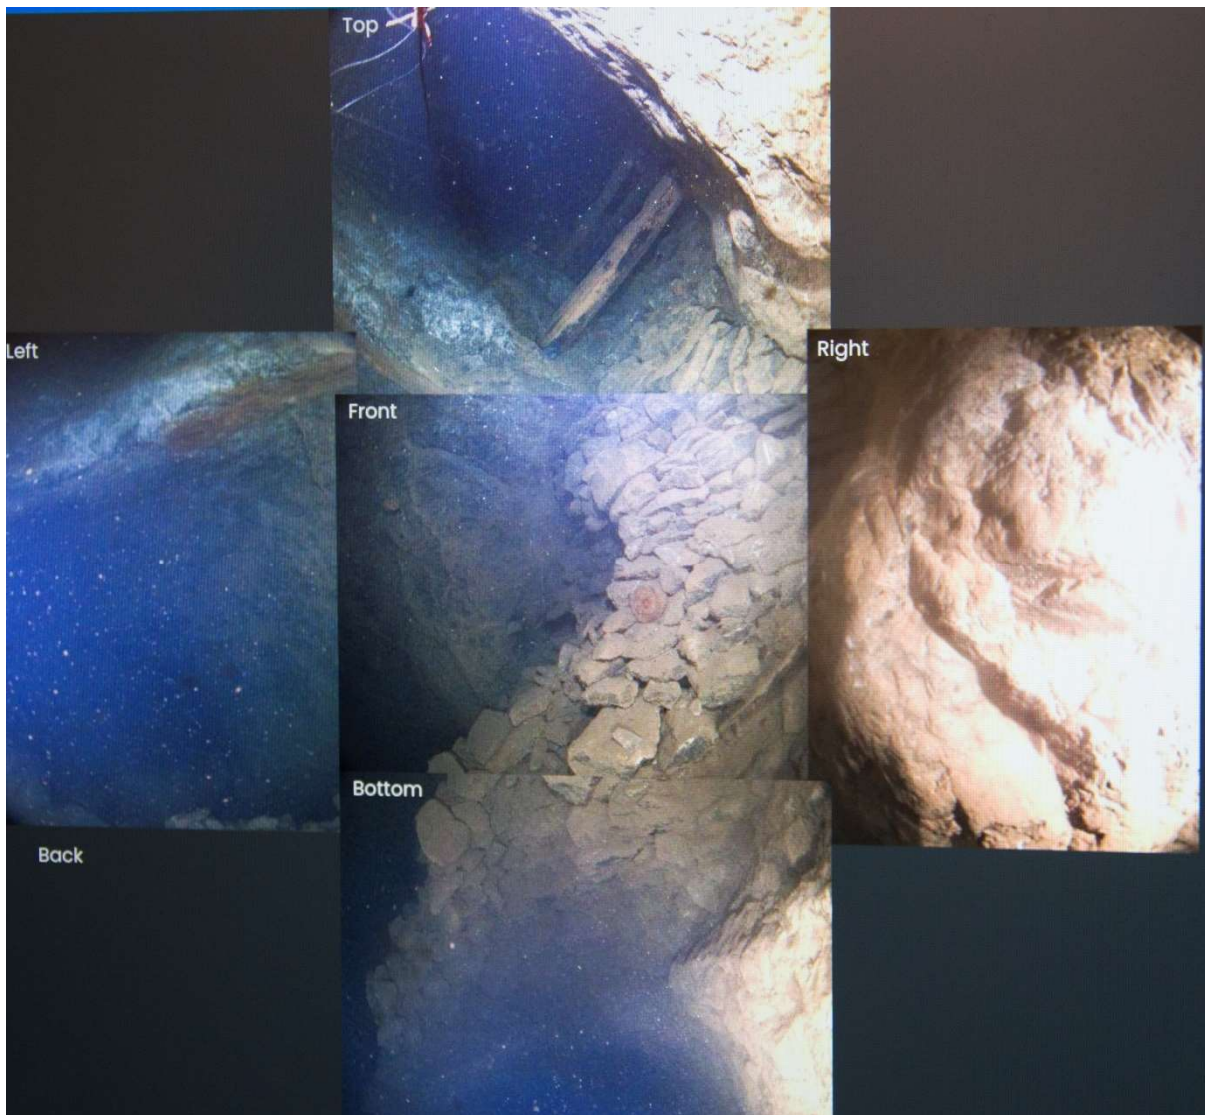
Plate 14: The five camera views photographed from a monitor in real time during the 2022 dive at the winding shaft, taken when the robot was facing roughly horizontally to investigate features at WS12. The main cavity of WS12 lies to the left, while the winding shaft is to the top and bottom. The drystone wall goes up to a timber platform at the left side of WS11; note the small circular ‘wheel’ near the centre of the ‘Front’ image.

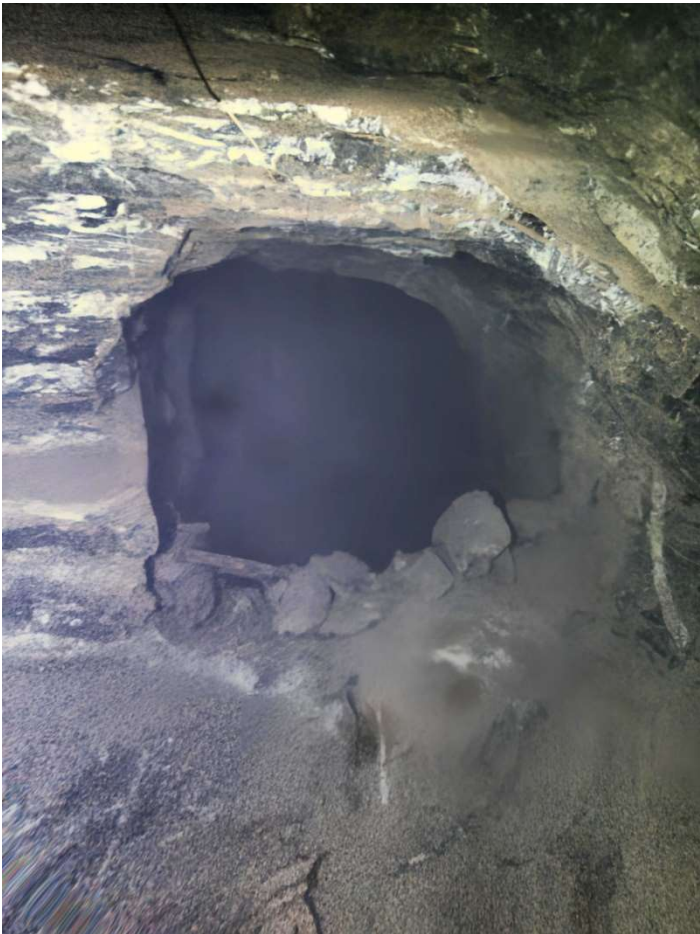
Plate 15: The WS5 opening looked at from the PW6 'main pipe working', with the side walls of the winding shaft just visible behind the rubble-covered ledge between the two features.

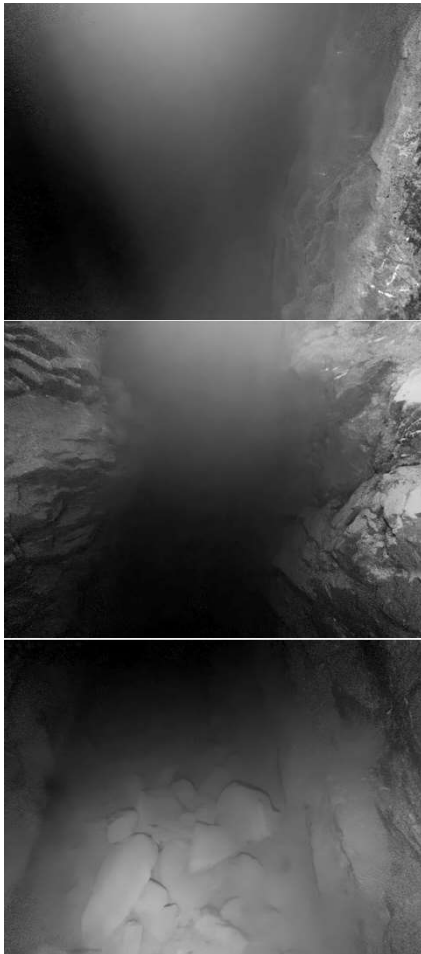
Plate 16: The tall PW11A 'stope-like' passage with sinuous sides running off the NNW end of the PW11 main chamber, which is so tall that it can only be captured by looking at three cameras simultaneously

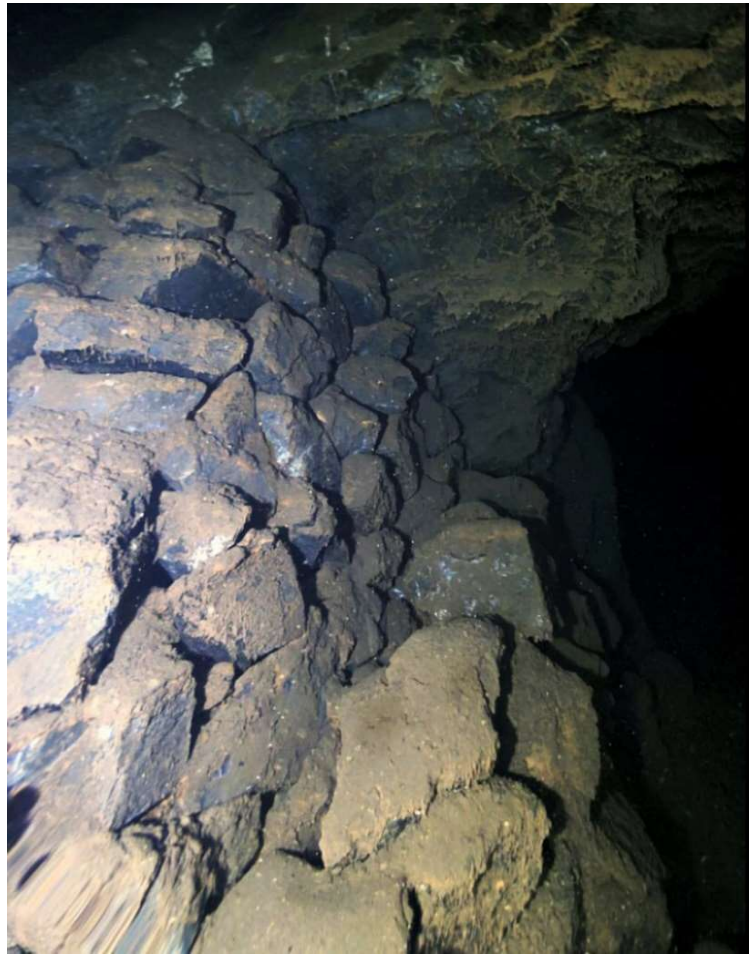
Plate 17: One of the packs of deads at PW11B, with a bedrock pillar behind, and to the right one of the openings that has not yet been explored but probably goes to the PS8 'side pipe workings' at the side of the pumping shaft

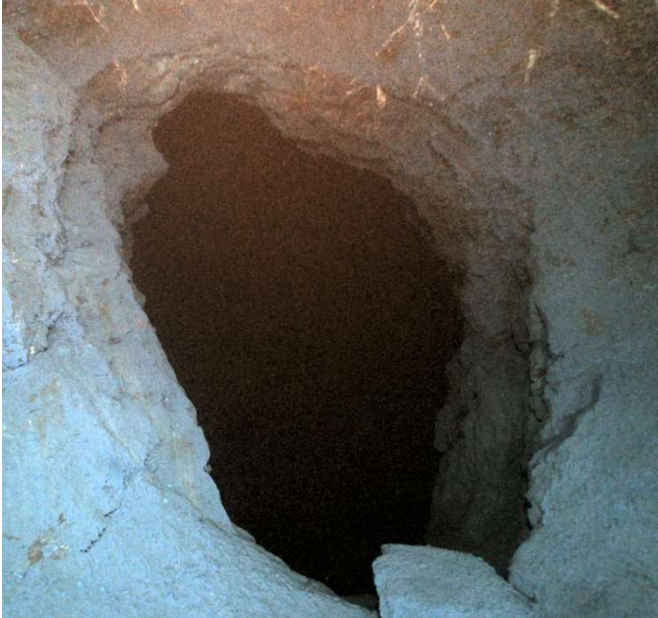
Plate 18: The hole in the main chamber wall at PS11B that leads into the PS8 'side pipe working' entered from the pumping shaft

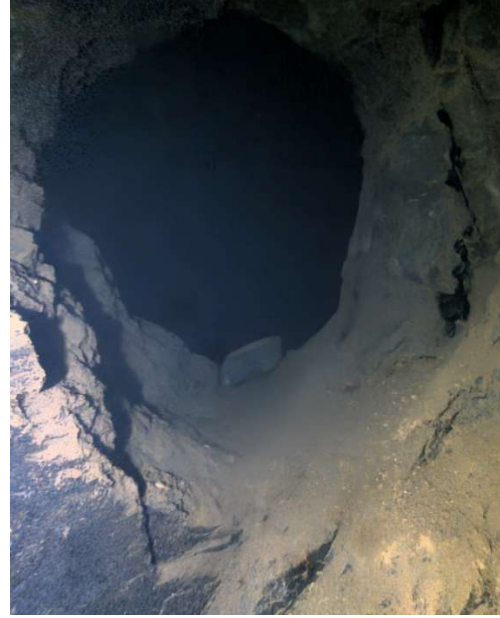
Plate 19: The hole in the main chamber wall at PS11B as seen from the other side where it is high in 'side pipe working' entered from the pumping shaft (PS8)
