EITRM116871: D2.3 Geoscientific evaluation of pilots

KAVA Reference (Number, Acronym, Full Title): 19160, UNEXUP, UNEXMIN Upscaling

Name of the author/Responsible partner: Hilco van Moerkerk, Zorana Milosevic, Steve Henley (RCI), Richard Papp (UGR), John Barnatt (Ecton Mine Educational Trust), Richard Shaw (Ecton Mine Educational Trust)

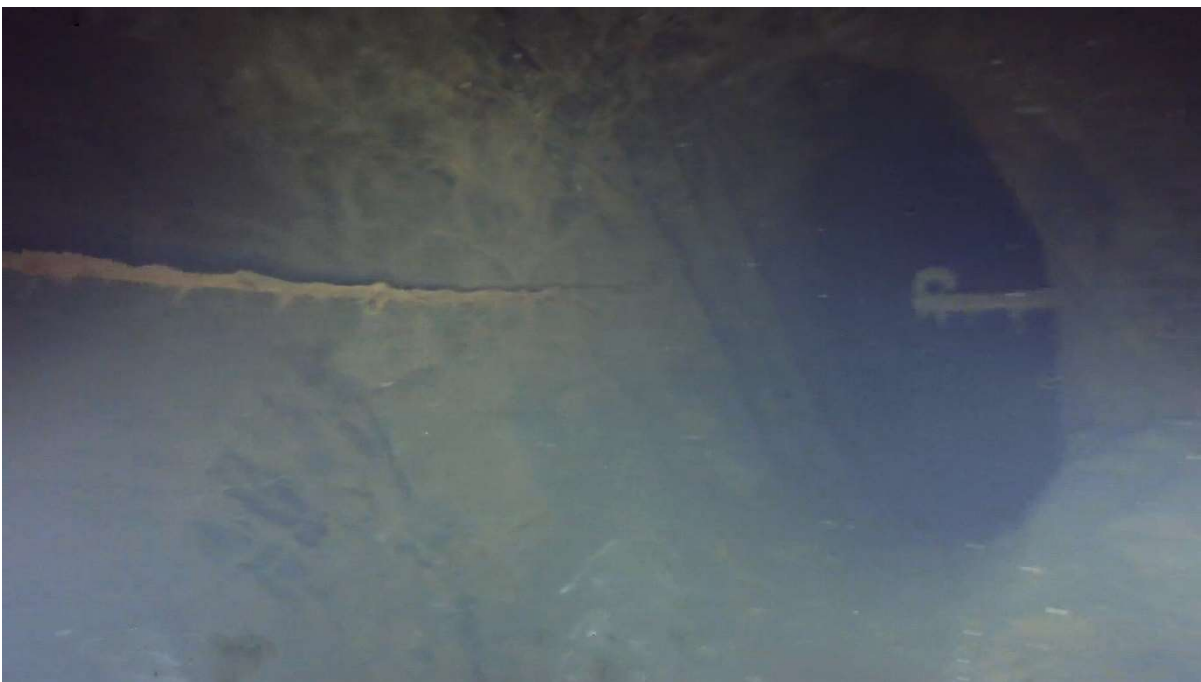
Plate 20: The metal chain across the large 'pipe working' that runs WNW from the PW1 upper chamber in the 'main pipe working'. The camera is looking into the 'cross cut' running NNW. The chain provided a 'hand-rail' for a bridge near the 'pipe working' roof, with a hook on the opposite side for a second chain. Presumably there was once a timber that was used to walk on

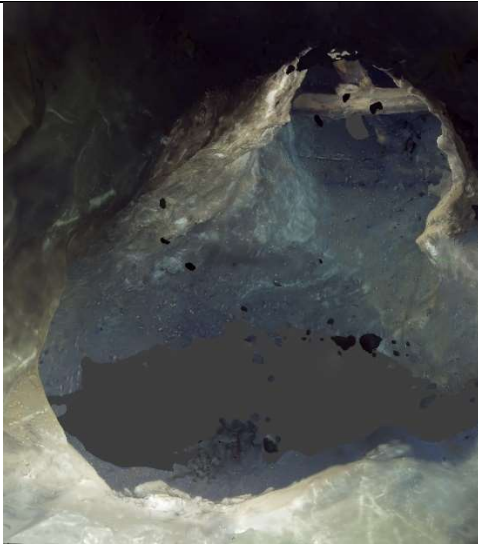
Plate 21: A composite image compiled using 'Agisoft Metashape' photogrammetry software using camera video footage taken by the BlueROV2 submersible. This shows the rising 'side pipe working' passage to the eastern end of the PW1 chamber. The timbers above, with two beams supported a timber working floor, one plank of which remains, can also be looked down upon from a small chamber' running from the north-east corner of the main void just above the water

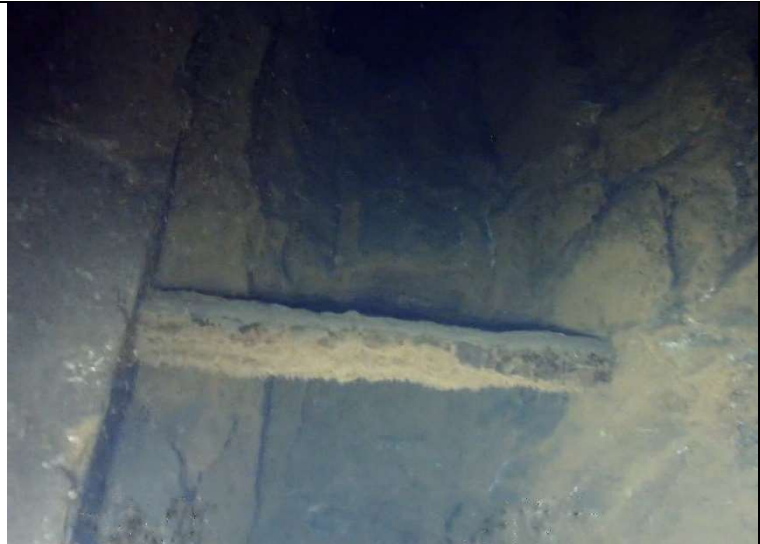
Plate 22: A timber beam, presumably for a working platform, in the tall alcove near the north-eastern corner of the upper 'main pipe working' chamber at PW1

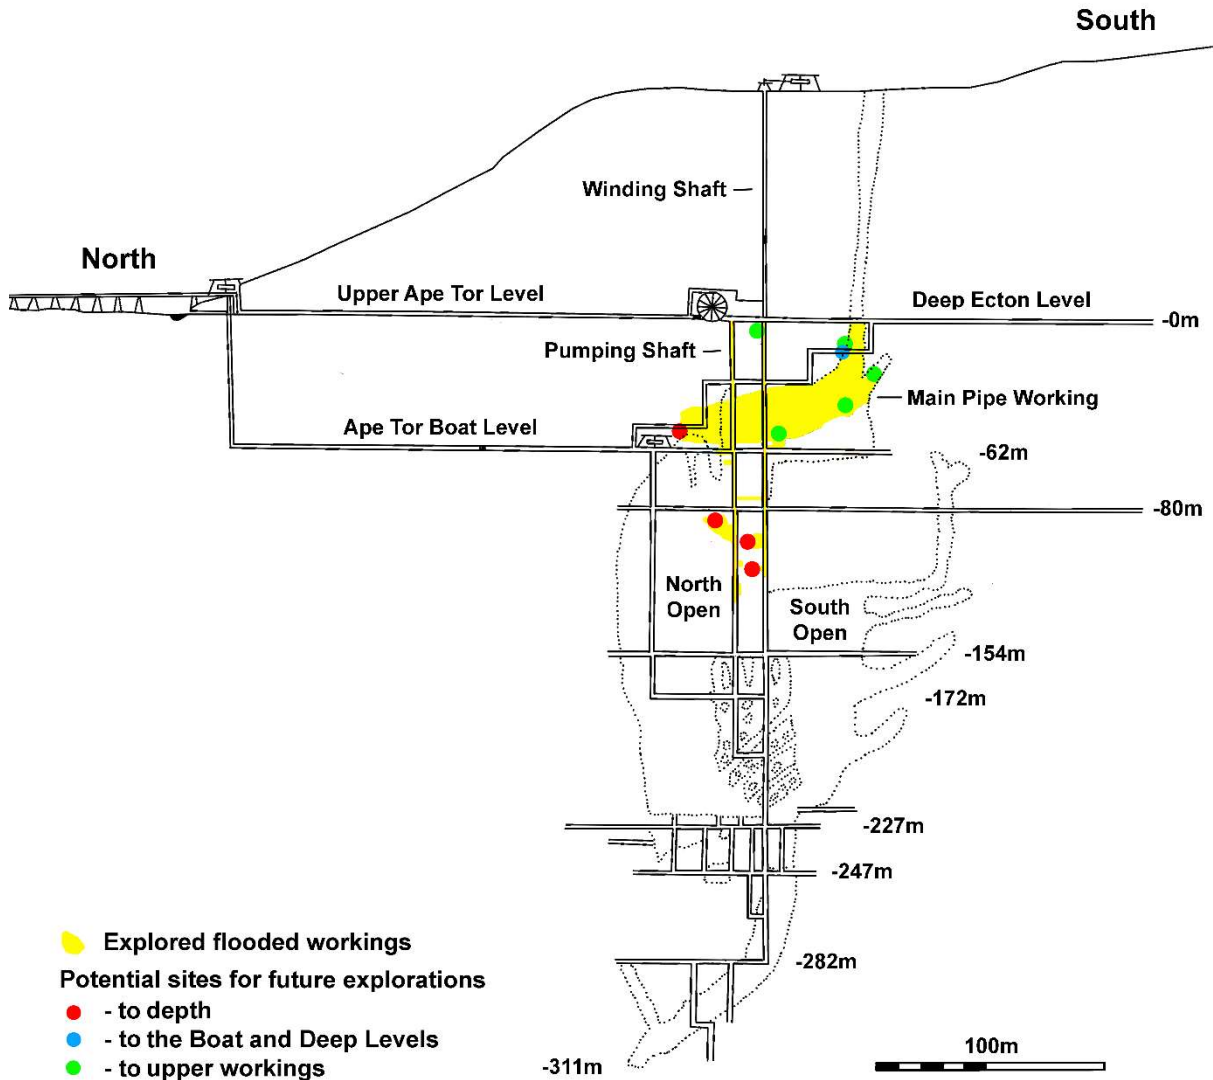
Figure 31 The distribution of known potential leads for future exploration after the 2022 dives, as listed in Table 7, imposed on the Meads' 1858 mine section. A distinction is drawn between those that may lead to the 'main pipe workings' at depth, one that could lead to the documented canal at -62m, and others where there are further explorations to be made in the upper workings.

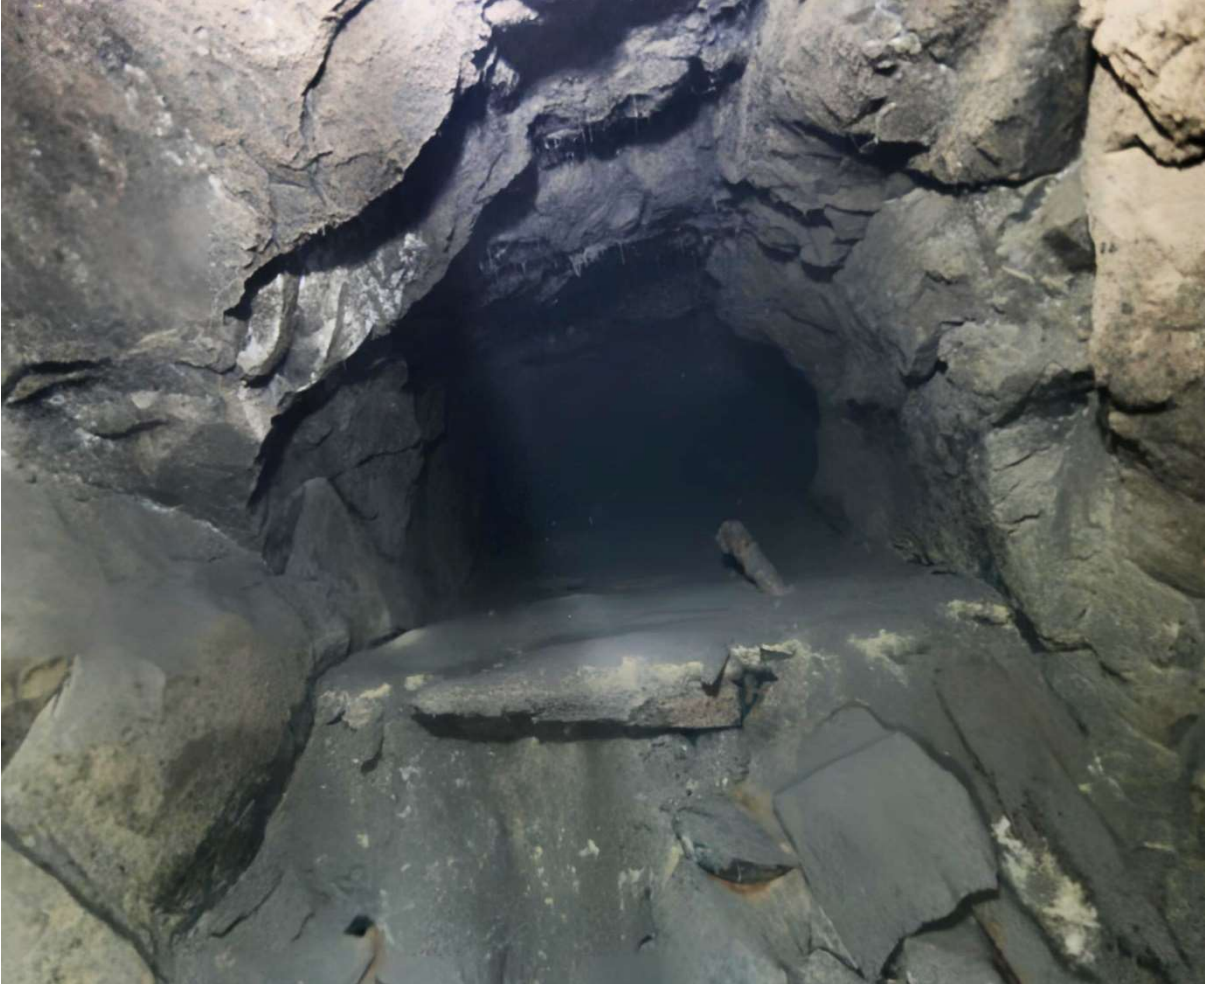
Plate 26: This small, part-backfilled WS1 'level' heads north from the winding shaft at a point only just below c. -5.0m from the shaft top. It has not been entered and while it is heading towards the pumping shaft there is no matching opening at this depth and thus its destination is elsewhere

<p>-5.00m to -6.70m</p>	<p>WS1</p>	<p>Small ‘Level’: This passage lies at the north end of the shaft in the half towards its north-east corner (Fig. 7; Plate 26). The passage is round topped at the shaft wall and has a flat consolidated floor with a layer of rubble below; it was <i>c.</i> 1.7m high before the floor was added and it is <i>c.</i> 1.0m wide. The destination of this ‘level’, which heads northwards, is not known as there is no matching entrance in the pumping shaft. The ‘level’ bottom at the shaft wall is of rock and there is <i>c.</i> 1.0m of rubble fill above this. This fill contains a displaced sediment-covered timber at its top to the left. There is a small-diameter, displaced, metal pipe protruding from further down this fill to the right-of the timber; inside the passage its other end protrudes diagonally out of the passage floor.</p> <p>In the shaft wall, to the right side of the passage, set at a rock ledge, there is an iron pin with looped ‘eye’.</p> <p>There is a ‘garland’ channel above the ‘level’, cut into both sides and the north end of the shaft, with an apex at the north-west shaft corner at <i>c.</i> -3.2m down the shaft; both arms descending diagonally to the top of the ‘level’.</p> <p>Other ‘levels’ from the winding shaft are found at WS2, WS7, WS8, WS13 and probably WS12.</p>
